MW1 C STATION TRAINING AND INCIDENT CASE STUDIES

FILE NO. 2023 / 31.

**4th ALARM CIRCULAR QUAY HIGH-RISE
BUILDING UNDER DEMOLITION FIRE.**

Incident Type: Incident Type: High-Rise Office Building Fire (under demolition).

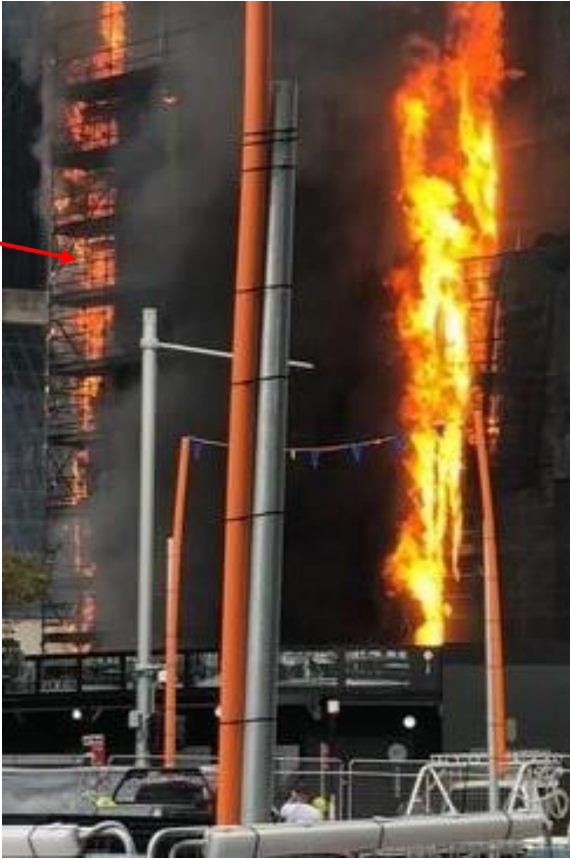
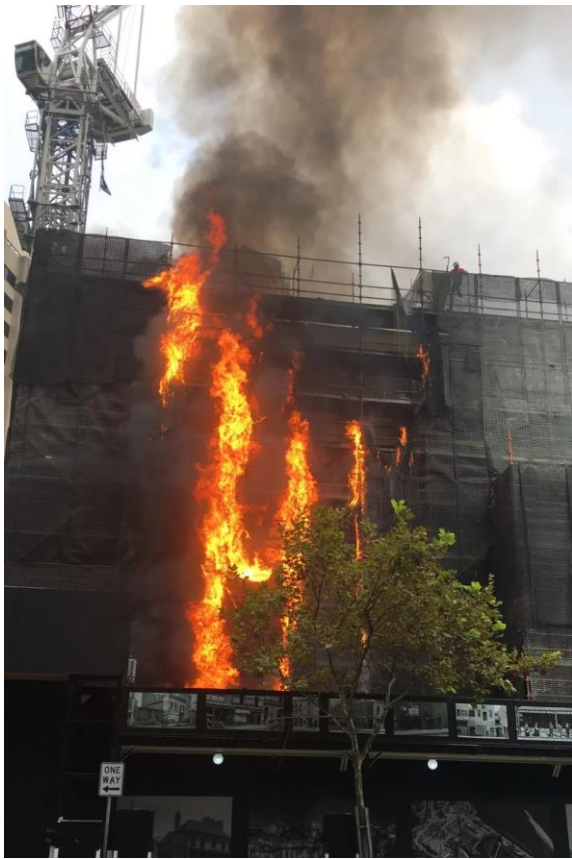
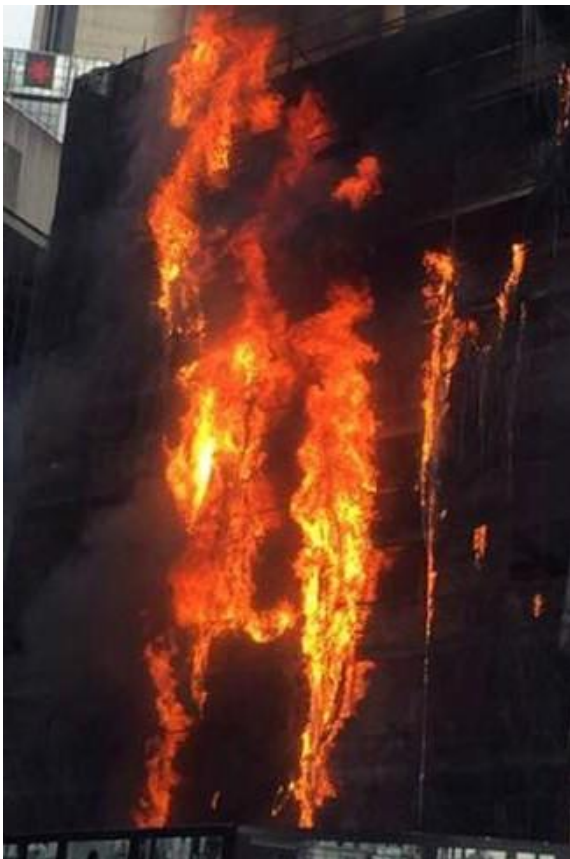
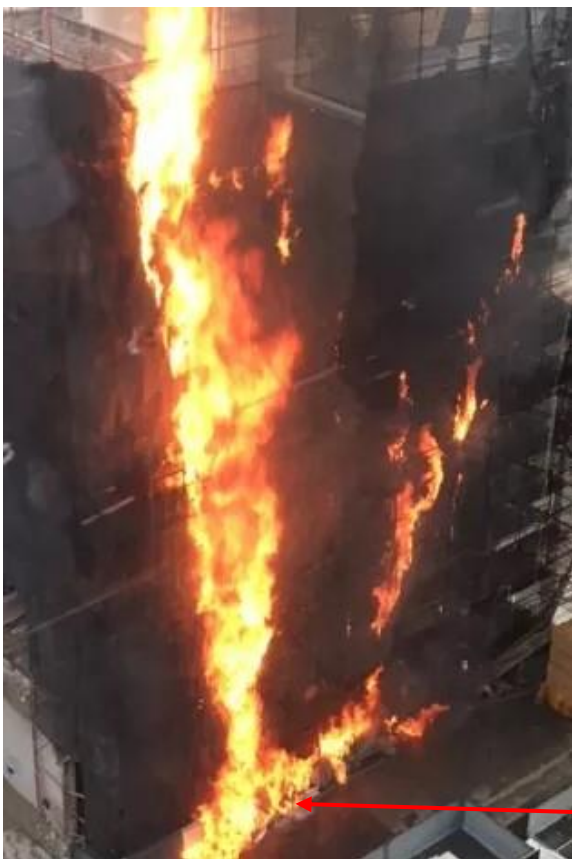
Fire ascending the external scaffold mesh on the Alpha side of the building. Flames spread rapidly in a vertical direction from bottom to top and then began spreading laterally. Photograph on the top left shows fire (A) has now progressed to the Bravo side wall. Burning material that has fallen from the mesh has ignited fresh fires at ground level (B). These fires spread into the basement where the gas cylinders were stored.

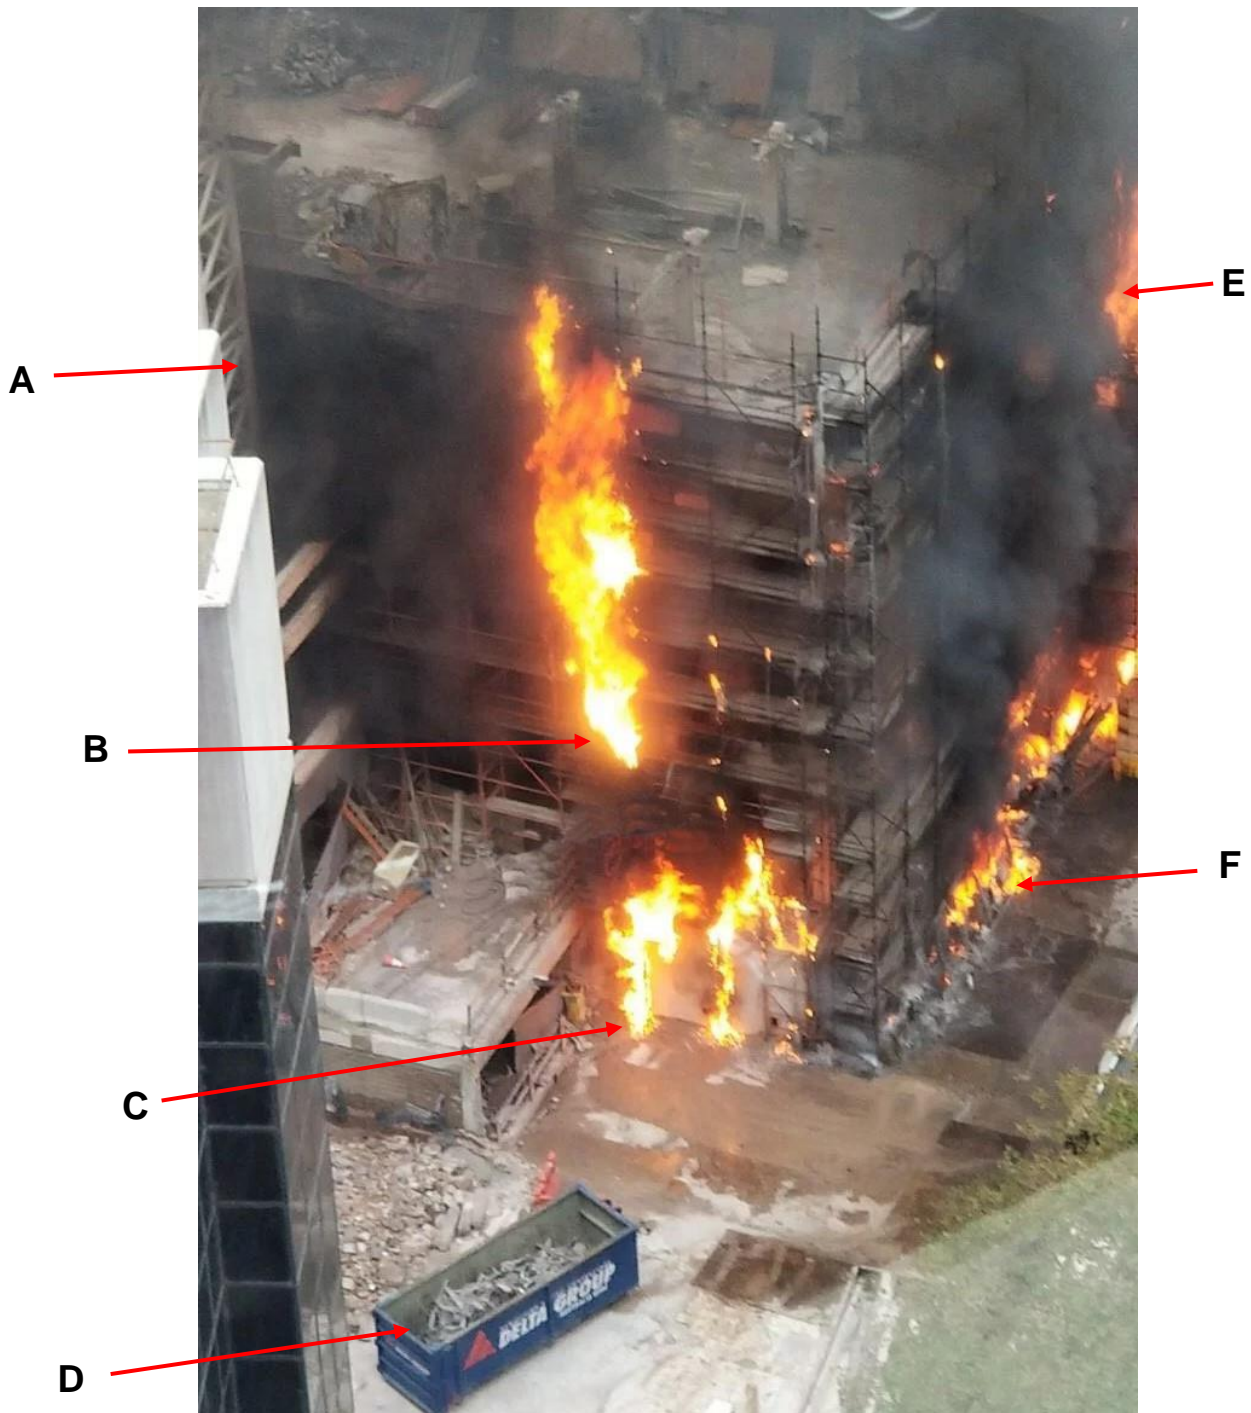
The fire scene shortly at about the time firefighters arrived: **A** The tower crane in the path of the spreading fire. **B** Fire spreading along the Bravo side scaffold mesh from right to left. **C** Fire that has ignited at ground level due to burning mesh falling, **D** Firefighters attacking the basement fire used this steel waste bin as a shield when the gas cylinders were exploding. **E** Fire spreading through the Alpha side scaffold mesh towards the Delta side of the building. **F** Fire that has ignited at ground level due to burning falling mesh. This fire involves stored rolled mesh and is spreading into the basement where gas cylinders are stored.

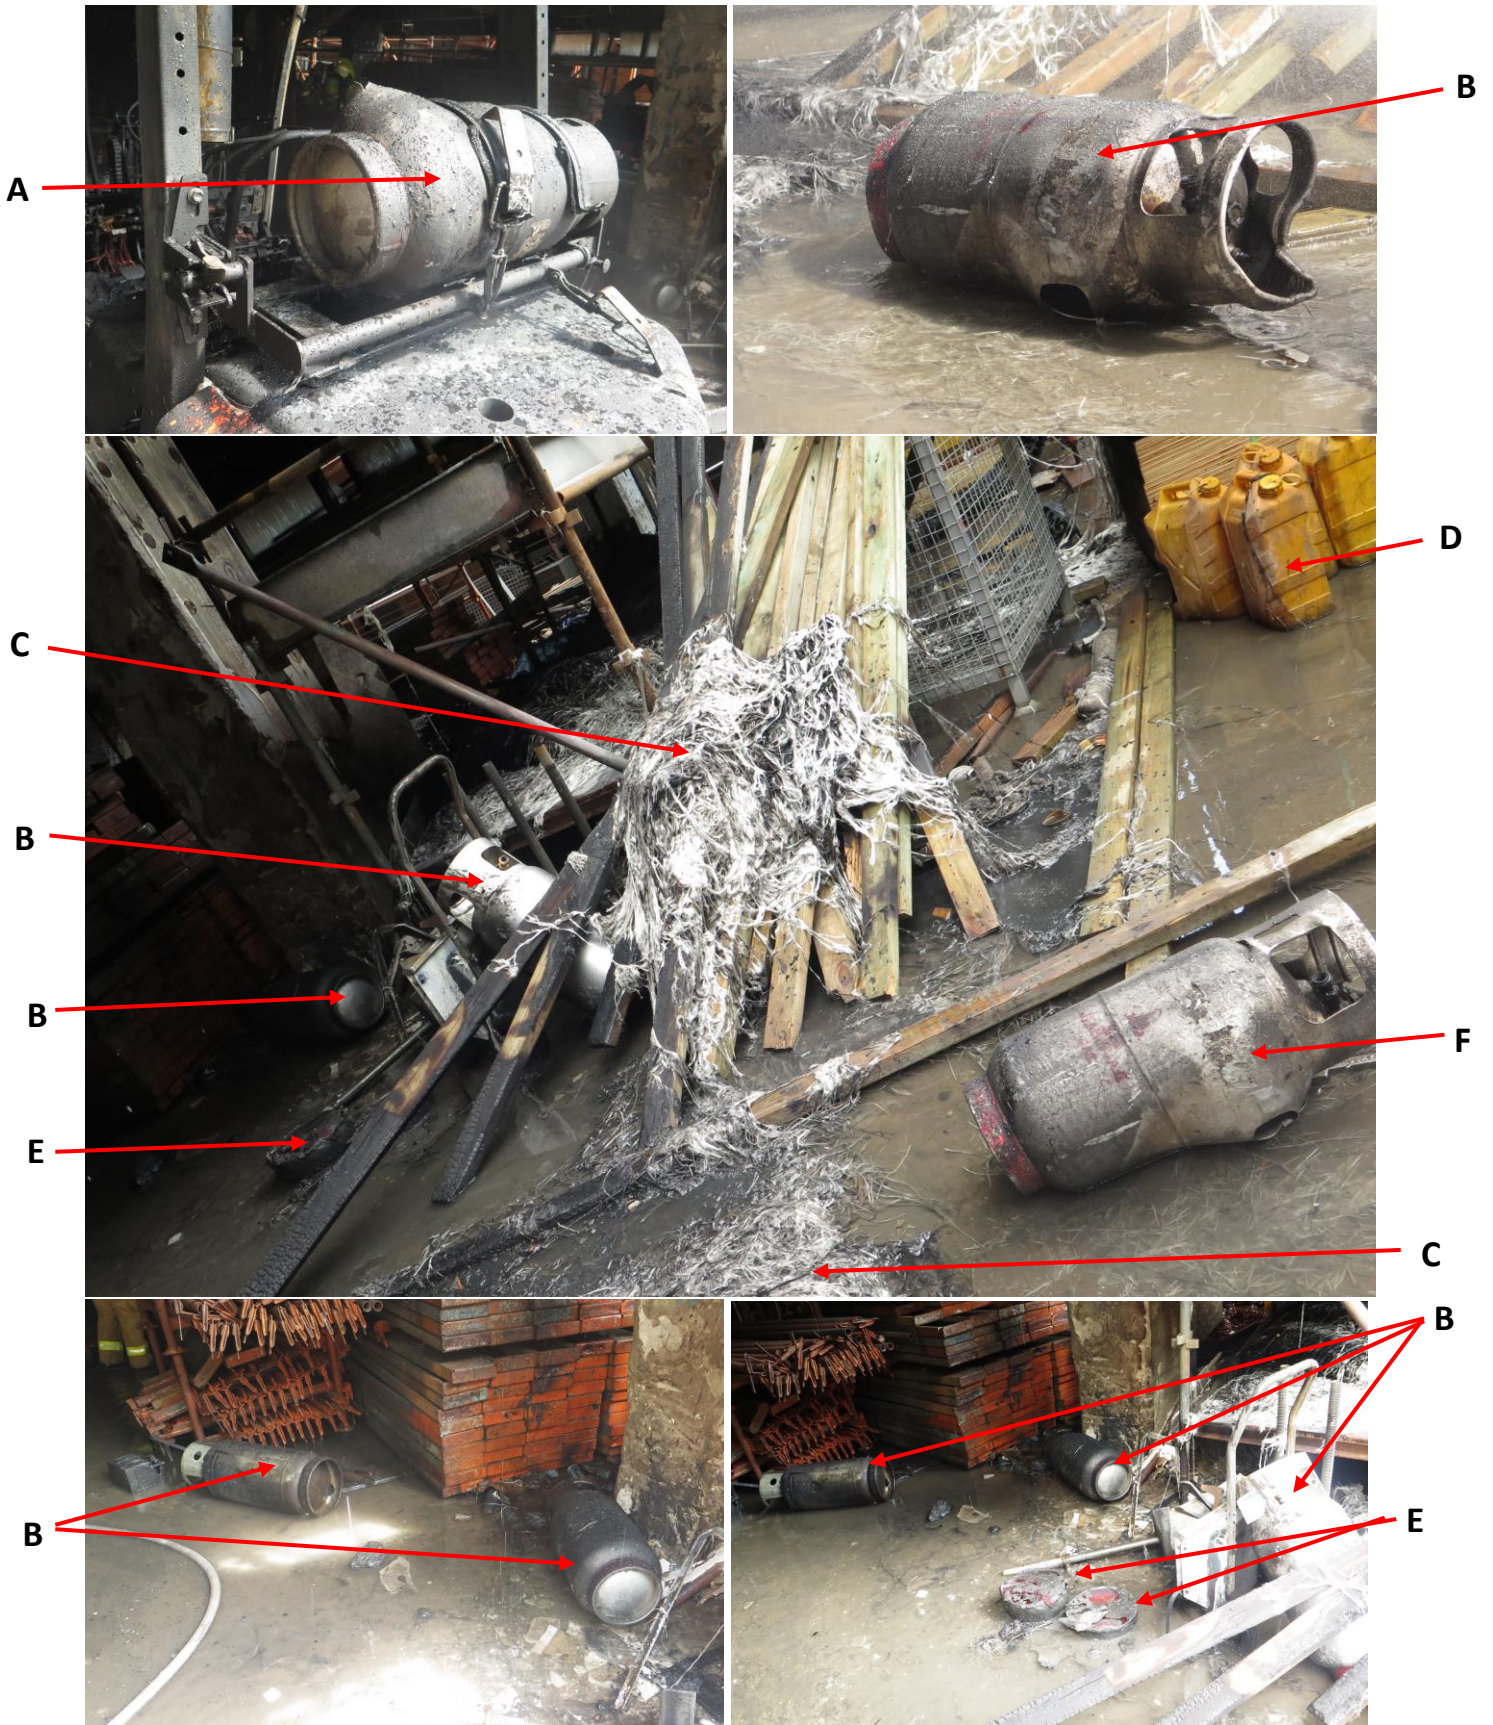
b. When temperatures beyond the capacity of pressure relief valves to operate adequately, the cylinder casing ruptured due to “over-pressure”, resulting in a BLEVE (Boiling Liquid Expanding Vapour Explosion) occurring. These events caused the sudden release of the liquid contents of the cylinder that rapidly expanded and mixed with air, producing an explosion. The cylinders or parts of the cylinder were projected extremely violently due to this explosion. Heat caused by the explosion was extreme.

c. The lighter cylinder casings of some LPG cylinders exposed to flame impact burnt through, allowing gas to escape and rapidly burn.

A Ruptured LPG cylinder on a forklift **B** Projected LPG cylinders. **C** Fallen high-density Polyurethane mesh creating intense fire activity at the basement entrance. **D** Stored diesel fuel. **E** Remnants of LPG cylinders following BLEVE. **F** Ruptured and projected LPG cylinders.

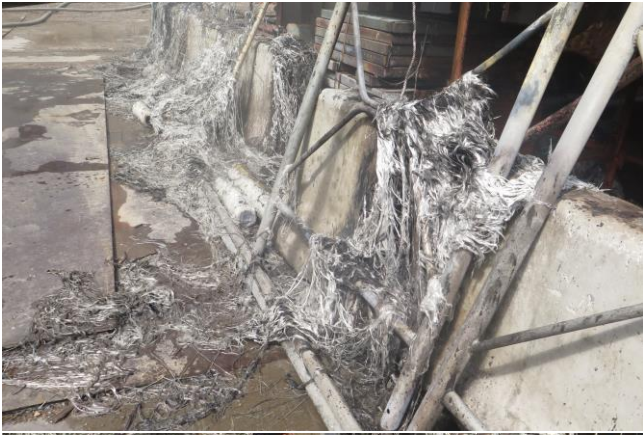
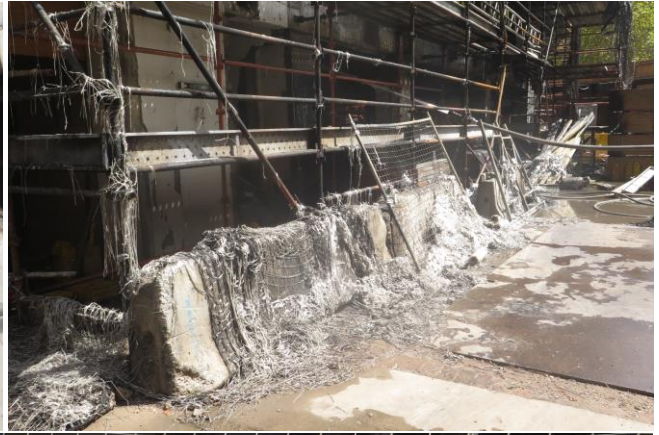
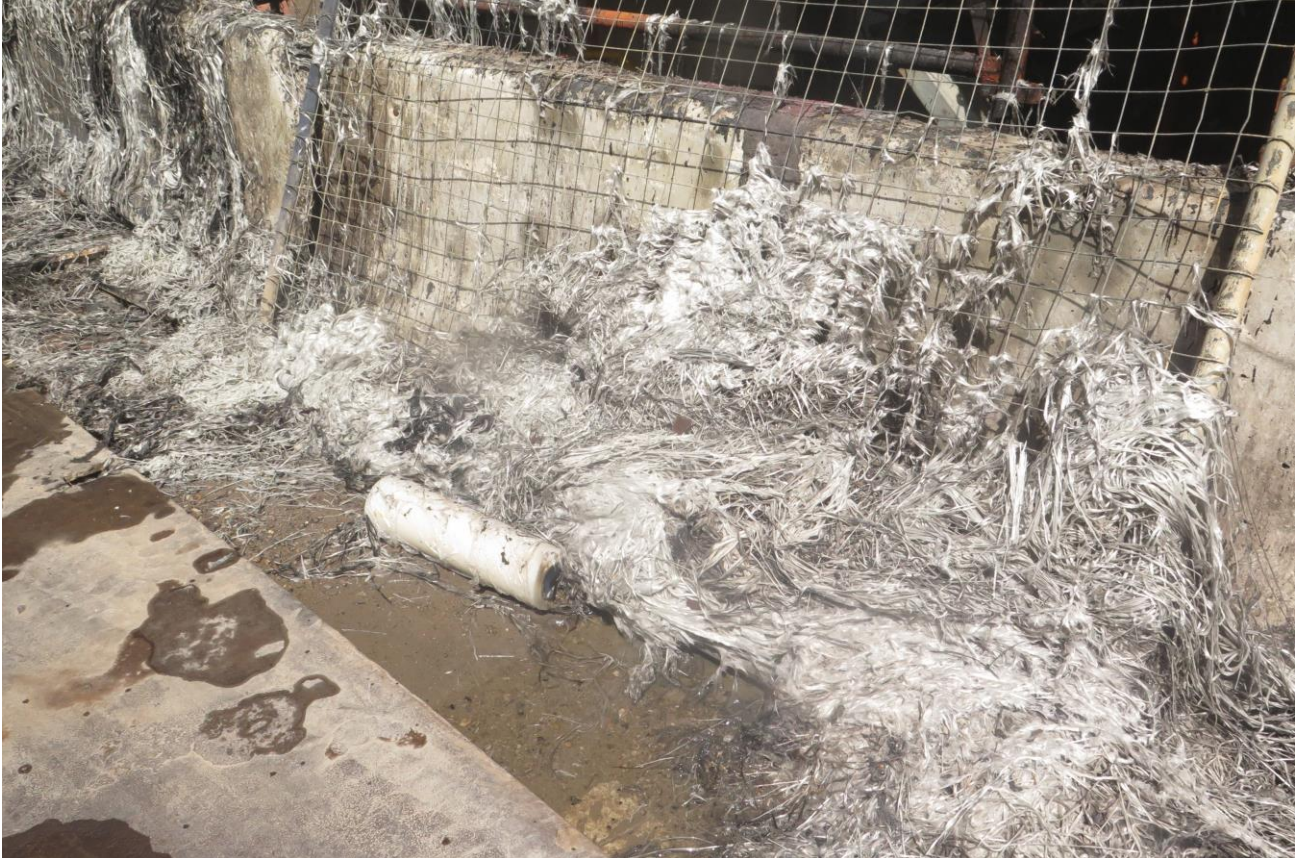
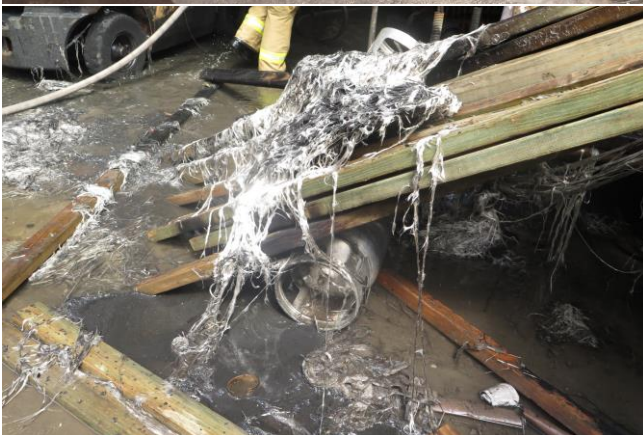
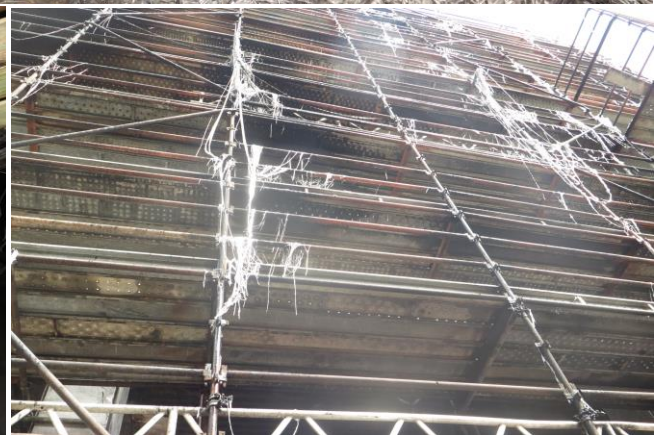
Fire initially involved scaffolding containment mesh, formed of high-density polyurethane and fiberglass reinforced banding. The **burning mesh separated and fell** igniting fresh fires on lower levels and at ground level, adjacent to the basement. Fire intensity of the burning mesh was severe, resulting in fire entry into the basement and explosion of multiple stored gas cylinders within the basement.

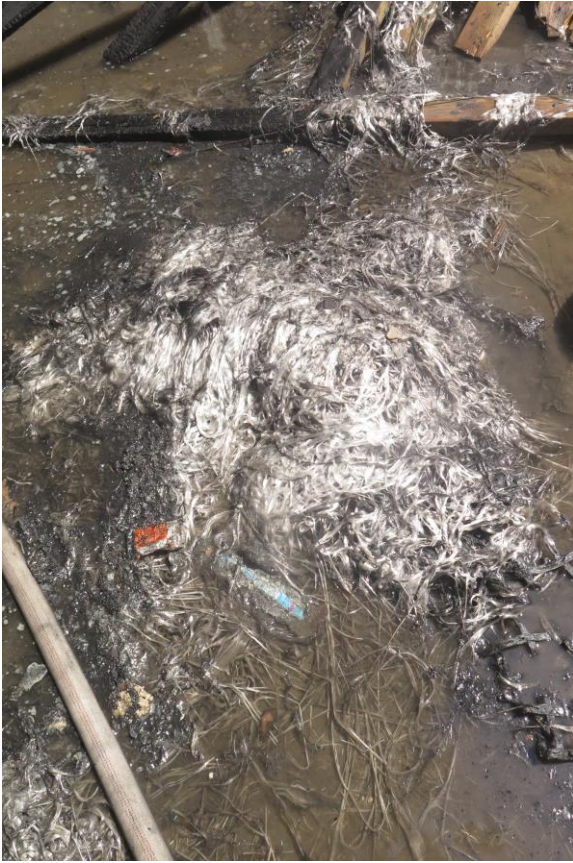
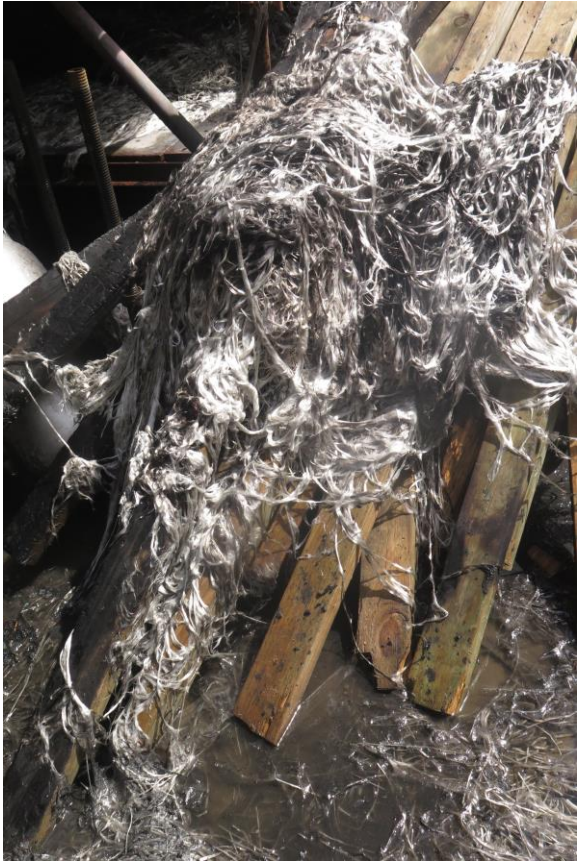
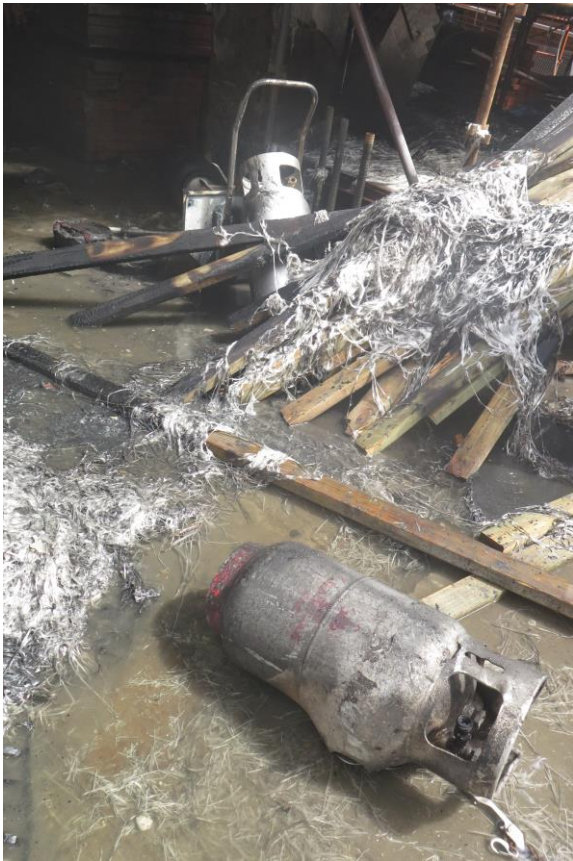
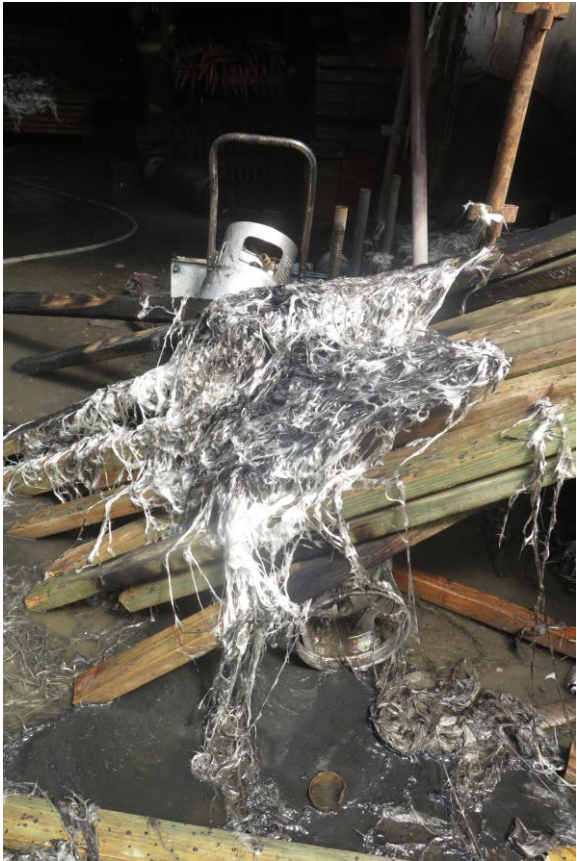
Fire initially involved scaffold containment mesh, formed of high-density polyurethane and fibreglass reinforced banding. The **burning mesh separated and fell** igniting fresh fires on lower levels and at ground level, adjacent to the basement. Fire intensity of the burning mesh was severe, resulting in fire entry into the basement and explosion of multiple stored gas cylinders within the basement.

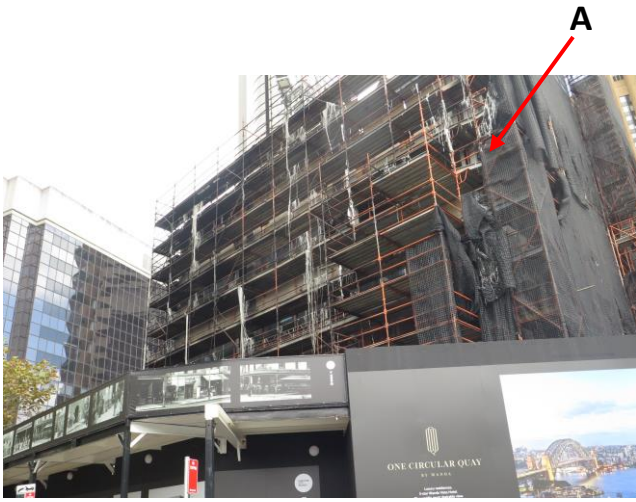
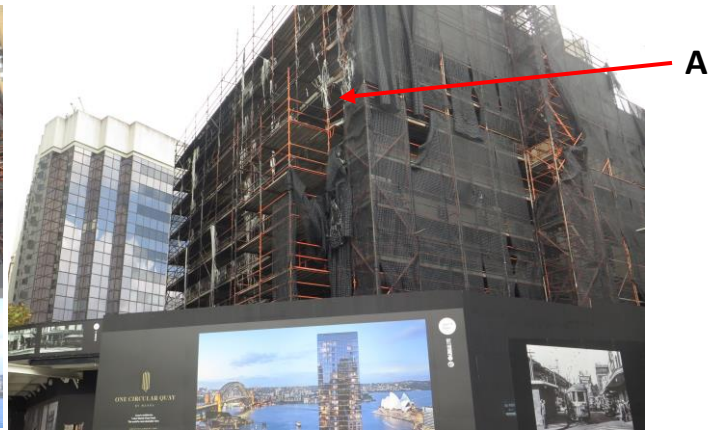
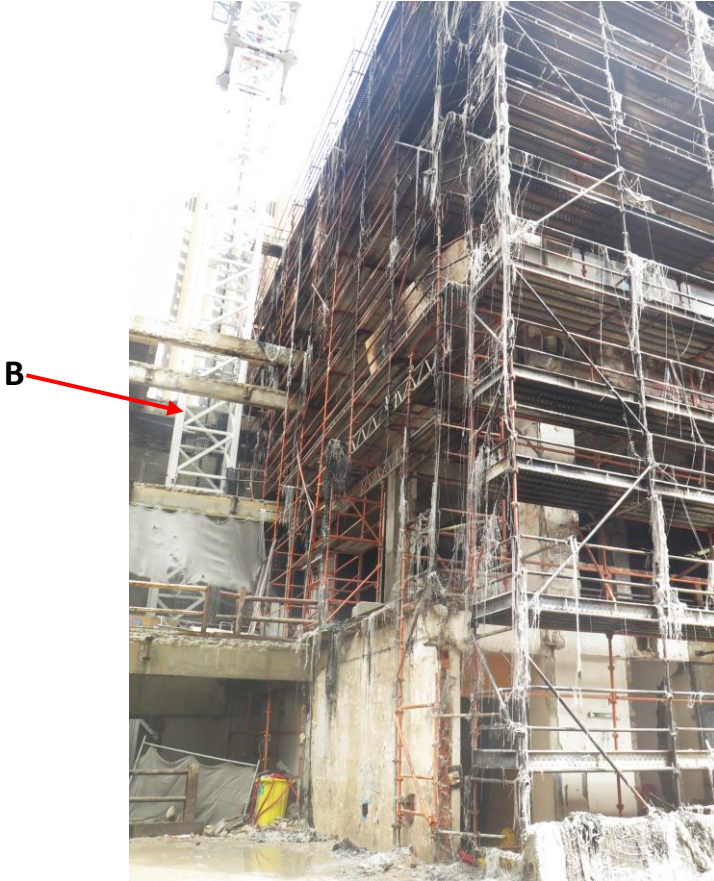
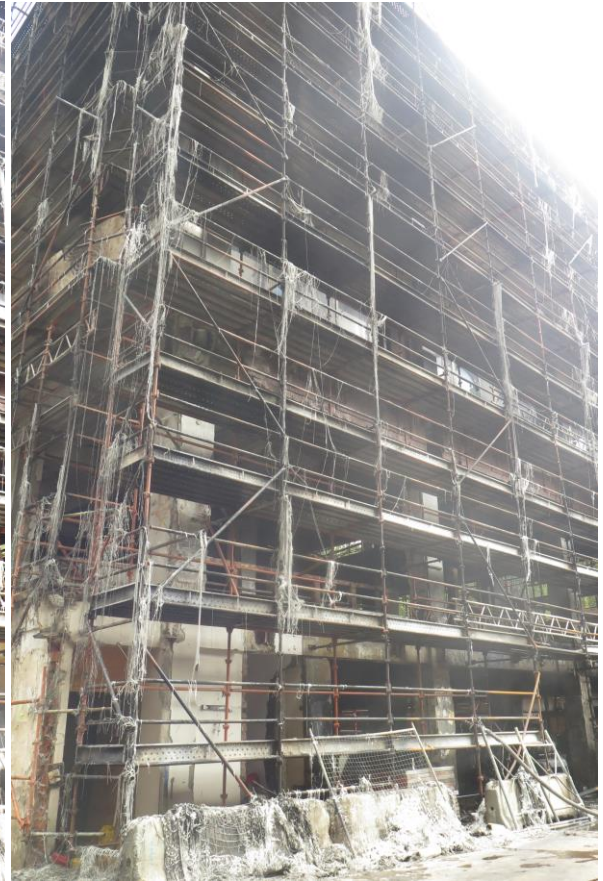
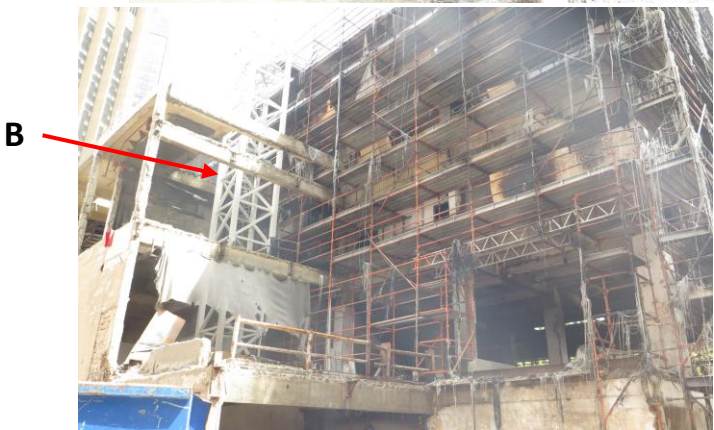
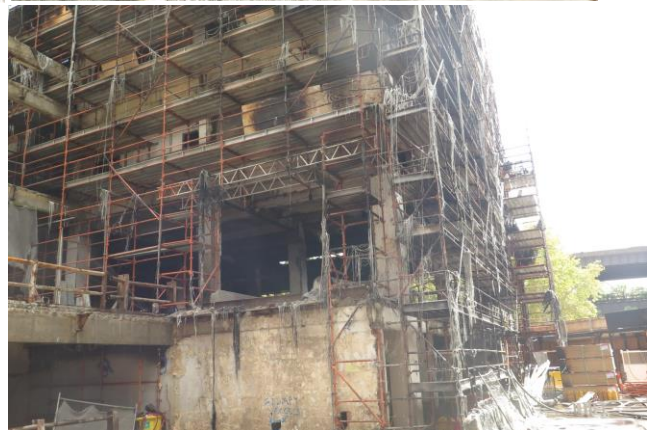
Fire burnt through the scaffold containment mesh on the Alpha and Bravo sides of the building. Ladder Platform 4 firefighters established containment on the Alpha/Delta corner **A**. Ladder Platform 1 cut the fire off on the mid point of the Bravo side. The steel support tower of the tower crane **B** was vulnerable to fire impact and protected by cooling streams from Ladder Platform 1.

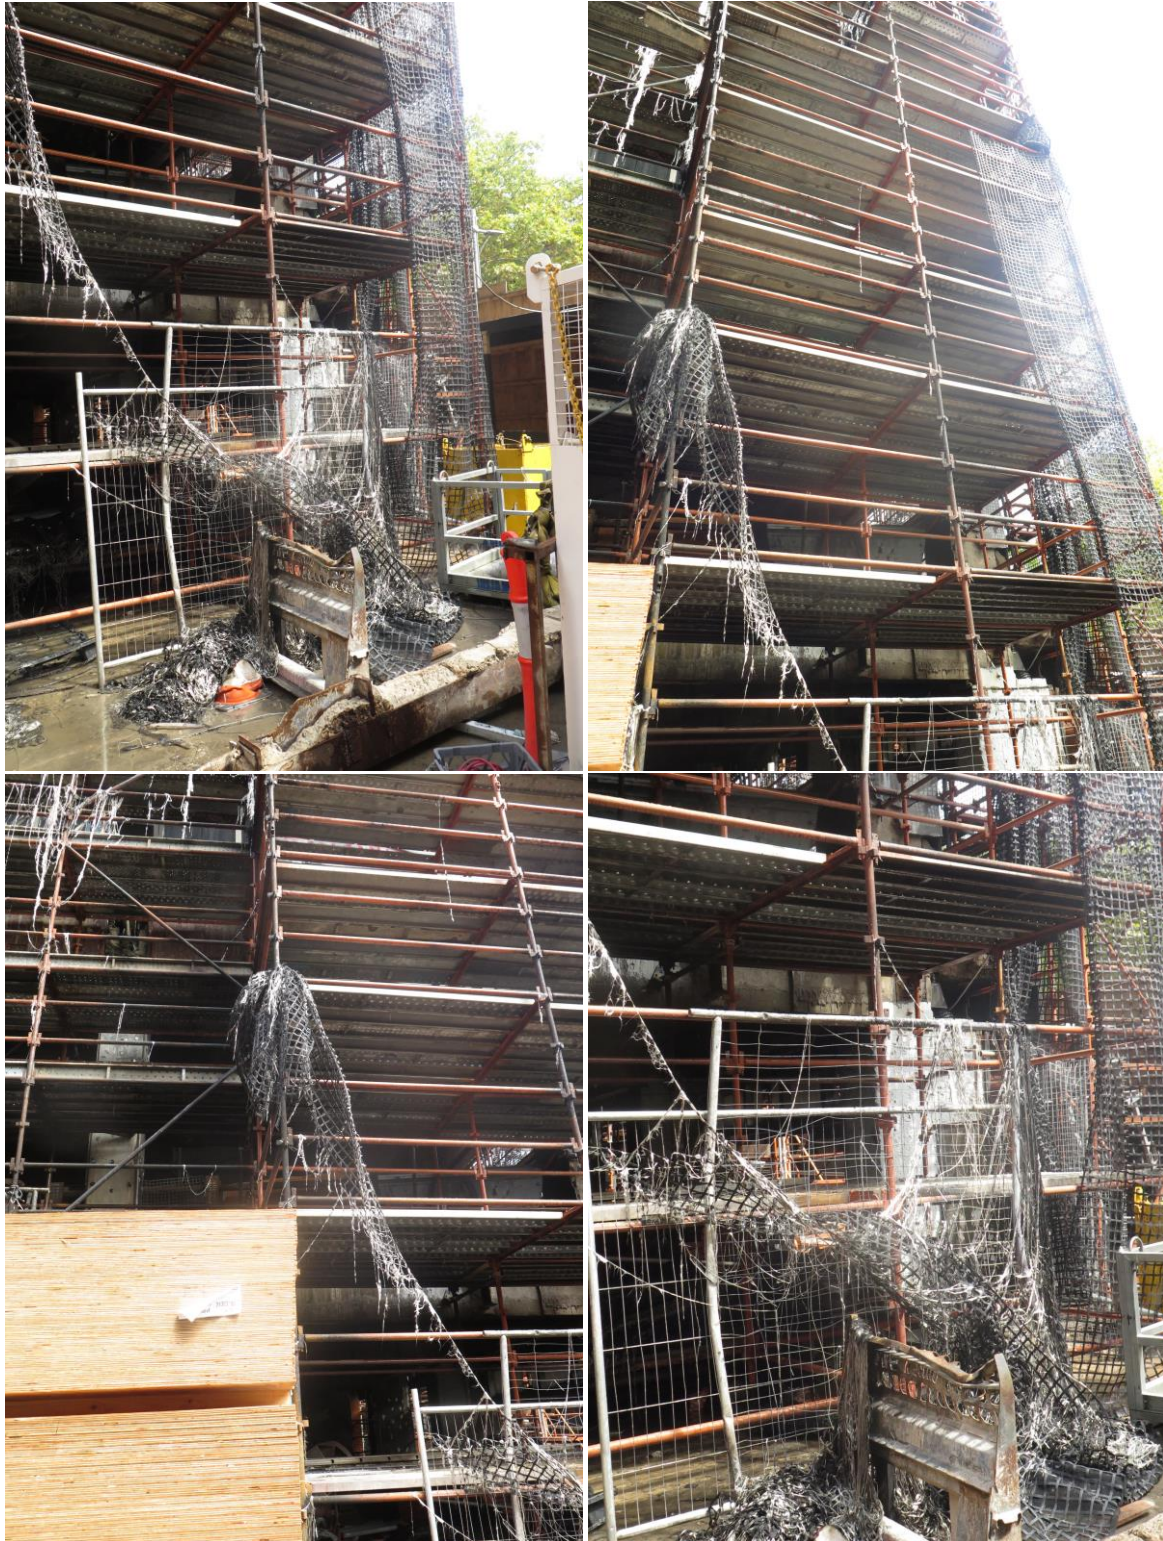
As fire ascended and progressed through the scaffold containment mesh, the material forming the mesh lost strength and failed, allowing large sections of burning high-density polyurethane to separate and fall, igniting new fires. There were three problems with the scaffold containment mesh; fire ascended the mesh, fire travelled sideways and fire “dropped down” ignited new fires on lower levels.
