MW1 C STATION TRAINING AND INCIDENT CASE STUDIES

FILE NO. SR / 02.

**11th ALARM PORT KEMBLA ETHANOL BULK
STORAGE TANK FIRE**

Flammable Liquid Bulk Storage Tank Fire - Full Surface Fire.

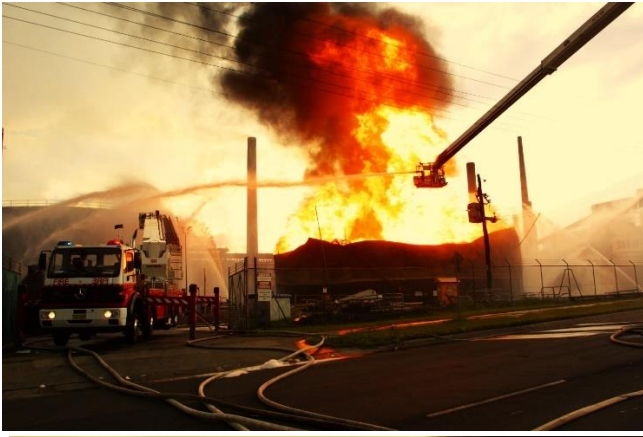
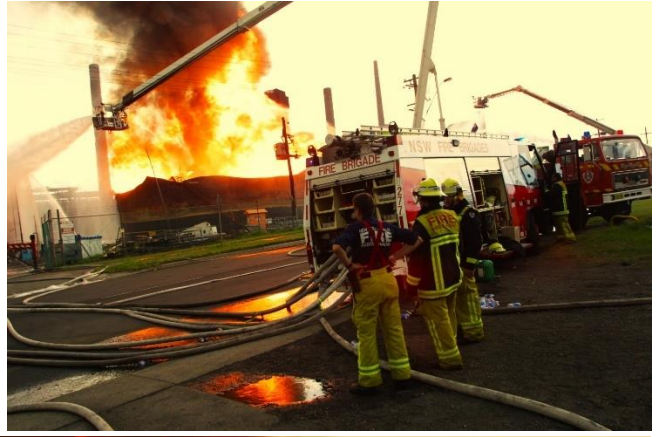
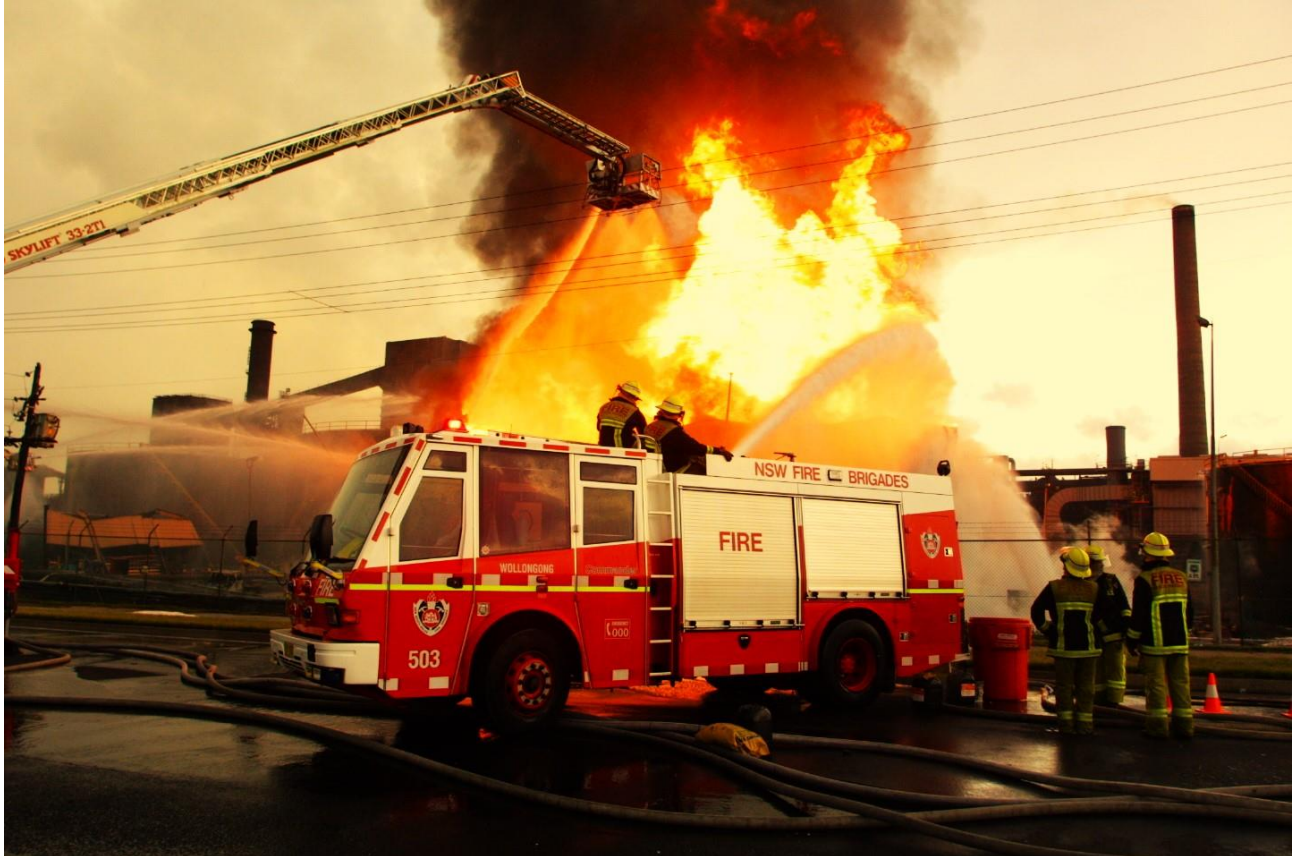
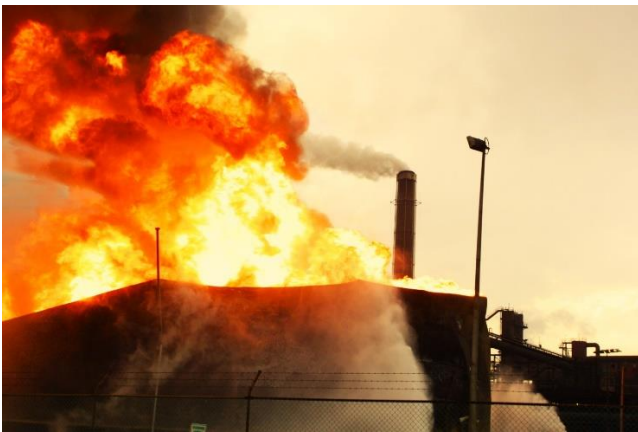
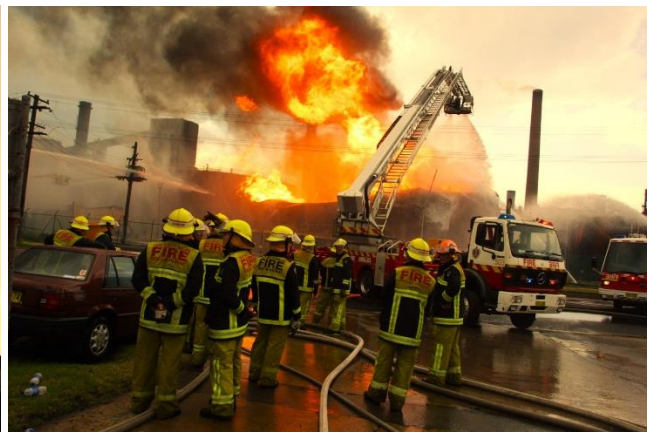
Upper: Hydraulic Platform 21 and Ladder Platform 18 direct an aerial master stream onto the side of heavily threatened Tank 14 containing 13 million litres of heavy marine bunker fuel oil. Middle: Firefighters operating the Super Pumper 503 roof monitor direct a protective stream onto Tank 8. Lower: Flames erupt from the surface of the ethanol tank fire, creating enormous levels of radiant heat.

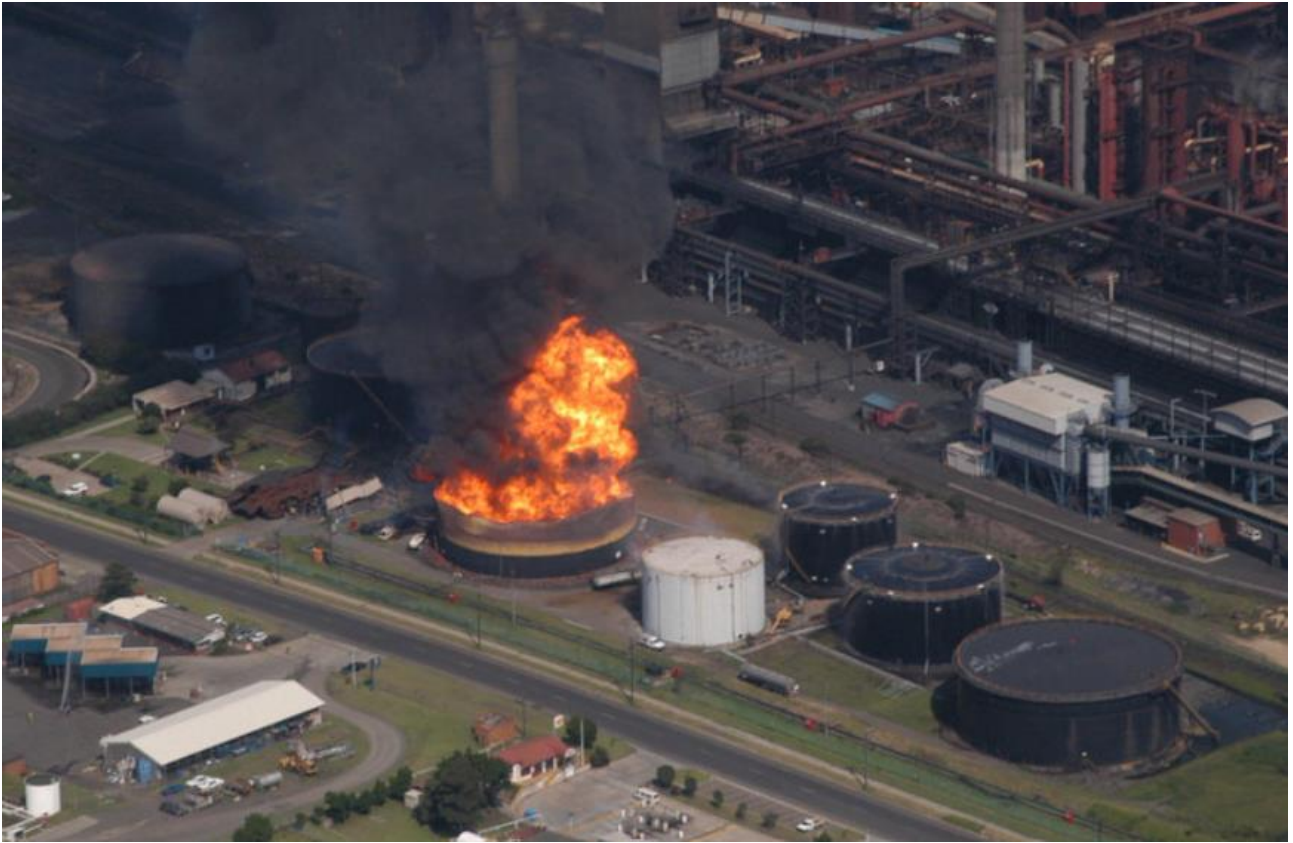
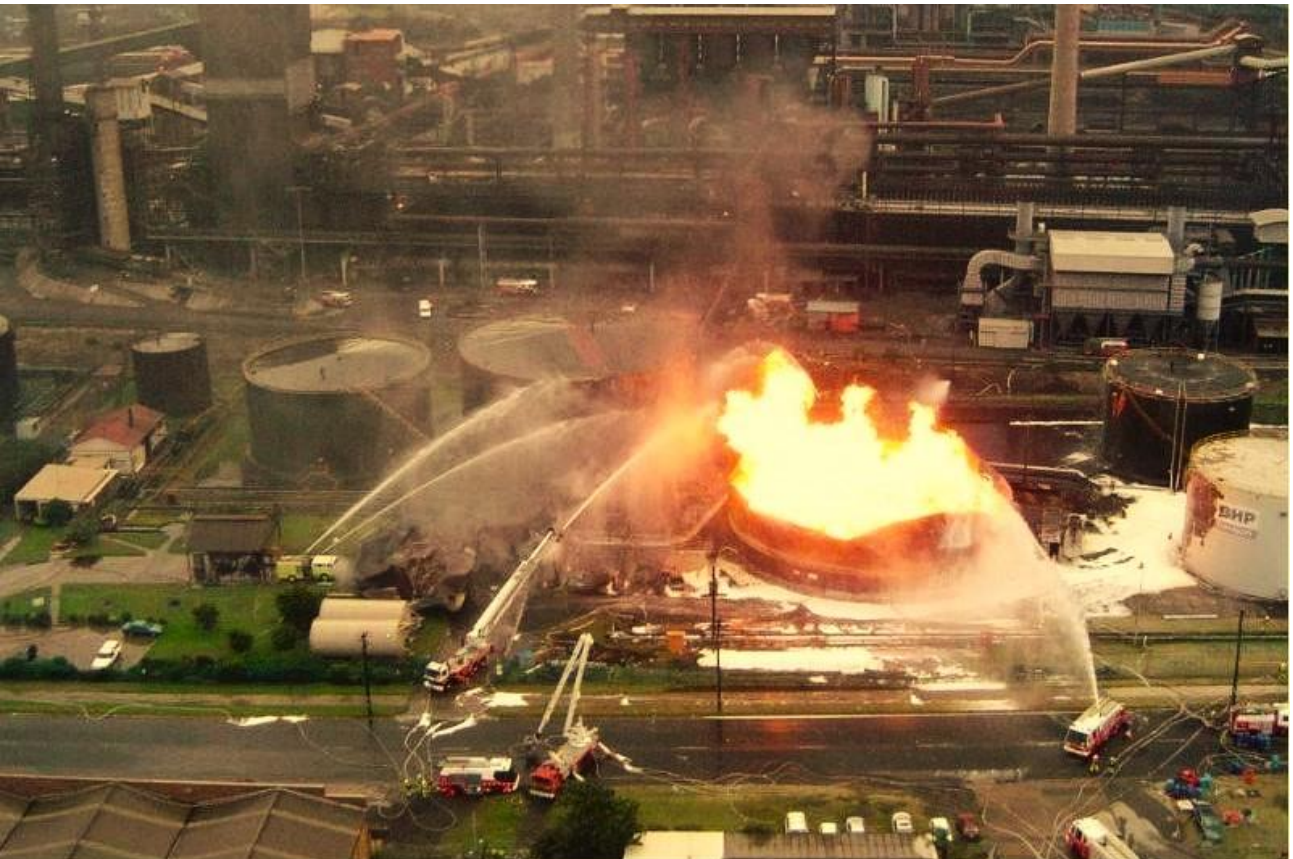
Upper: View from NSW Police helicopter Polair-1 shortly after fire broke out. Flame height is at least 80 metres above the top of the storage tank. Pyrolysis gases can be seen coming from the roof of the surrounding tanks.
Lower: Multiple master streams are in place, protecting heavily threatened Tank 14 and cooling the steel wall of the burning ethanol tank.

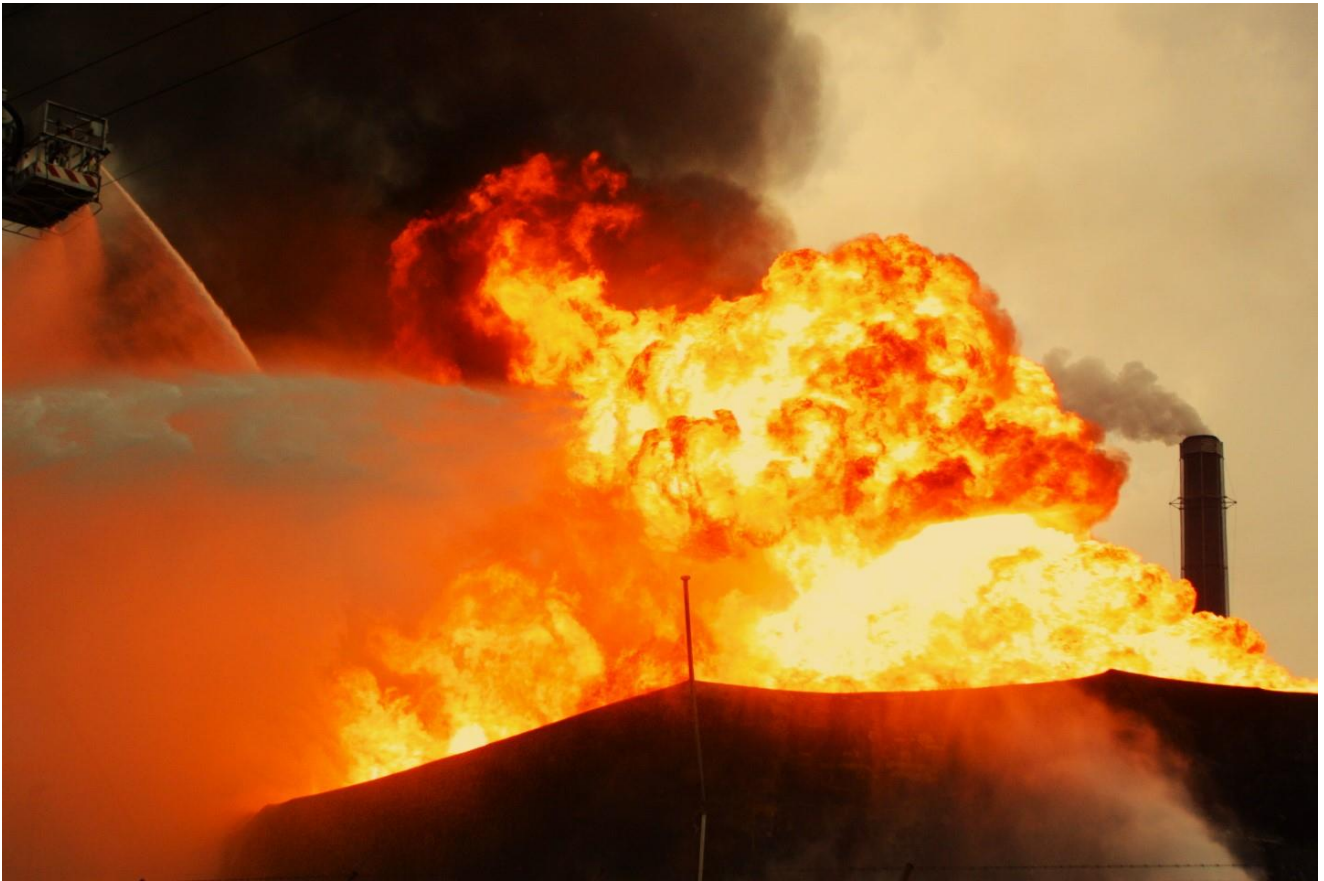
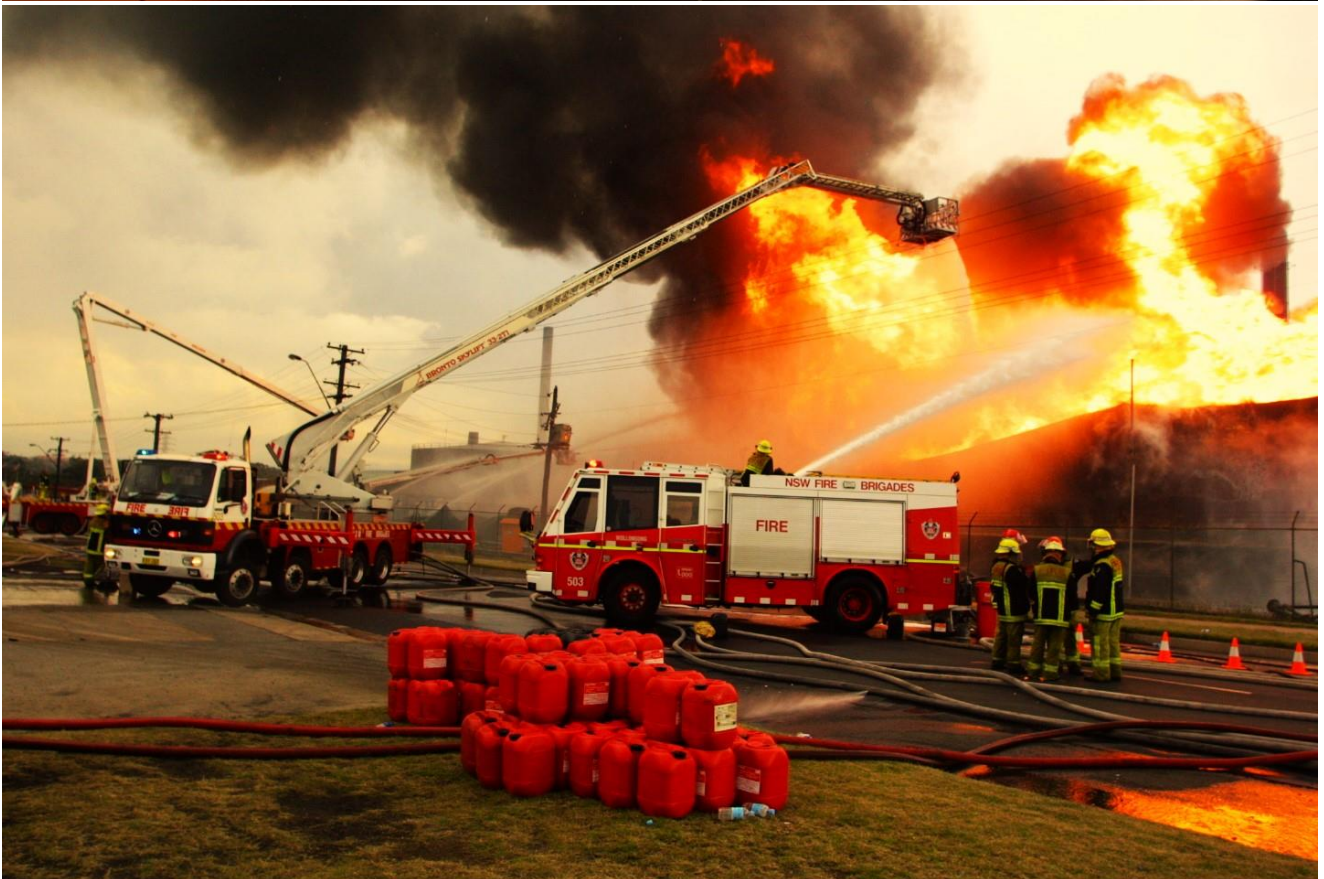
Fire activity from the burning ethanol was ferocious. The fire plume produced heat that was radiated downwards towards the fuel on the surface of the burning liquid, causing evaporation and resulting in more vapour being released. The released vapour mixed with air, drawn in from around the tank, before igniting.

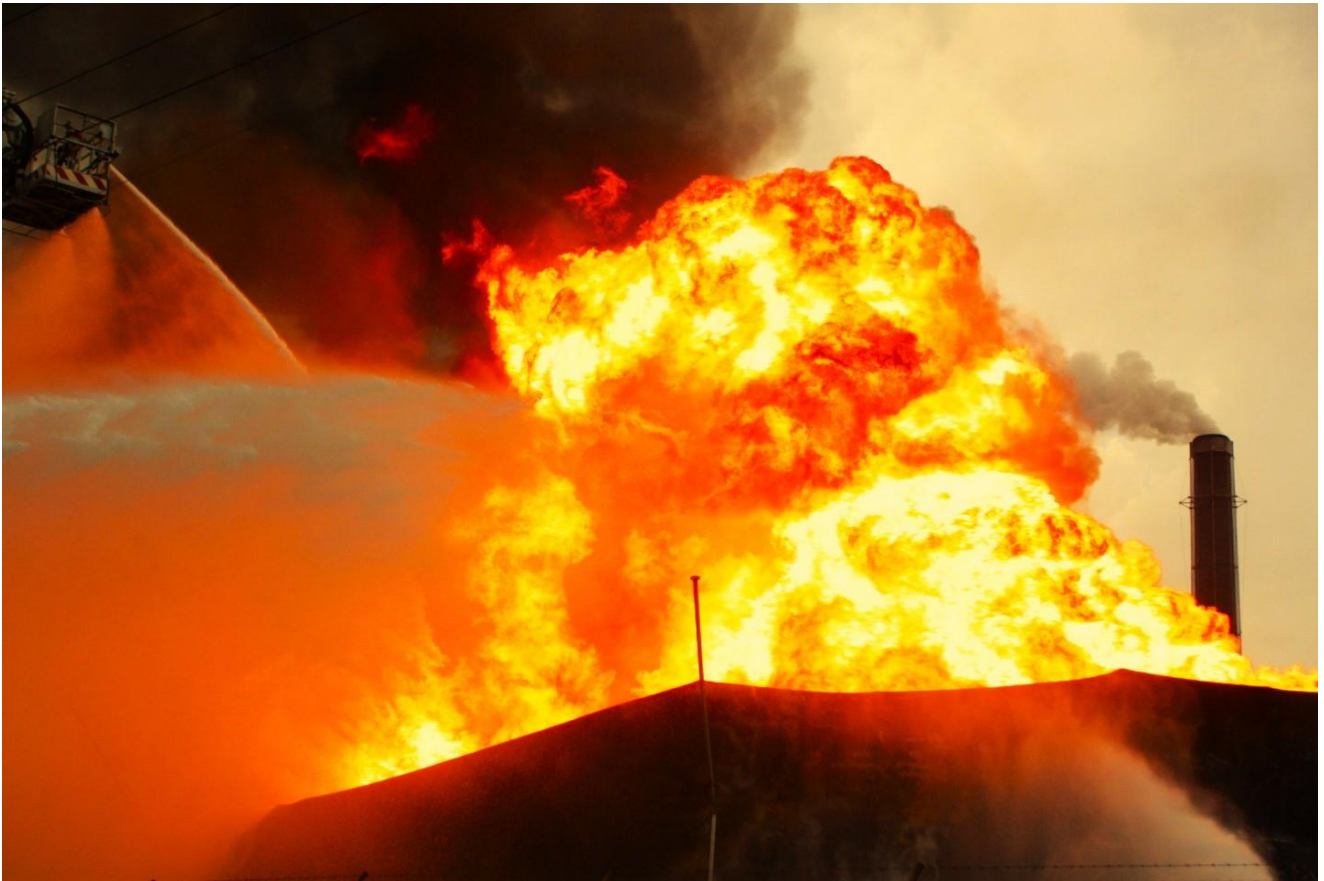
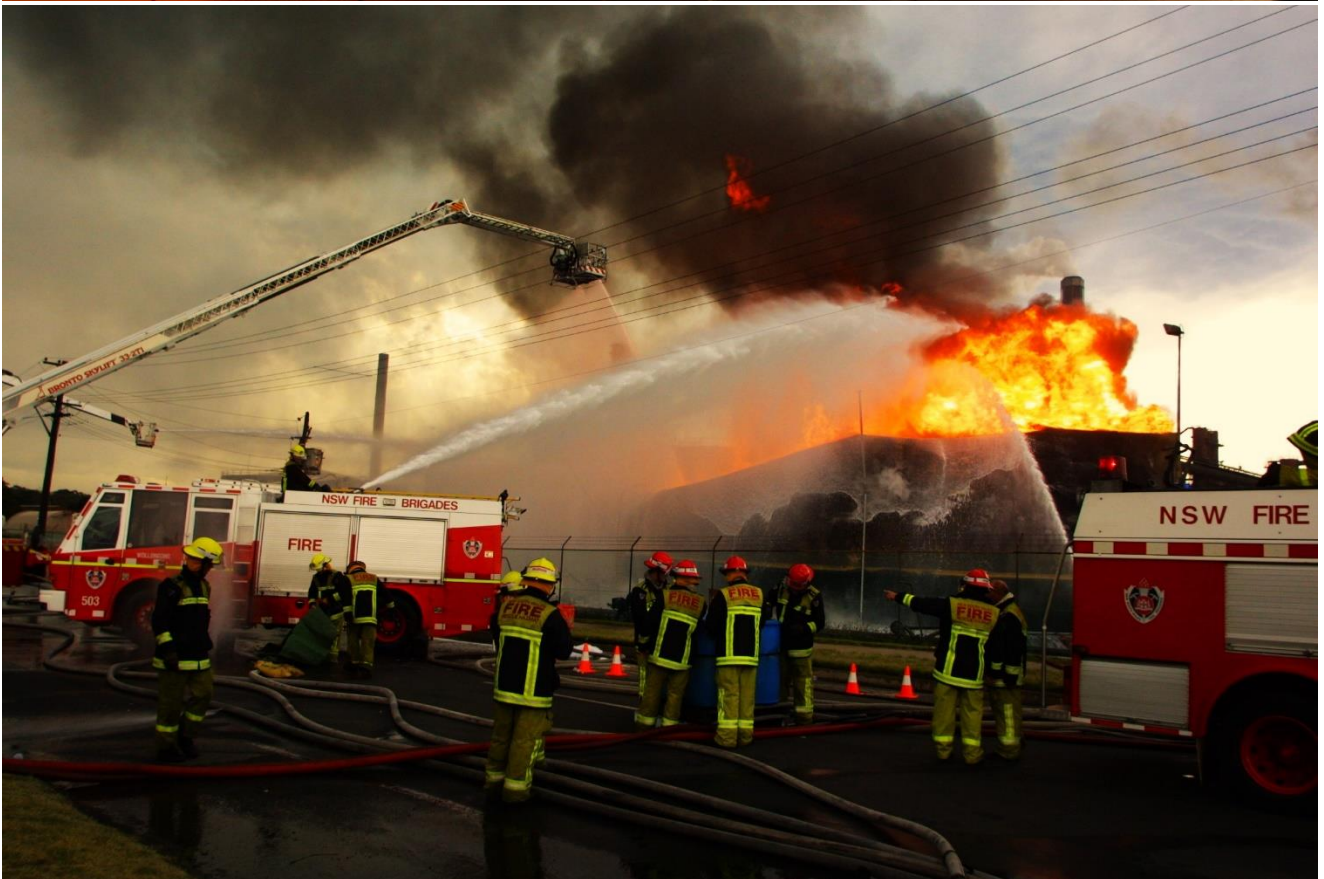
Fire activity from the burning ethanol was ferocious. The fire plume produced heat that was radiated downwards towards the fuel on the surface of the burning liquid, causing evaporation and resulting in more vapour being released. The released vapour mixed with air, drawn in from around the tank, before igniting.

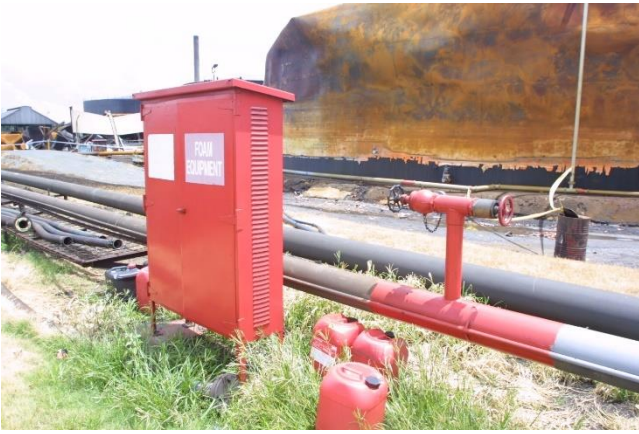
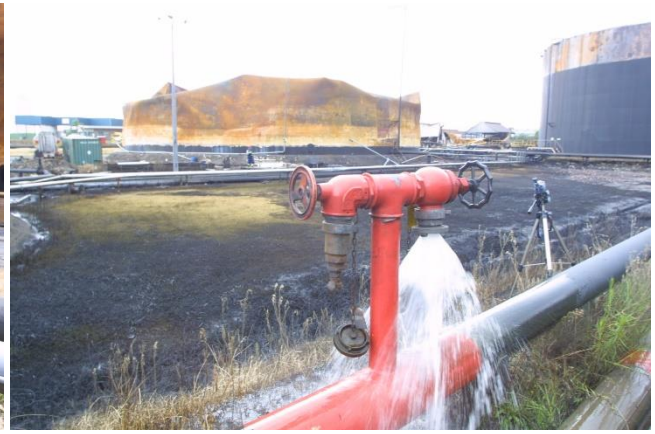
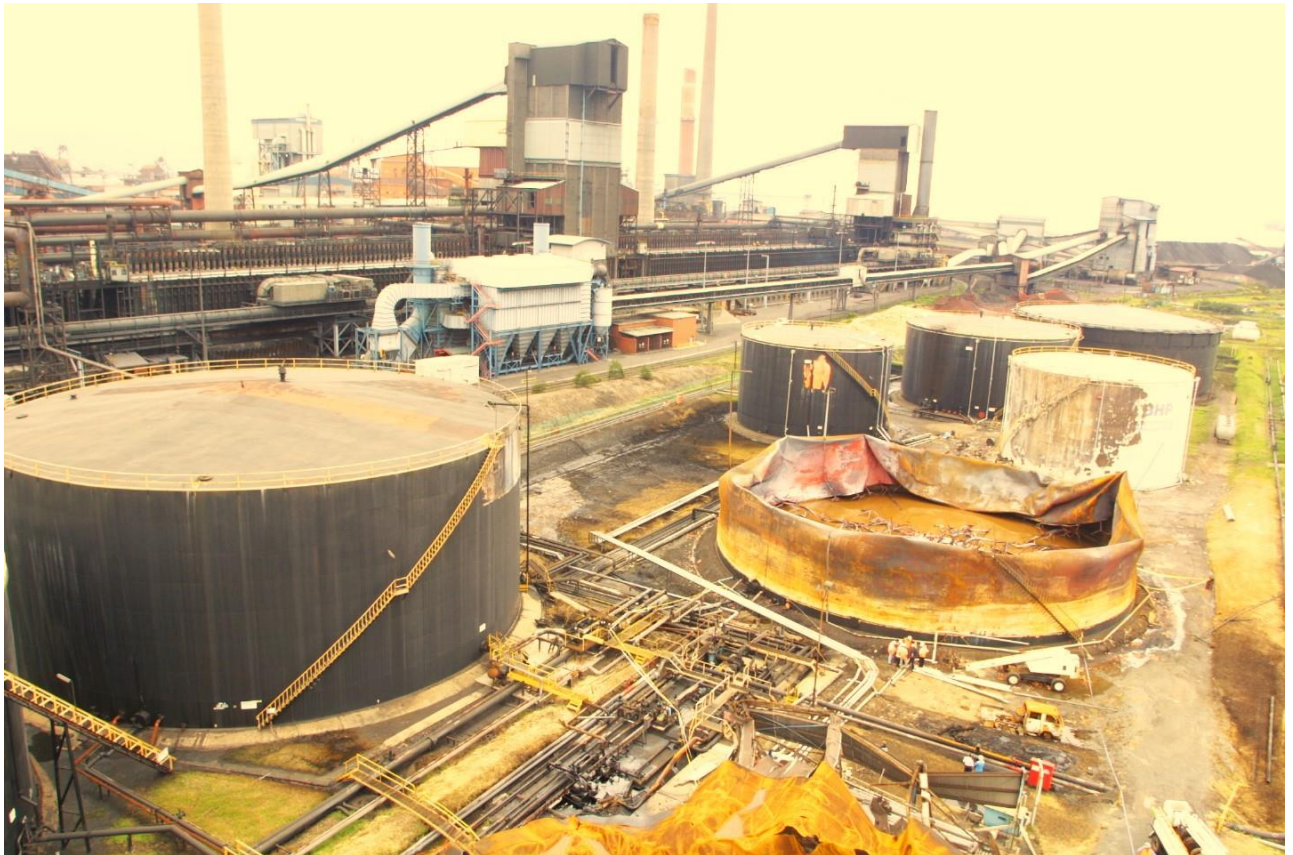
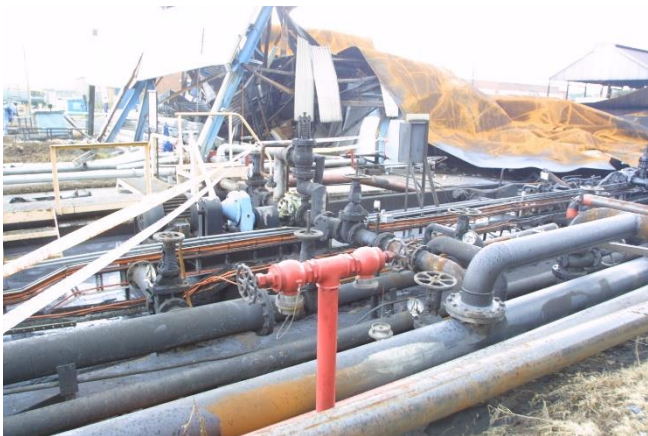
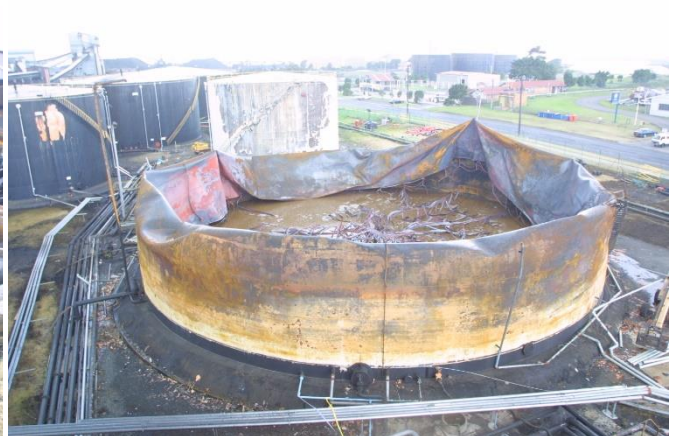
Upper: Twin headed attack hydrants were fitted to the site 150 mm diameter ring main. Radiant heat made operation of the ring main impractical. Middle: The burning ethanol tank was located in proximity to several storage tanks that came under significant threat. Lower (left) Attack hydrants were located on the bund wall. (right) The ethanol storage tank following extinguishment.
