MW1 C STATION TRAINING AND INCIDENT CASE STUDIES

FILE NO. SR/ 06 .

ROCKDALE PETROL TANKER FIRE

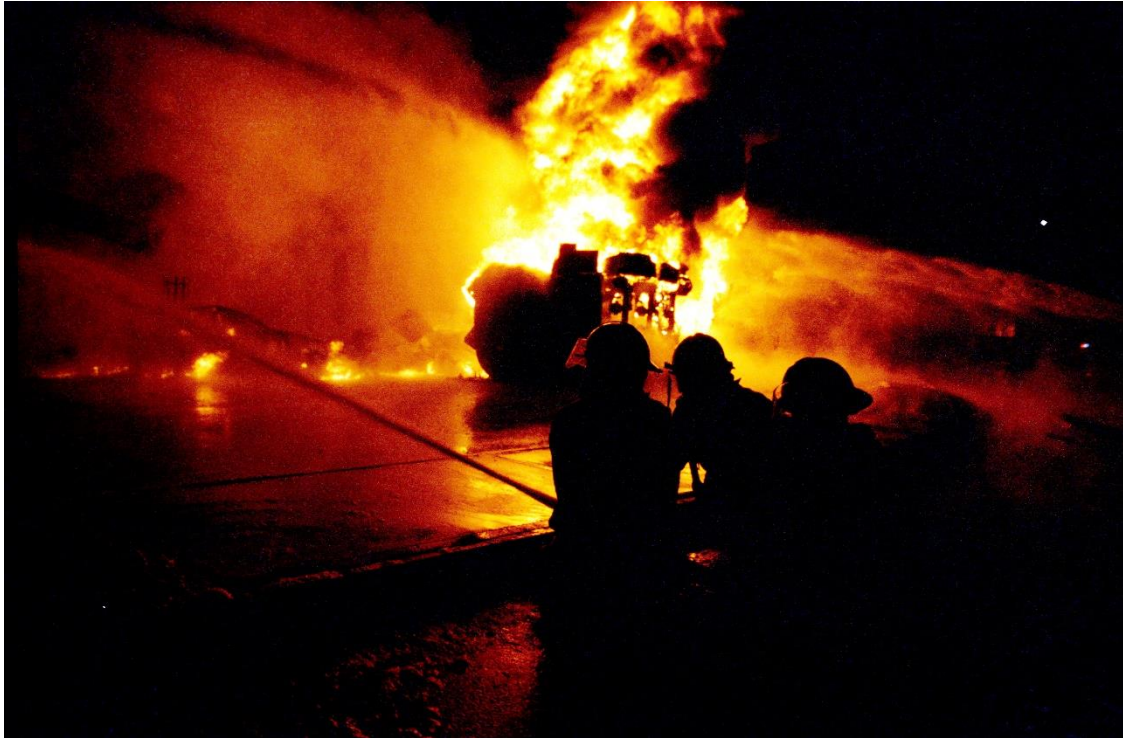
The overturned tanker burns fiercely against a row of shops with residential units above. Battling fierce radiant heat, firefighters are directing life-saving streams into a unit where persons remain trapped.

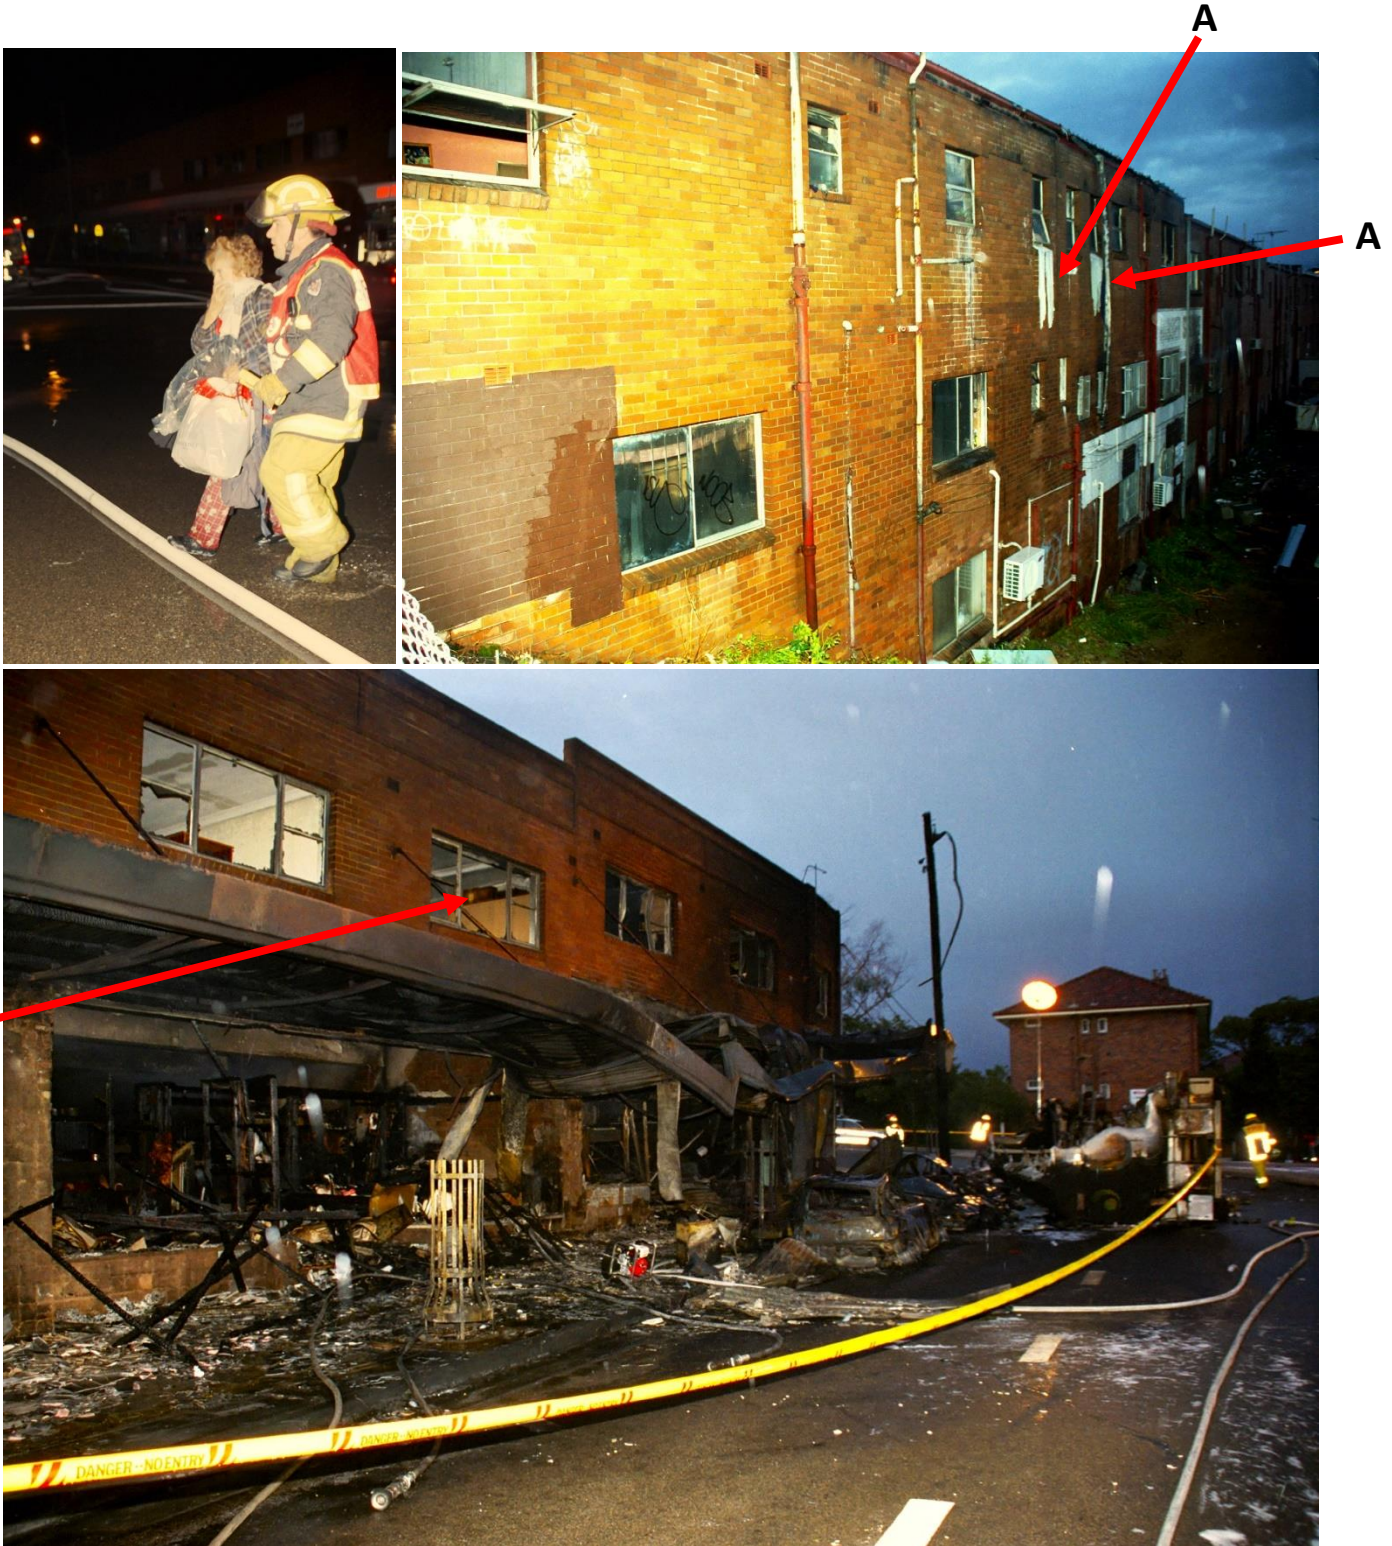
The rescue of Mrs Le vano from te aptmt above the tanker fire (top left). Rear view of fire building. Arrows (A) indiacte sheets tied together by Mrs Le Vano in an attempt to escape (top right). Rom the front of the building, Mrs Le Vano's apartment (B) was above several fully involved shops. This apartment ws protected by 70 mm streams, saving Mrs Le vano's life (bottom right).

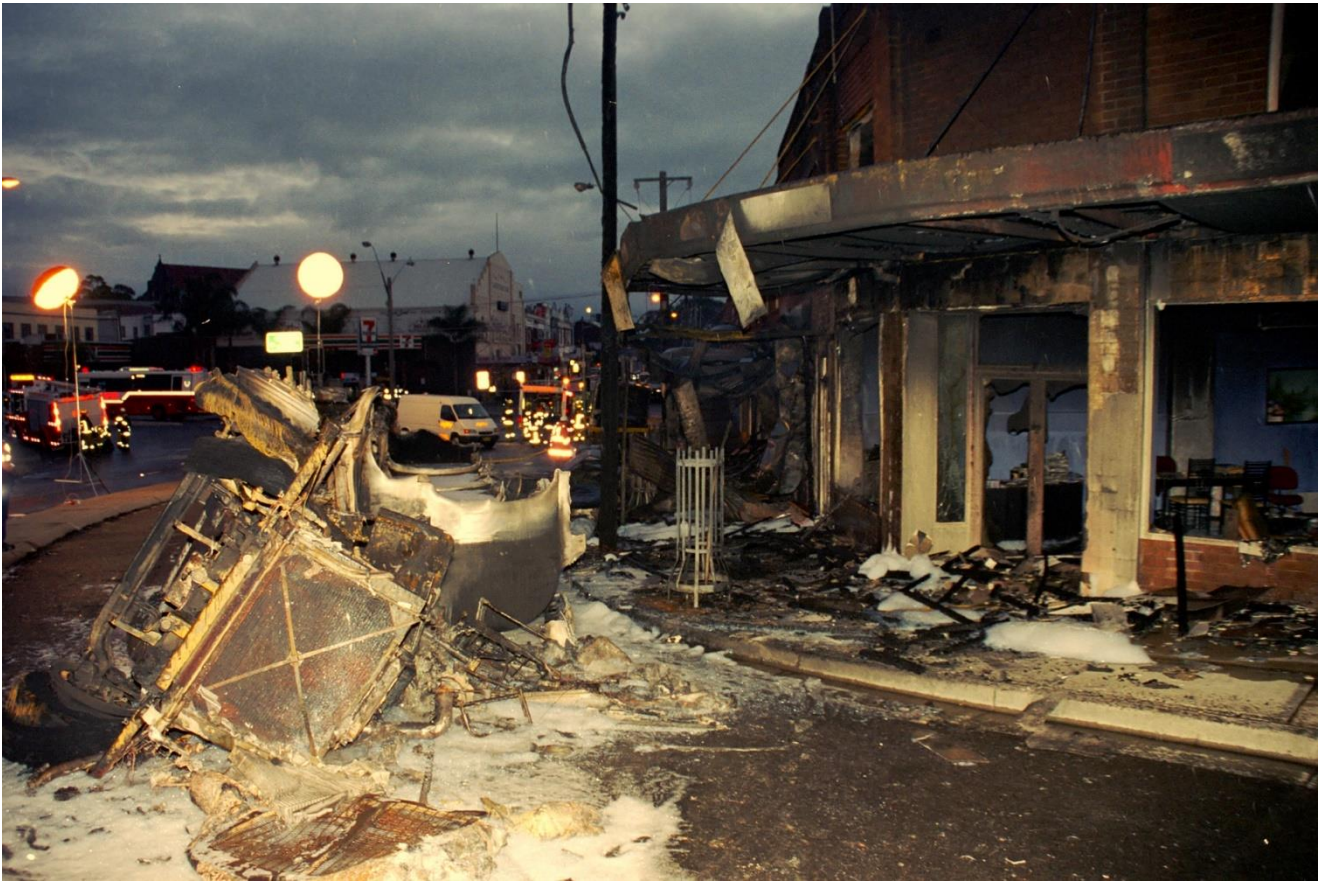
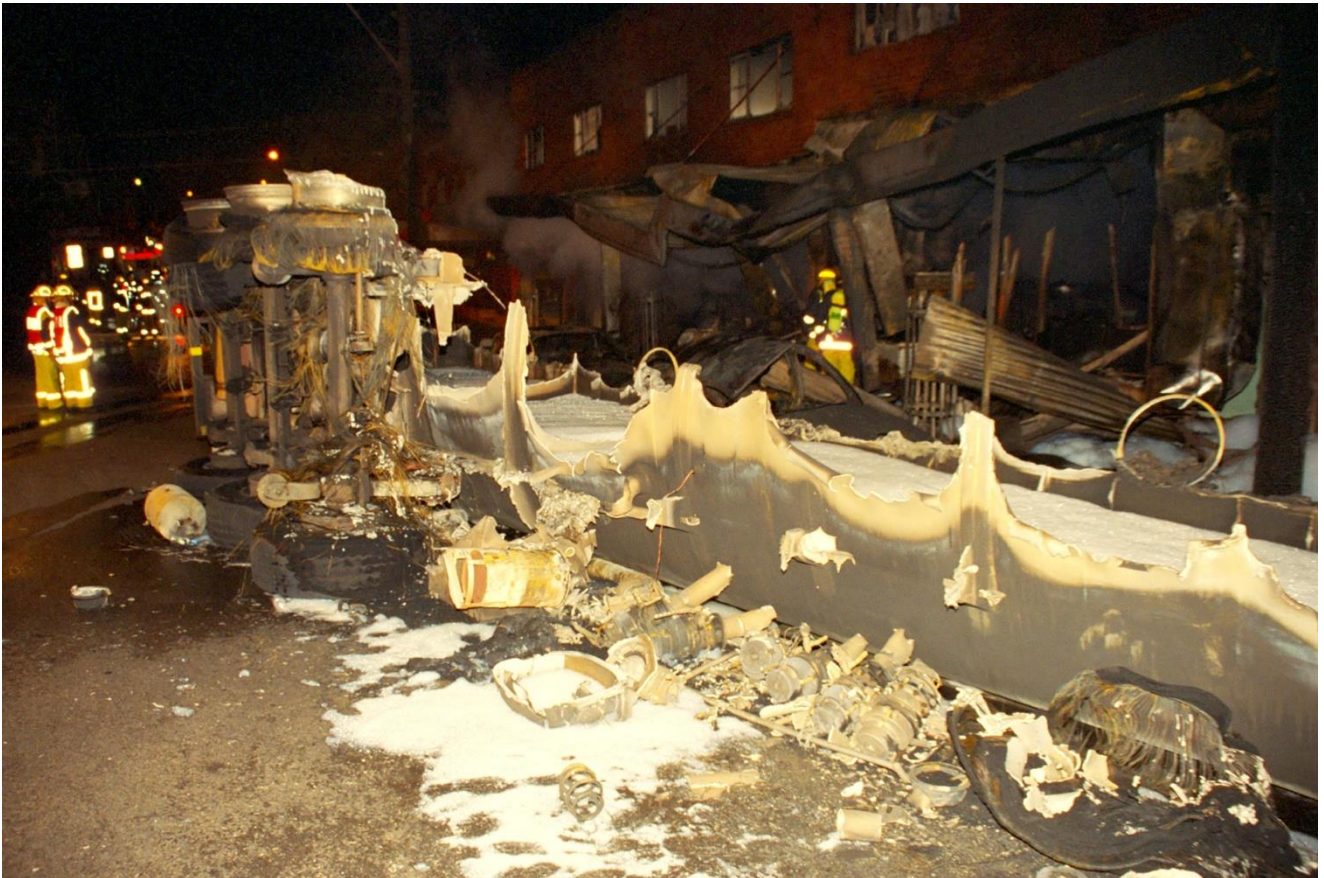
These views show how close the tanker came to the building at 102-120 Railway Street. The initial firefighting strategy was to try and protect the building until a foam attack could be commenced. This strategy saved the building and protected a trapped person inside the building.

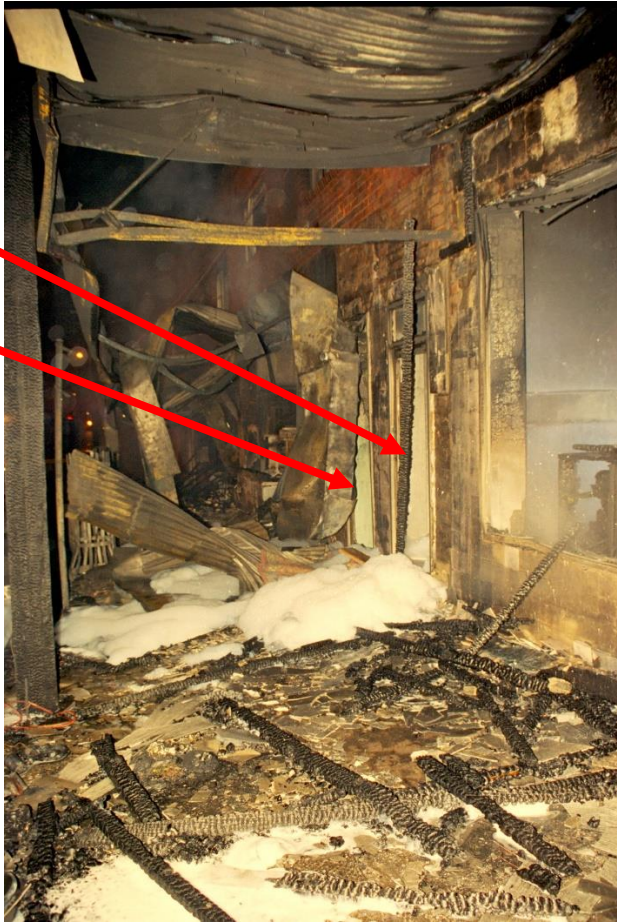
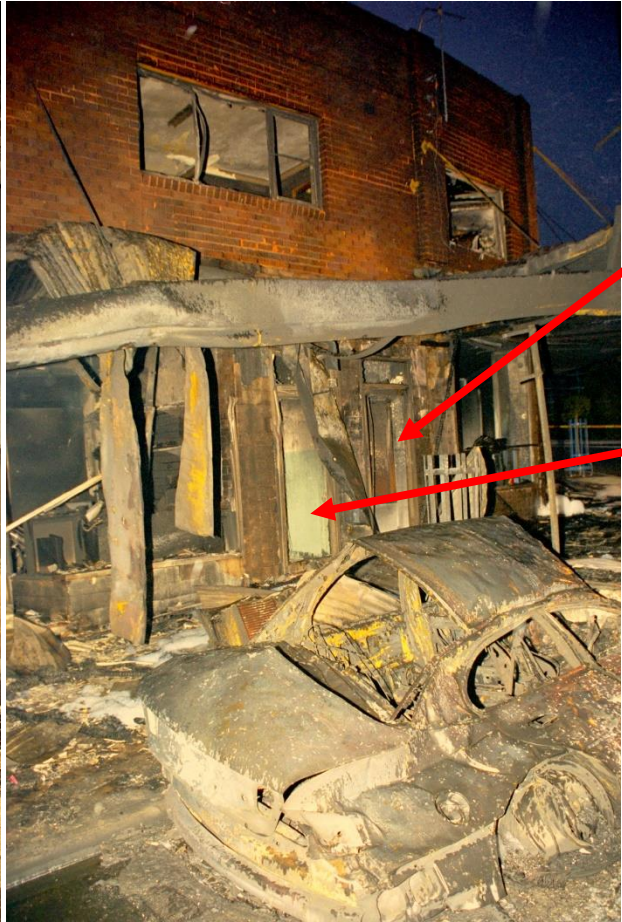
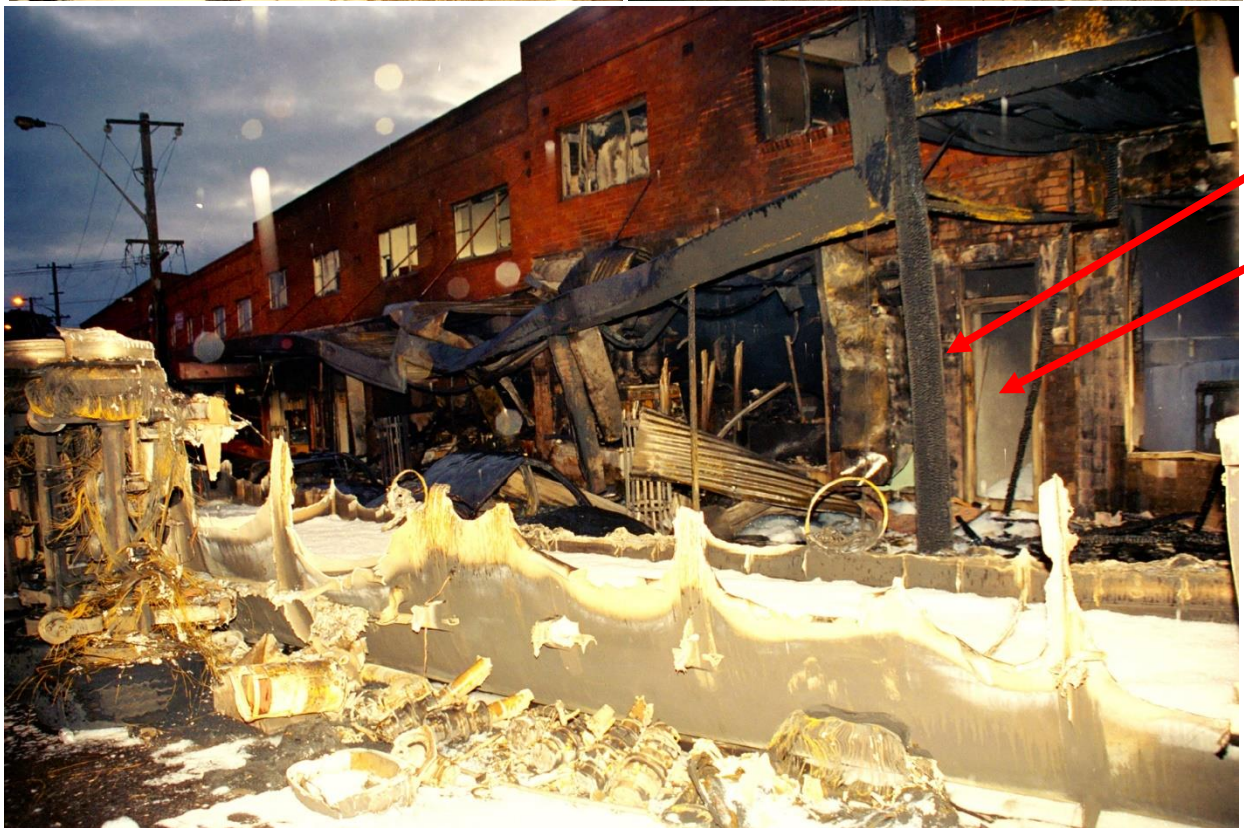
The entrance doors to units above the shops were completely impassable due to the fire, indicated by arrows. Heavy firefighting streams by initial arriving crews increased the survivability of the apartments above the entrance doors.

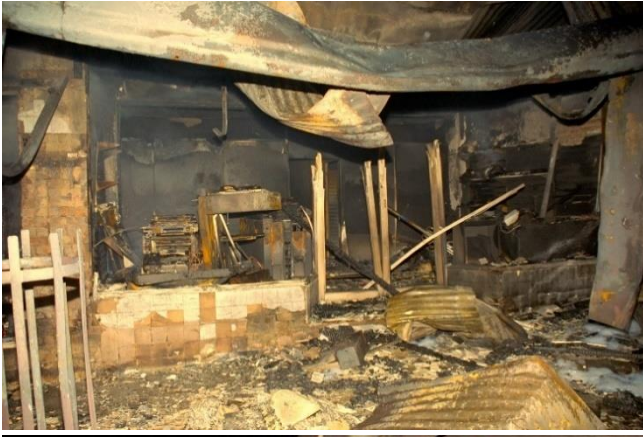
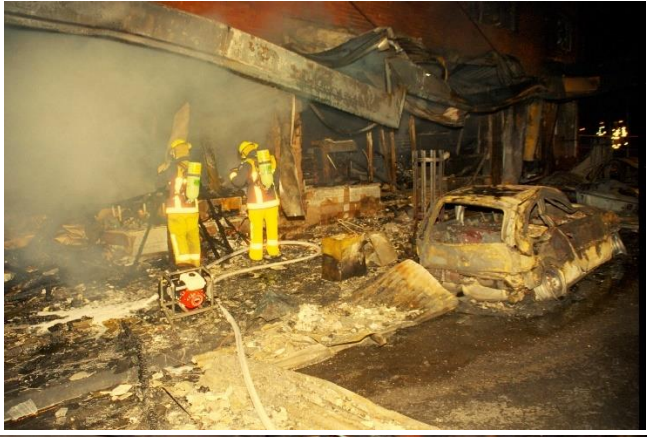
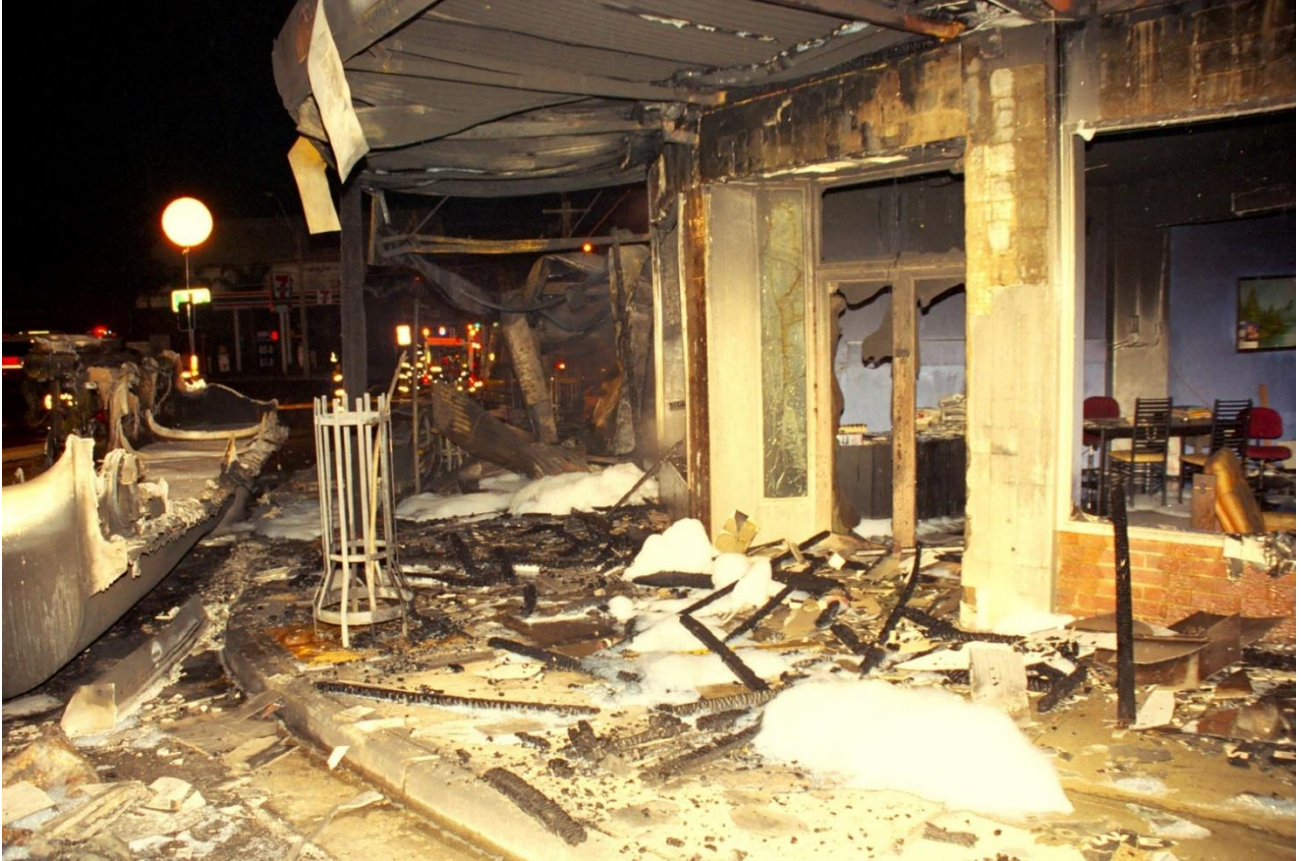
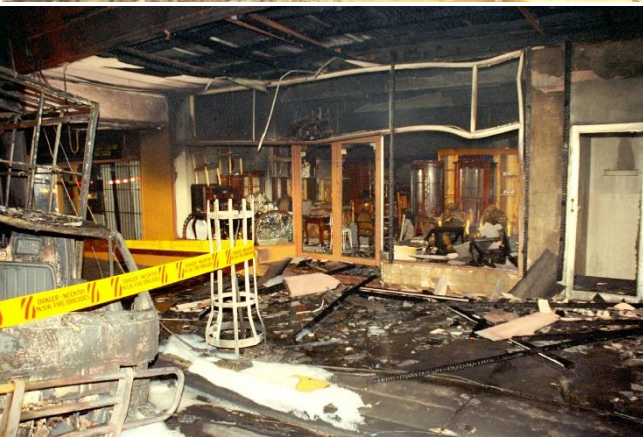
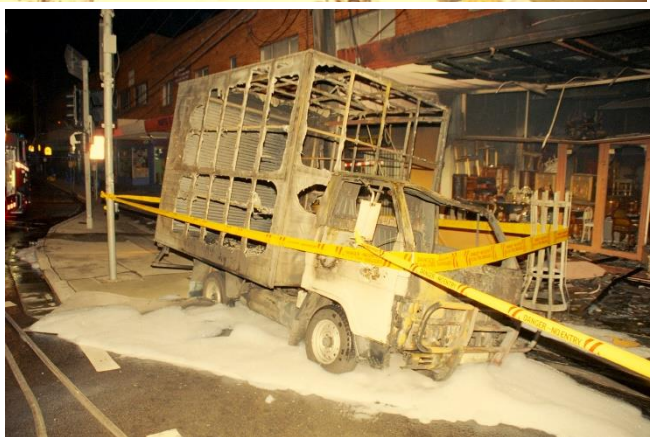
1. Fuel tanker and load totally destroyed by fire.
2. Two parked stationary cars and one parked light delivery truck totally destroyed by fire.
3. Four ground level shops severely damaged by fire.
4. Three level two apartments and one basement level apartment severely damaged by fire.
5. Heat, smoke and water damage to several level one shops and four apartments.
6. Partial fire damage to two shops (clothes tailor and antique furniture shop).

Severe fire damage occurred to four shops adjacent to the tanker (top and middle). Firefighters halted lateral fire progression at the antique furniture shop. A delivery truck at the front of the shop was destroyed (lower right) however firefighters saved all contents within the shop (lower left).

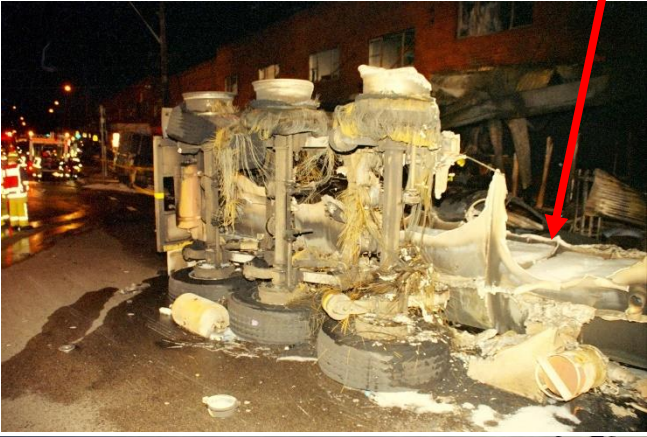
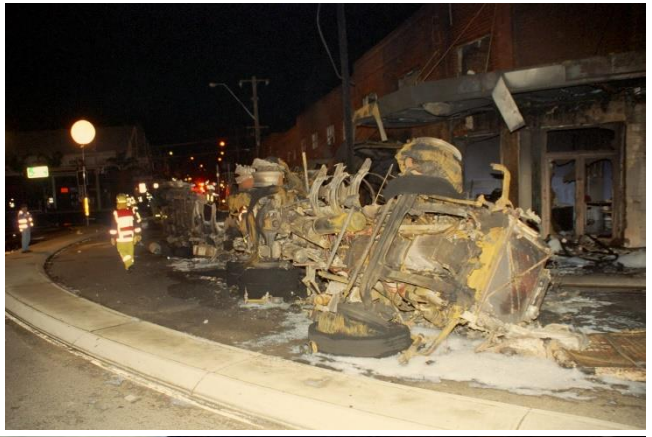
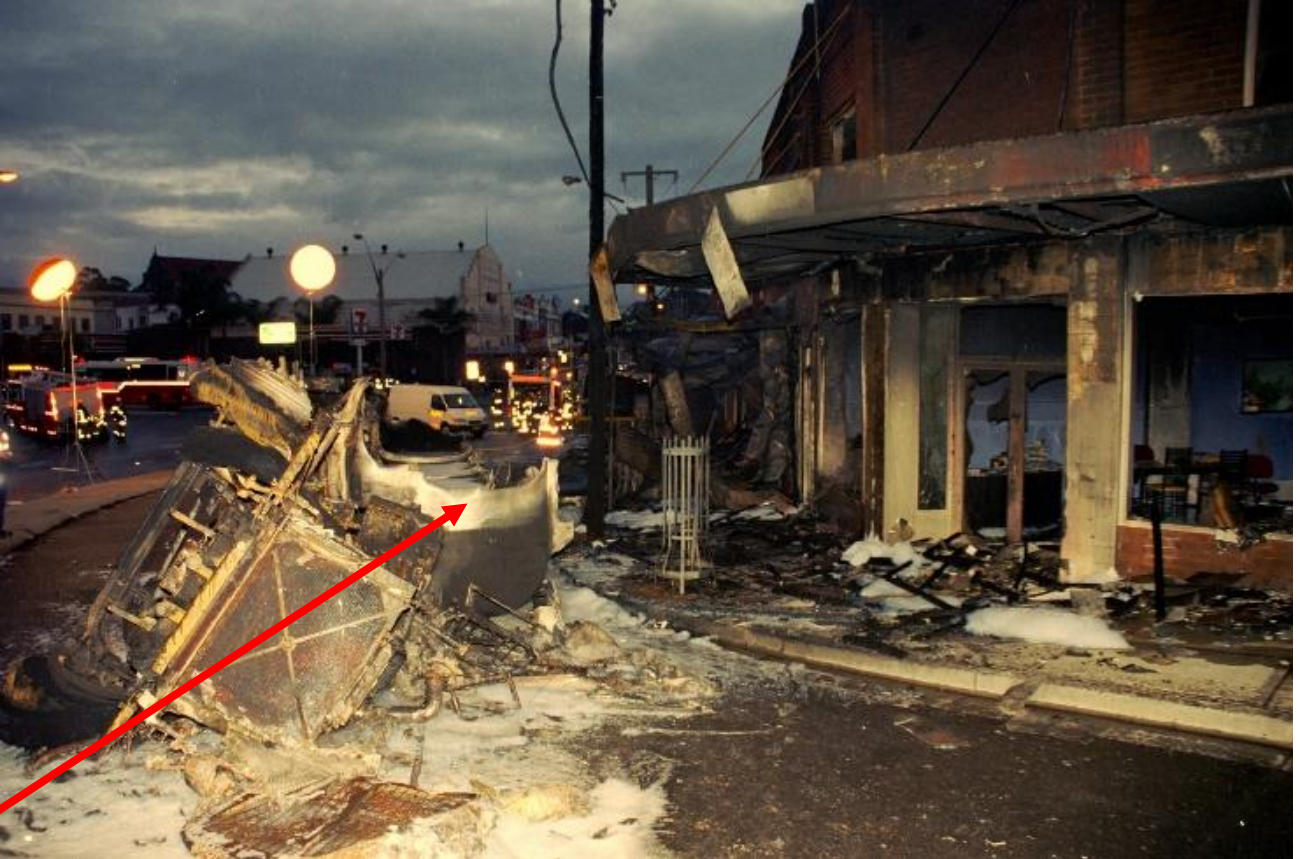
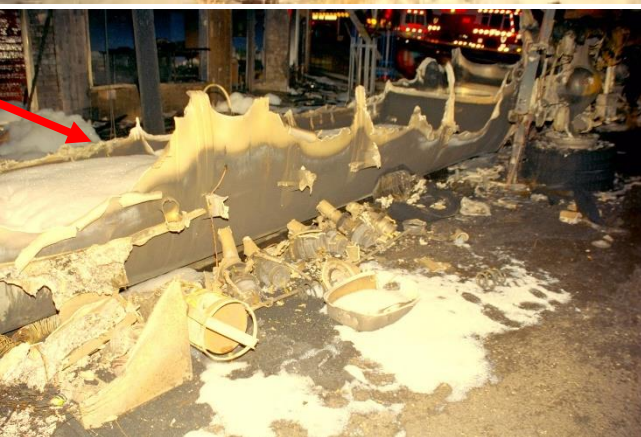
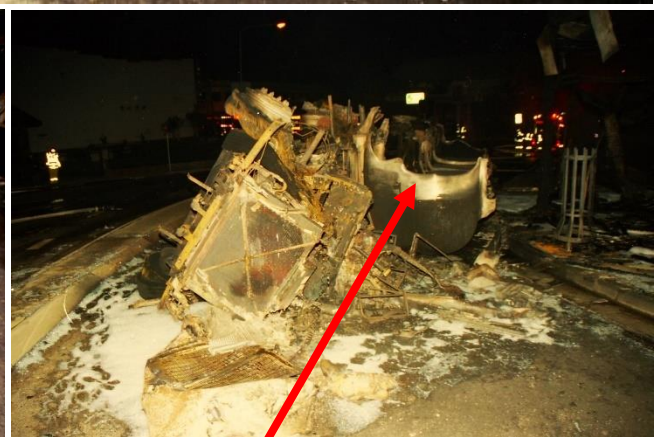
Severe fire damage to the tanker. The aluminium tanker shell “melted down” as the fire burnt lower. The remnants of the tanker shell (shown by arrows) are indicative of the levels of flammable liquid at the time of extinguishment. When attacking a flammable liquid fire, the objective of firefighters is to get foam onto the surface of the flammable liquid.

8. Following ignition of the tanker contents, **only the surface of the fuel was involved in fire. The fire burnt downwards at a rate of approximately 30 cm per hour.**

N.B., As the surface of the flammable liquid continues to burn downwards and the sides of tanker shell progressively melt, the width of the surface area of the burning area will continue to broaden, resulting in an increased area of fire.
