MW1 C STATION TRAINING AND INCIDENT CASE STUDIES

FILE NO. 2023 / 31.

**4th ALARM CIRCULAR QUAY HIGH-RISE
BUILDING UNDER DEMOLITION FIRE.**

Incident Type: Incident Type: High-Rise Office Building Fire (under demolition).

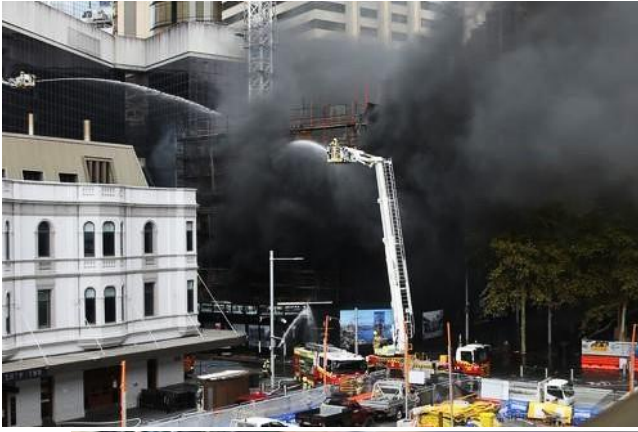
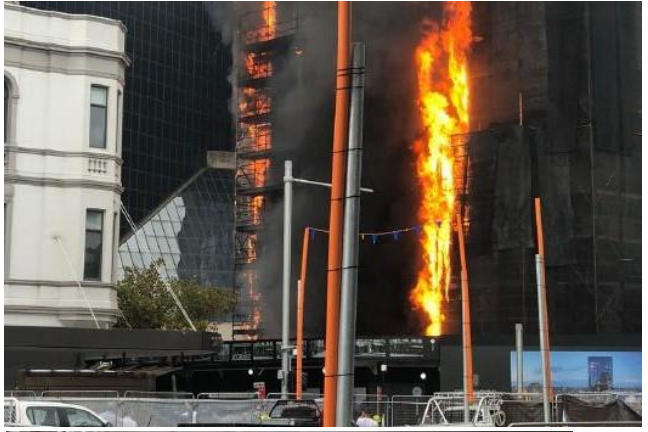
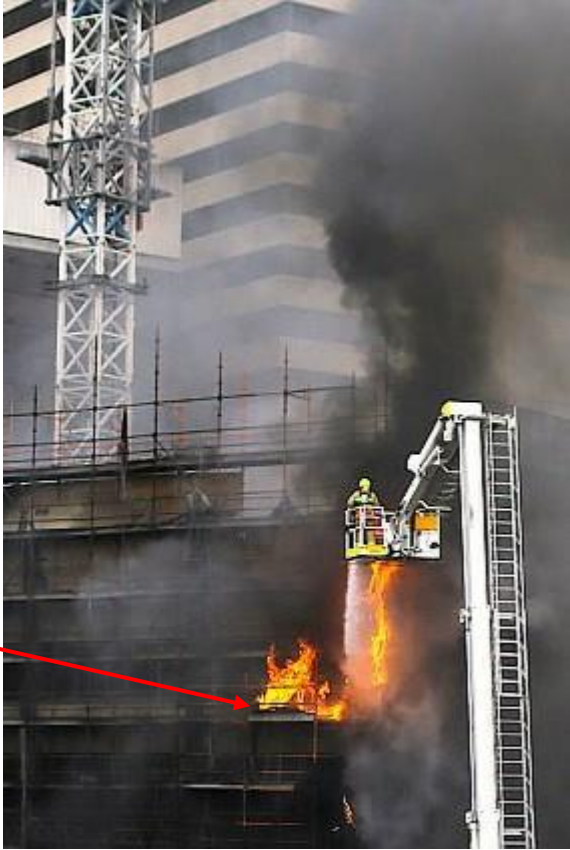
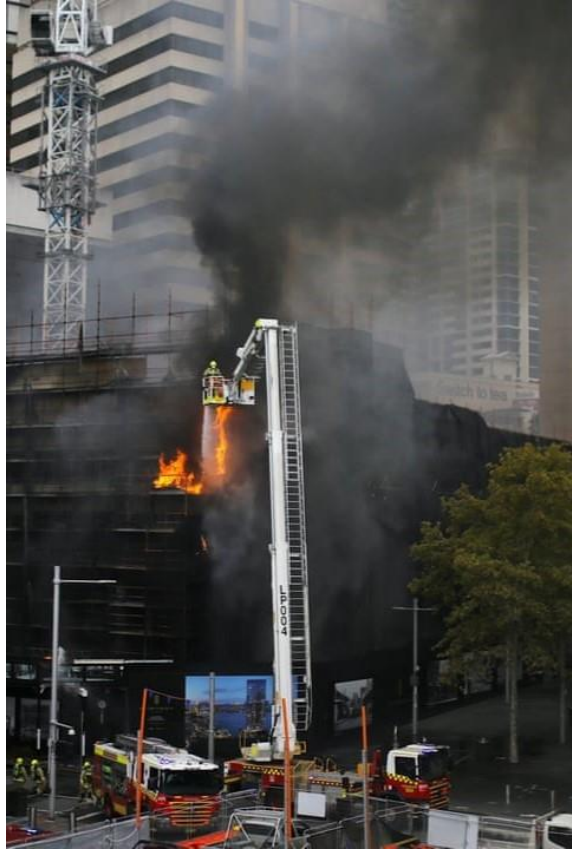
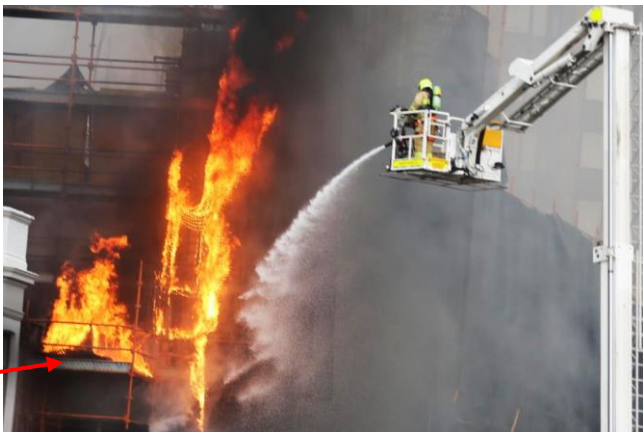
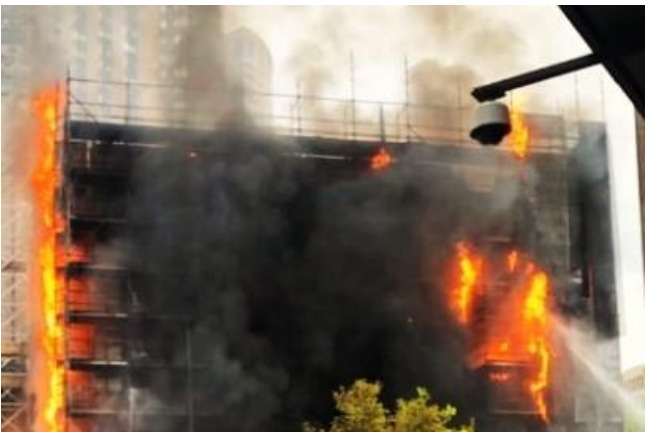
Ladder Platform 4 attacks fire burning within the Alpha side Scaffold mesh. Burning mesh has fallen and ignited combustible materials on the lower scaffolding **A** resulting in fire spread. The aerial streams achieved numerous incident objectives, including achieving fire containment, reducing fire intensity, extinguishment of spot fires and cooling of steel being impacted by fire (particularly the tower crane structure).

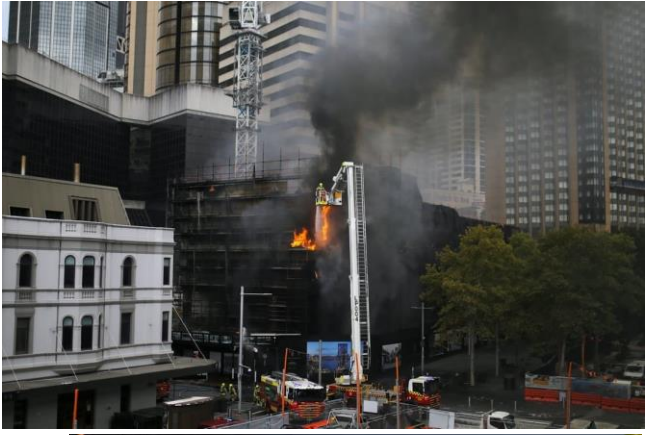
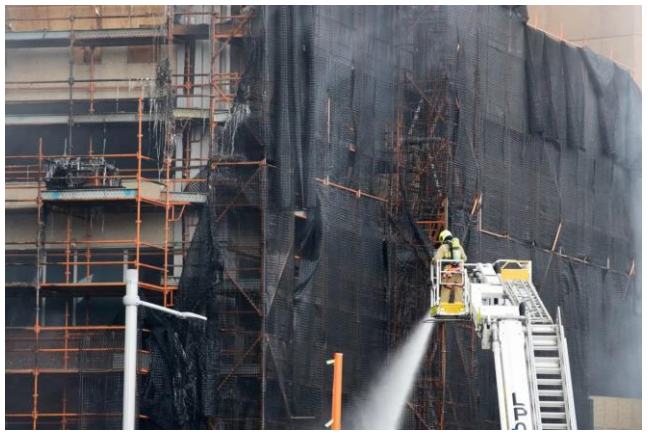
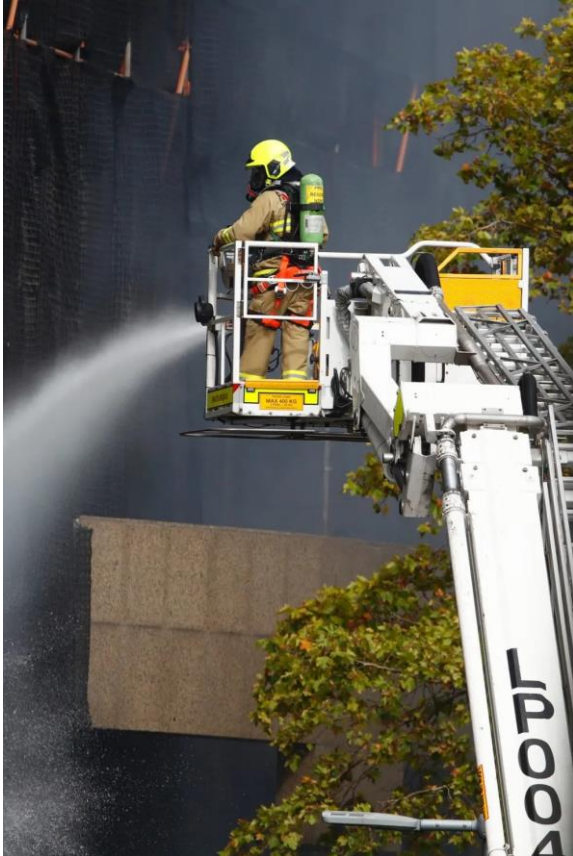
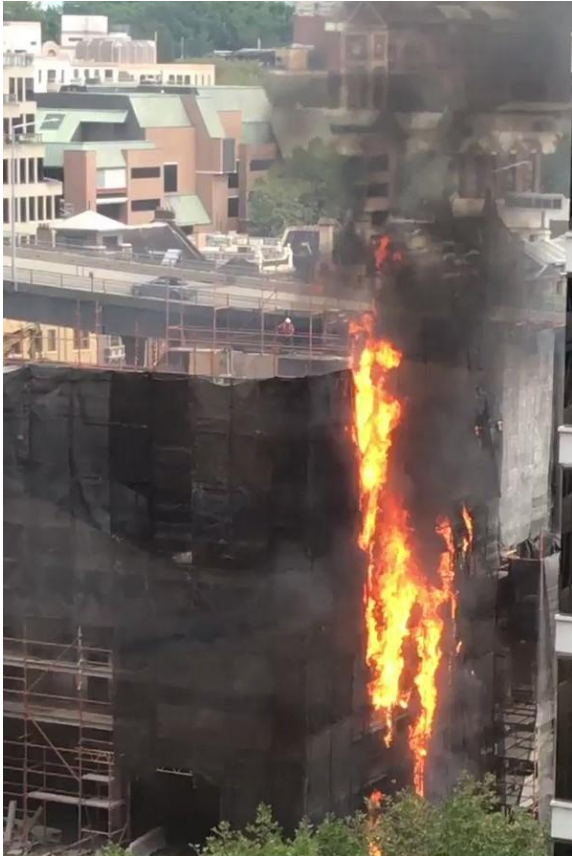
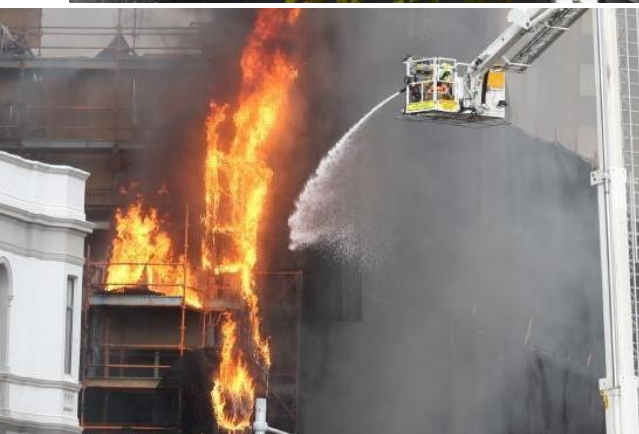
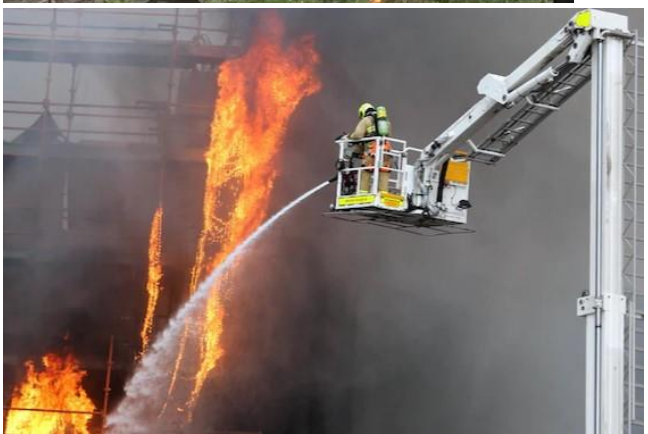
The aerial cage operator of Ladder Platform 4 attacks the fire burning on the Alpha side scaffold mesh, stopping fire from spreading to the Delta side of the building.

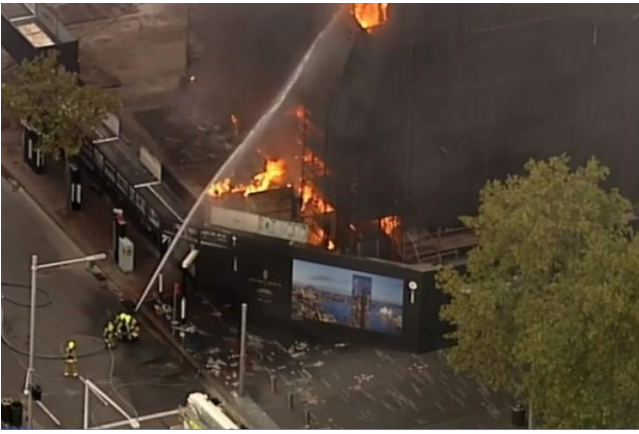
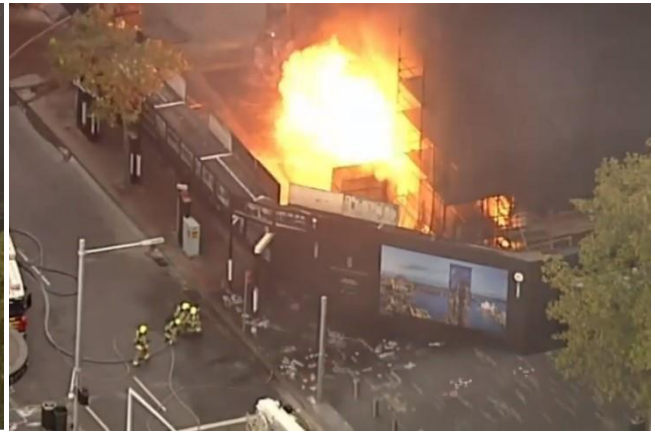
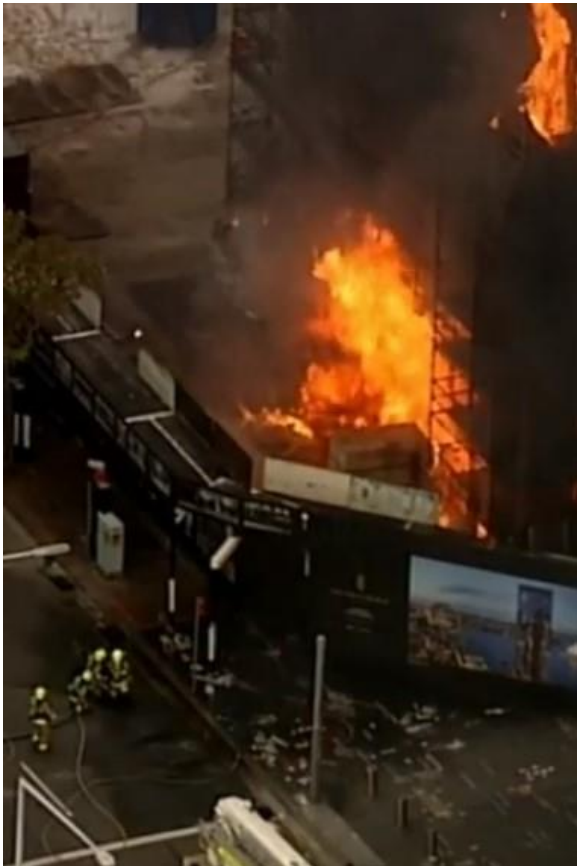
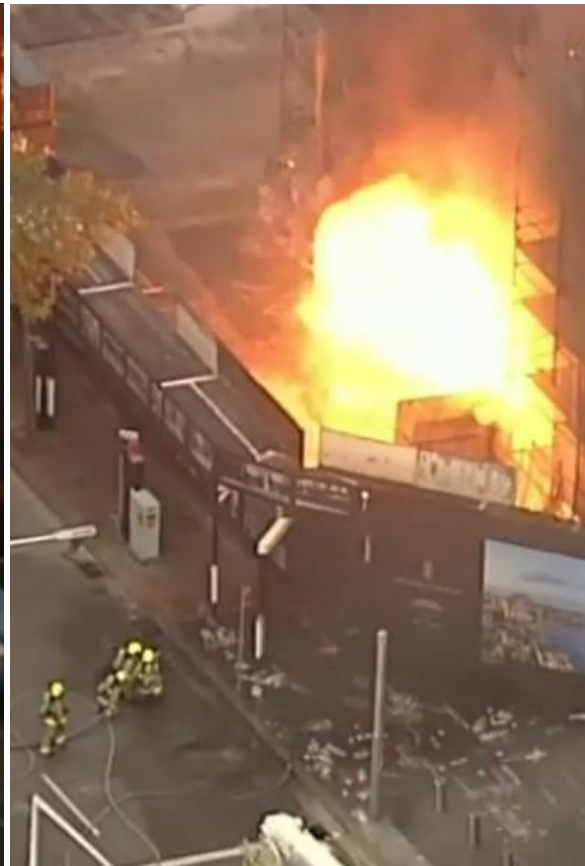
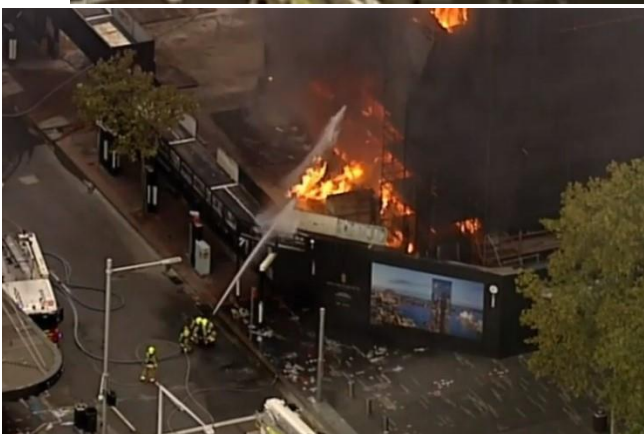
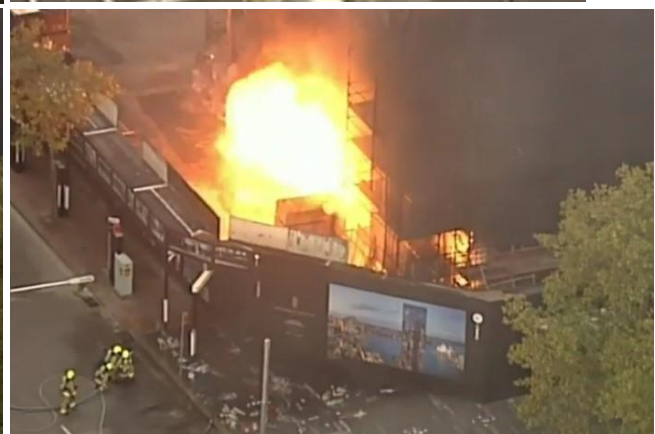
The fire was burning intensely within the basement, where numerous pressurised gas cylinders were stored. As fire intensity increased, a number of gas cylinder explosions occurred (this is discussed in much greater detail within the section below “*Fire Behaviour Considerations*”). These explosions caused the cylinders to be violently propelled through the air. The basement was open sided facing Pitt Street (Alpha side). Although most of the exploding cylinders were contained within the basement, a number were propelled through basement opening, beyond the building. The explosions were so powerful they produced pressure waves that could be felt at the fireground. Intense venting flame jets were released from other cylinders. As the explosions started to occur, firefighters operating 38 mm lines attacking the fire near the Alpha/Bravo corner used a large steel industrial bin as shielding.

“Shortly after commencing operations a number of explosions occurred. I observed a number of cylinders become airborne. There were at least 5 or 6 major explosions. Most of the cylinders were contained within the basement, however at least two of the cylinders were projected beyond the building.”

Gas cylinder explosions (Boiling Liquid Expanding Vapour Explosions/BLEVEs) occurred inside the basement. Several gas cylinders became flaming projectiles, travelling beyond the basement. These fire events are extremely dangerous. Firefighters used shielding and continued to fight the fire.

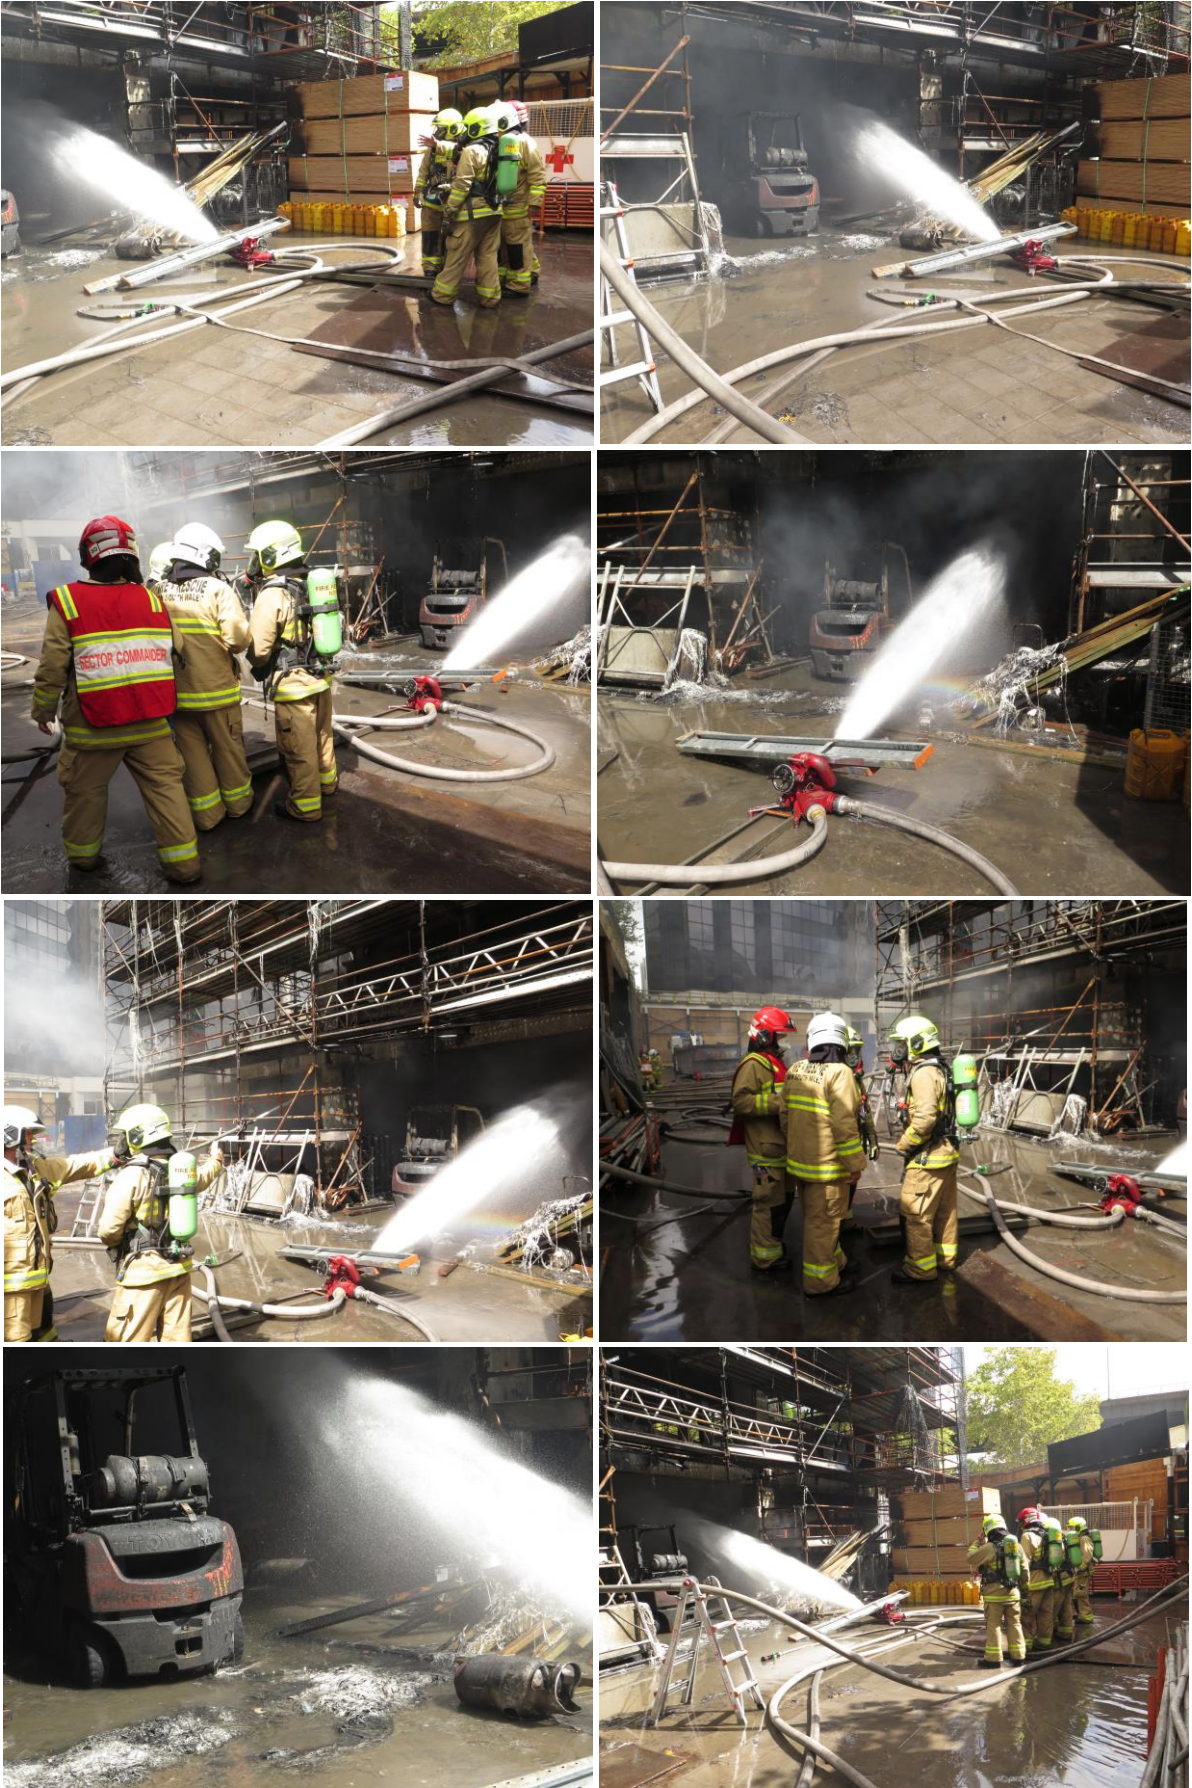
From the Alpha side of the building firefighters direct a ground monitor cooling deluge into the basement where numerous stored gas cylinders are located, successfully preventing further explosions from occurring.

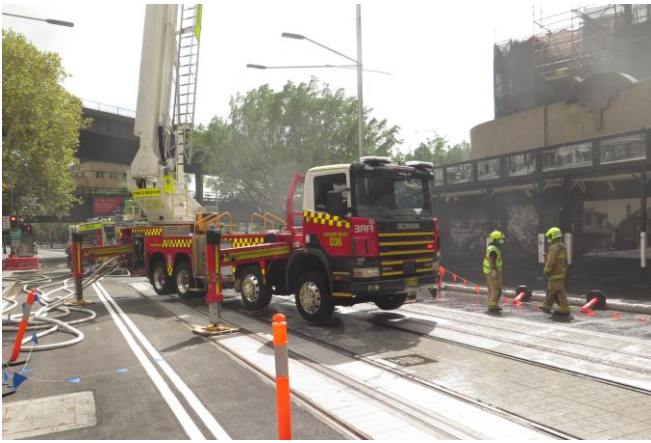
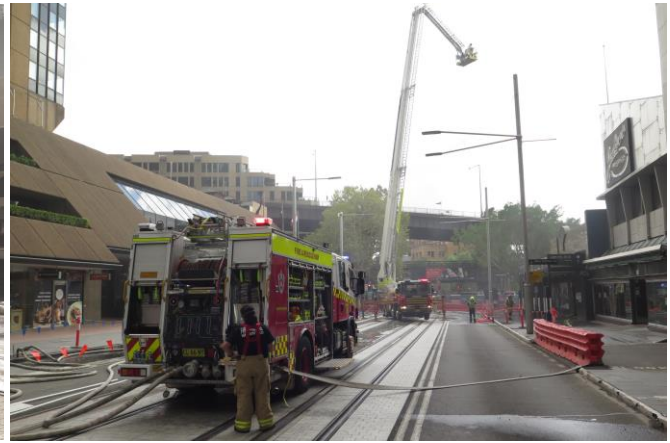
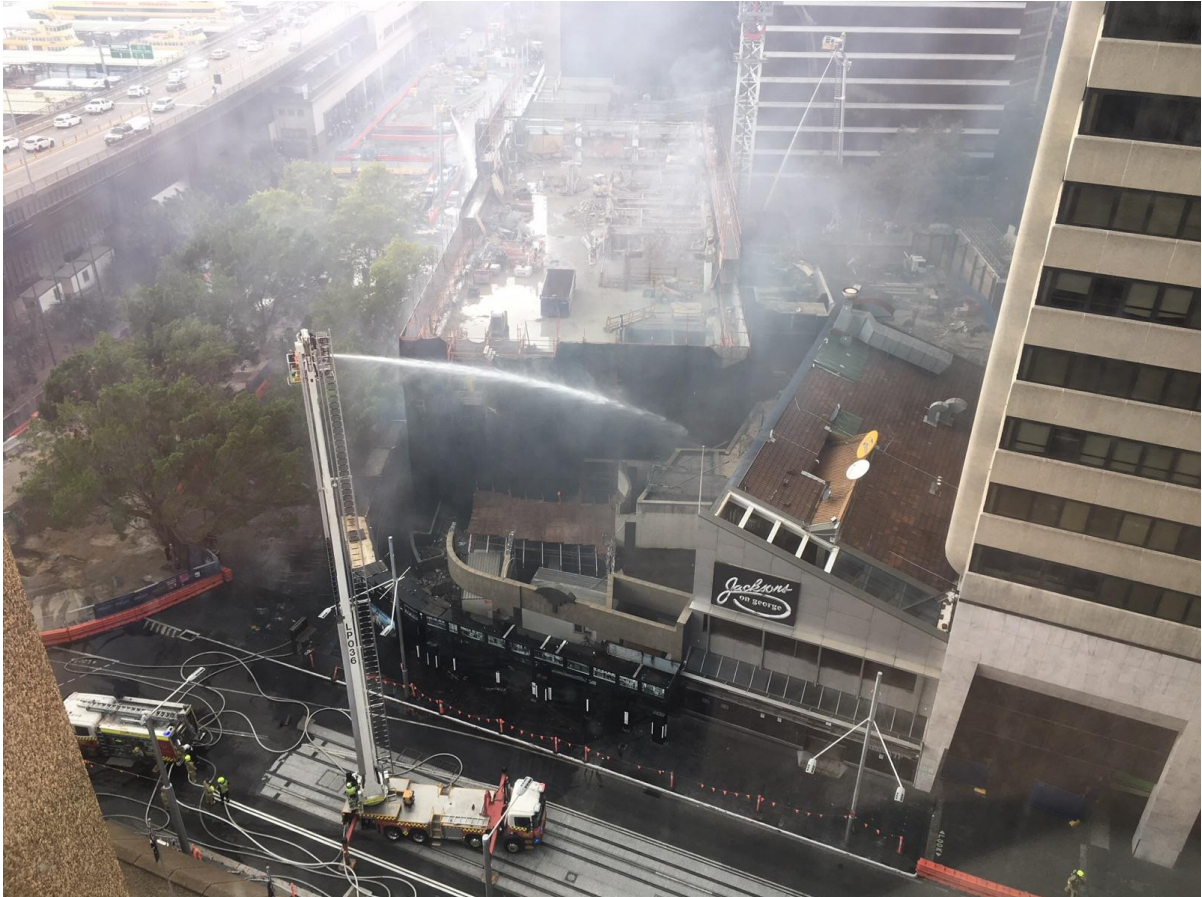
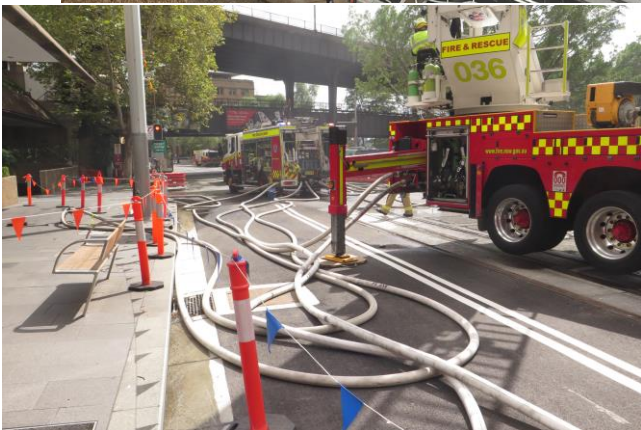
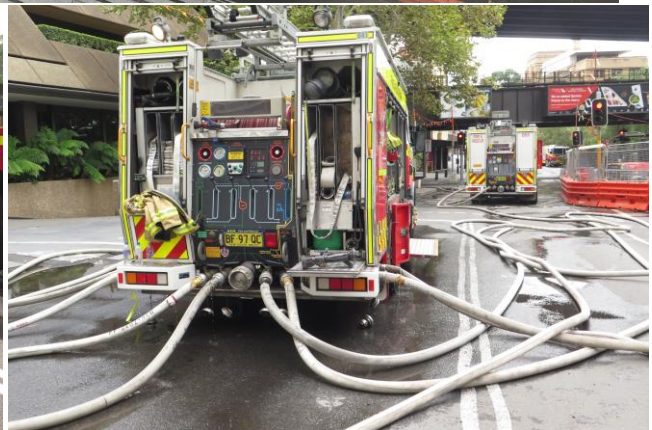
Charlie Sector Operations: Ladder Platform 36 attacks the fire on the Charlie Side. Pumper 53, Rescue Pumper 36 and Hazmat Pumper 51 attacked the fire on the Bravo/Charlie sides with hand lines.

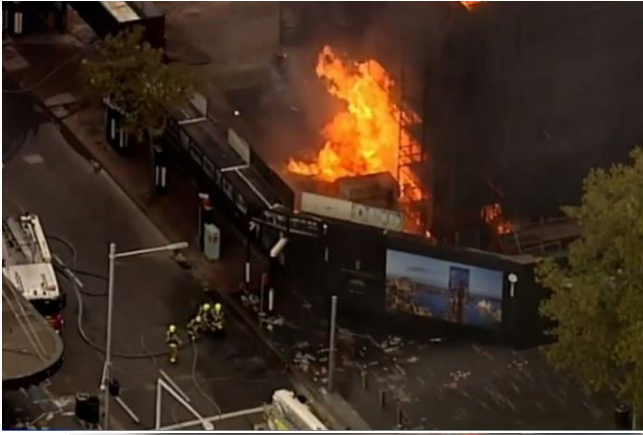
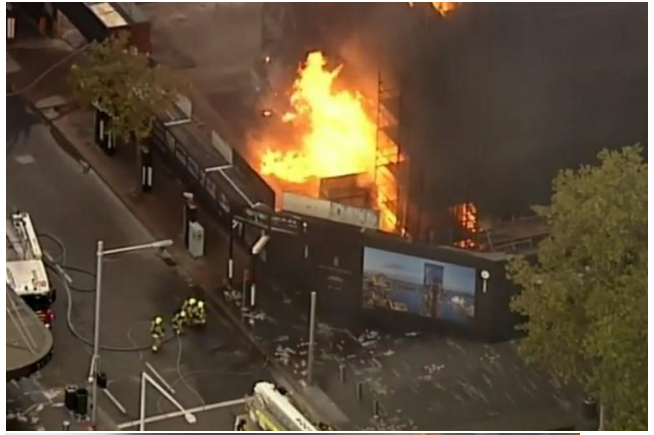
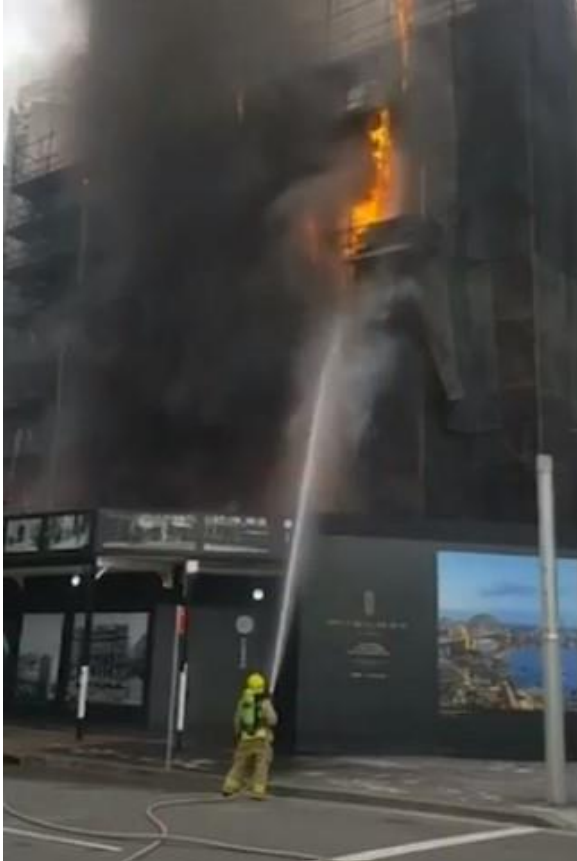
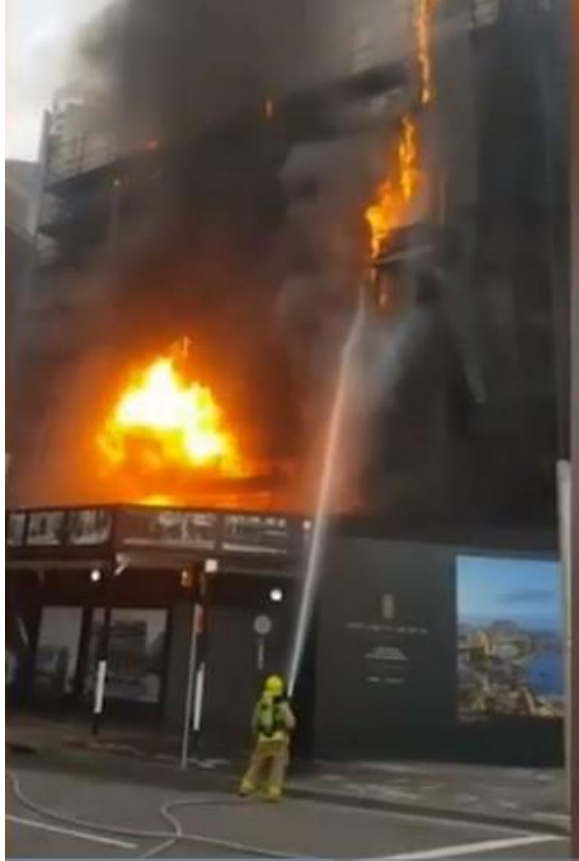
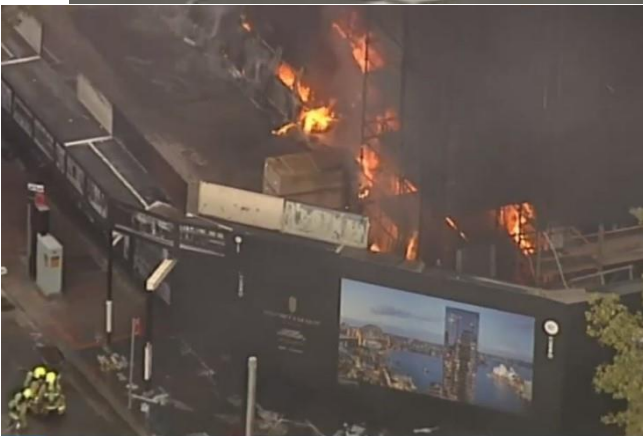
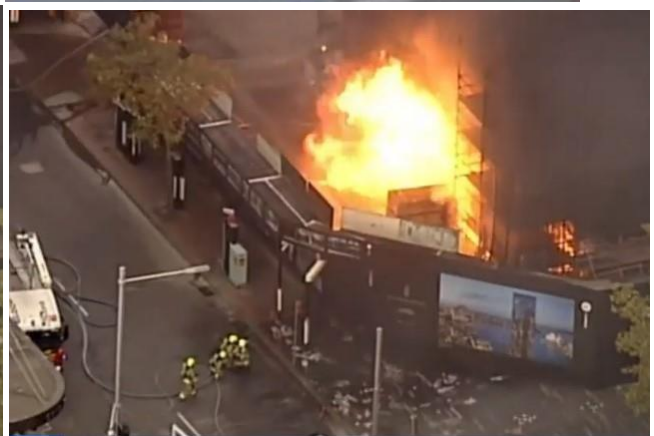
Firefighters encountered a number of LPG cylinder Boiling Liquid Expanding Vapour Explosions (BLEVEs) from severely heat impacted gas cylinders stored in the basement.

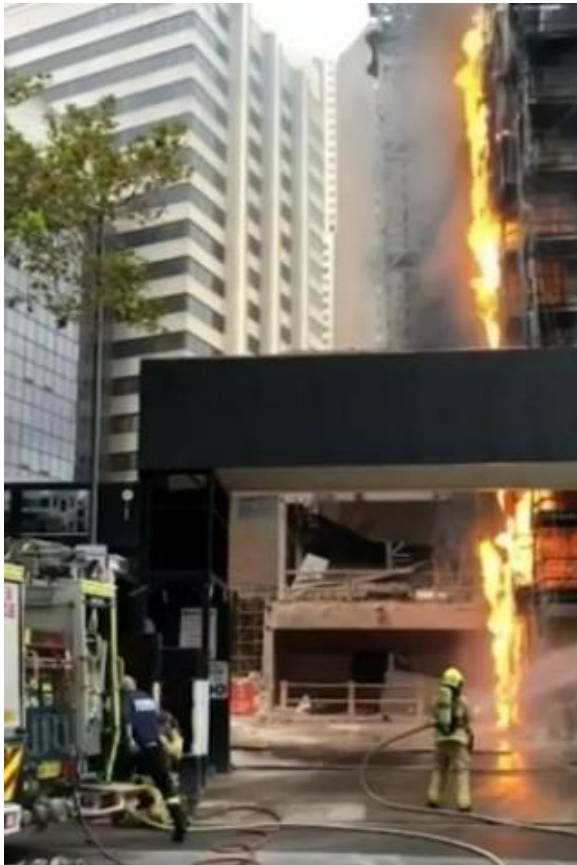
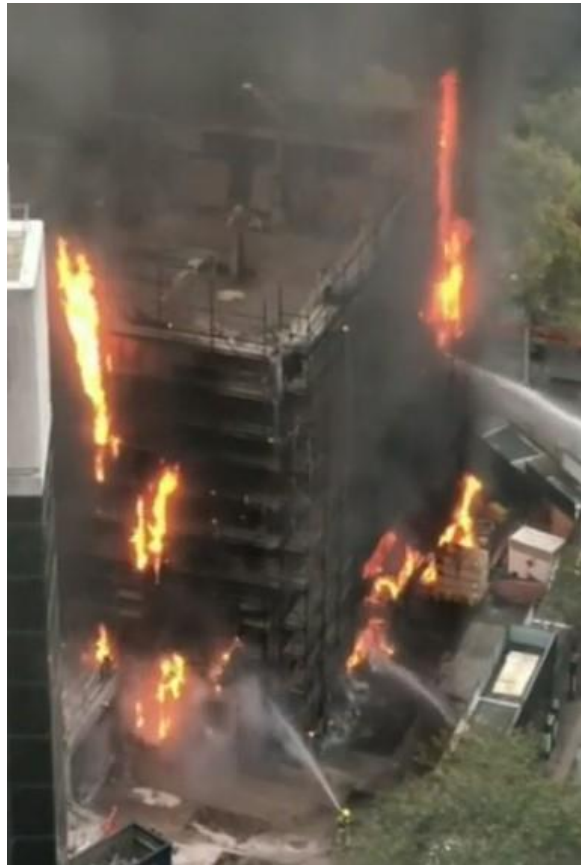
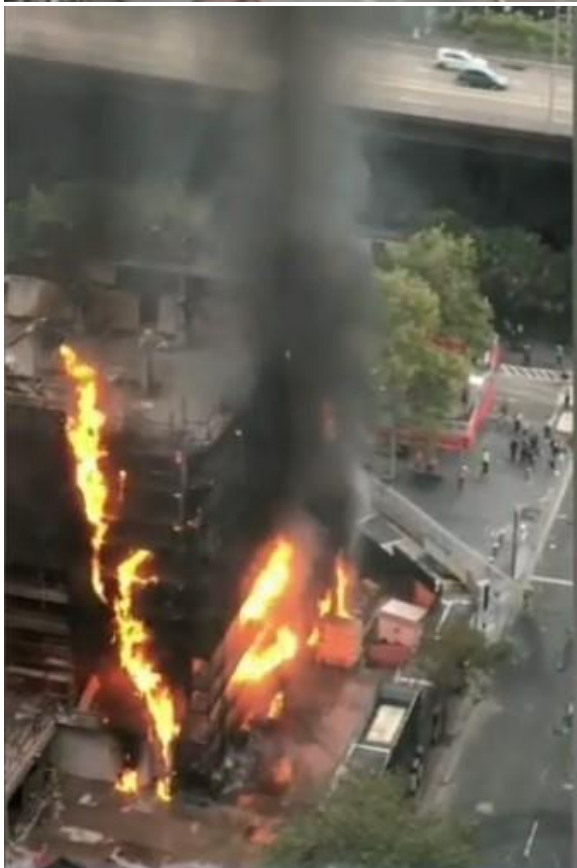
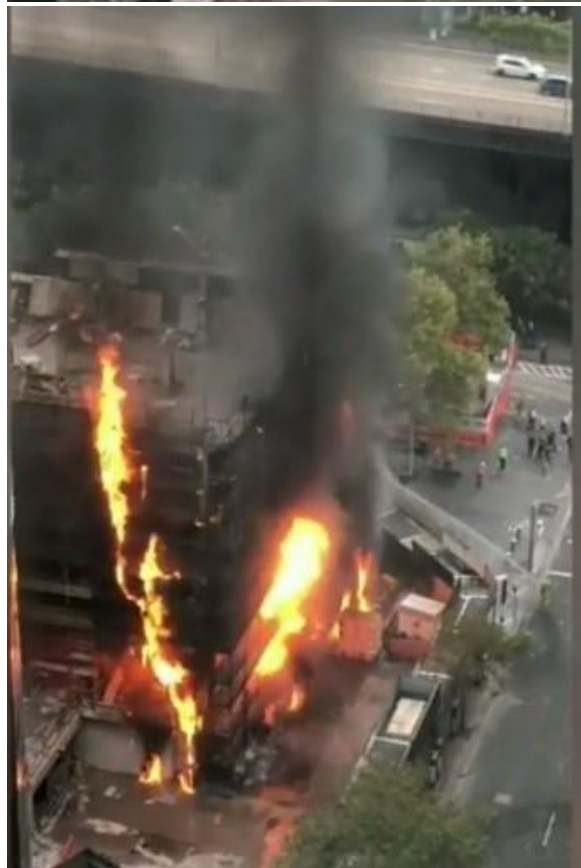
Vertical fire is spreading outwards towards the Delta and Charlie sides of the building, from Alpha and Bravo sides. Firefighters are attempting to establish containment. Visible in the lower pictures are flames resulting from LPG cylinder Boiling Liquid Expanding Vapour Explosions (BLEVEs).

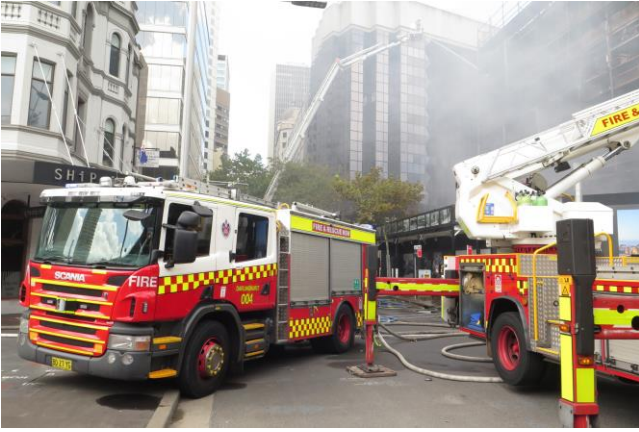
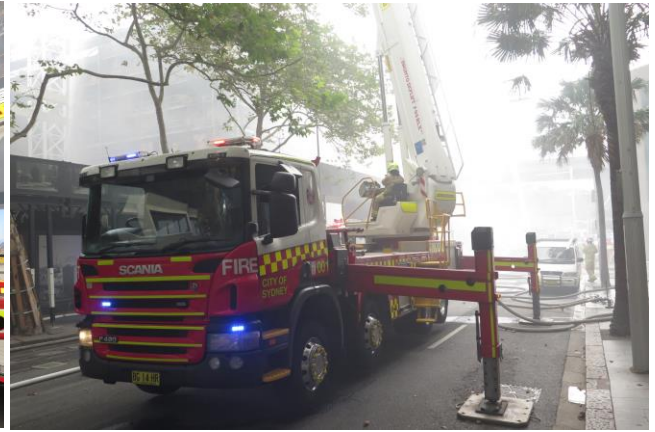
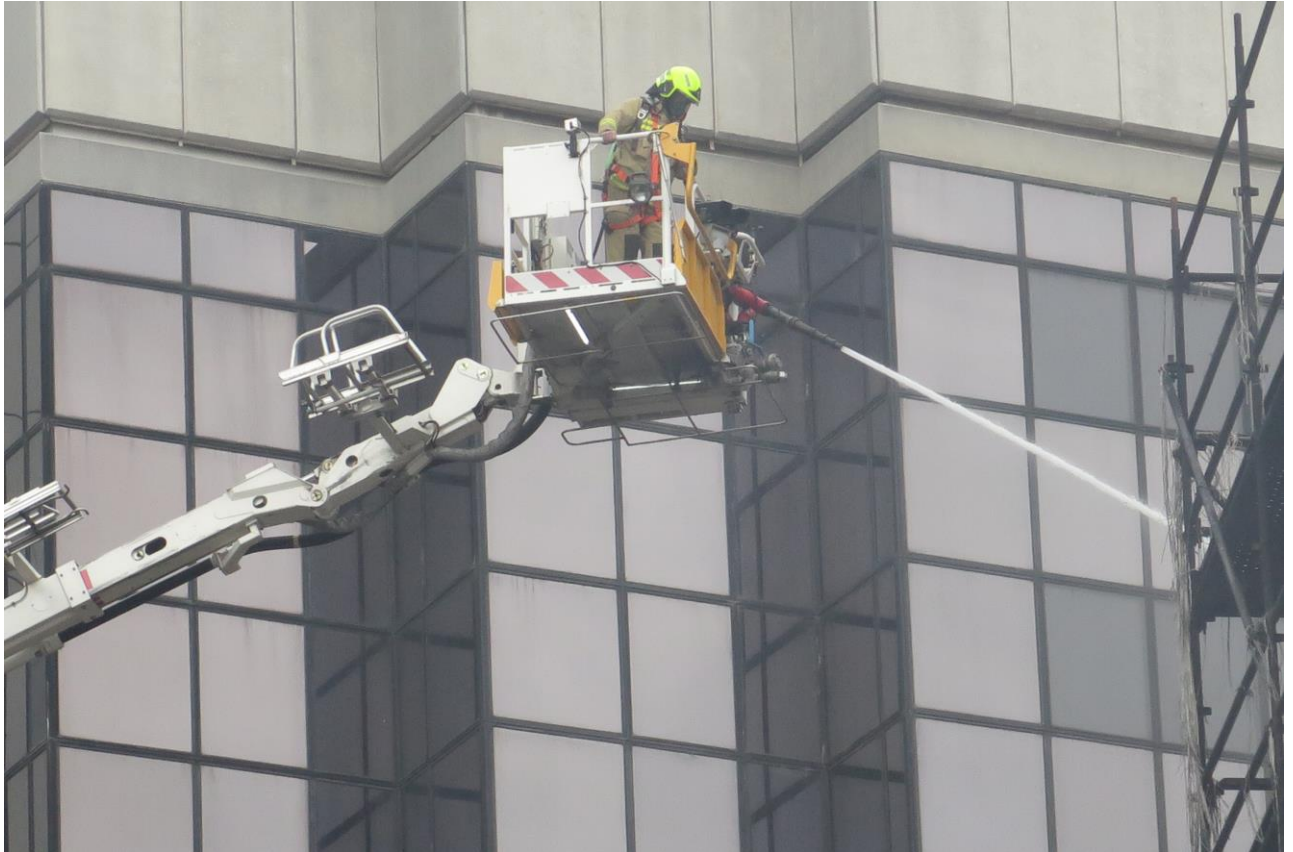
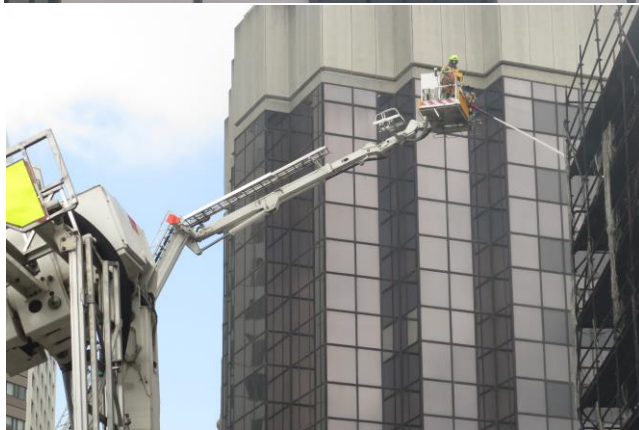
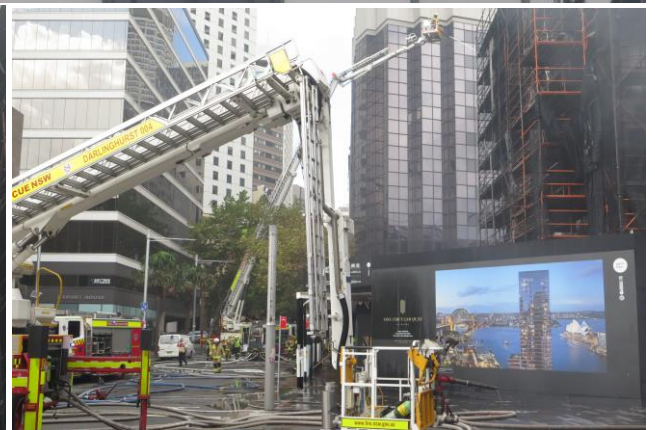
Ladder Platform 1 established cutoff of fire burning the perimeter scaffold mesh on the Bravo side. The aerial master stream was also used to cool the steel tower supporting the tower crane.

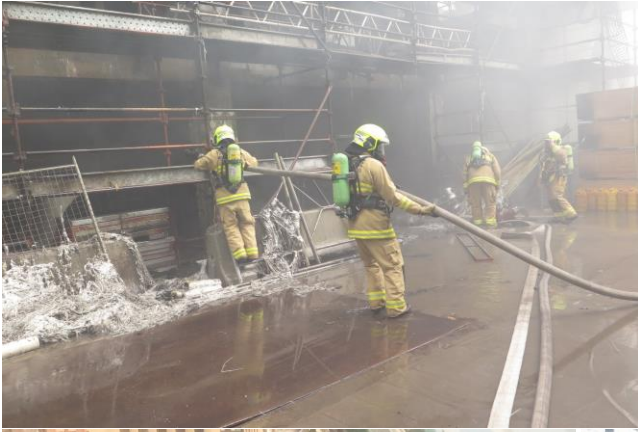
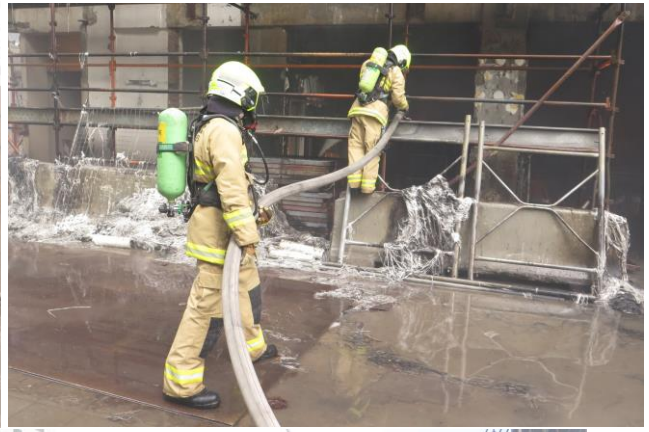
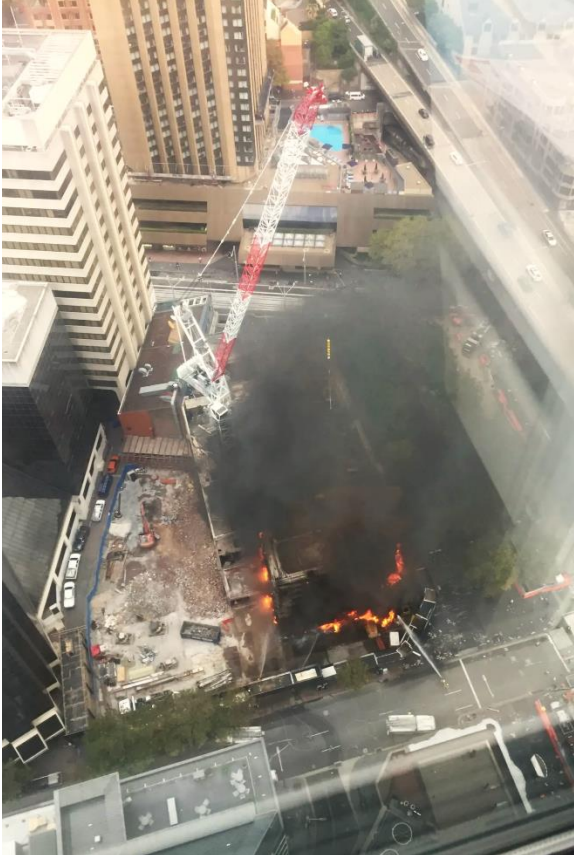
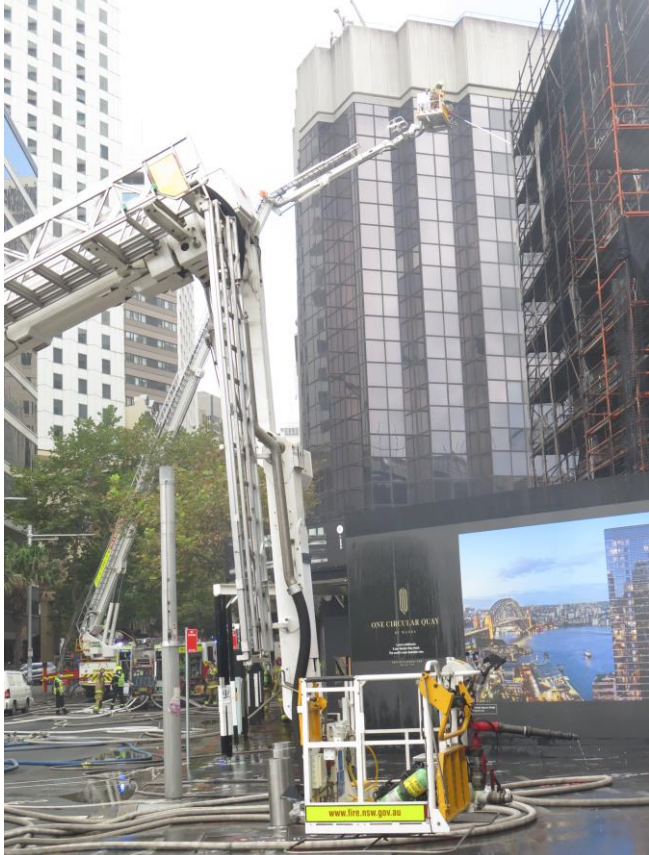
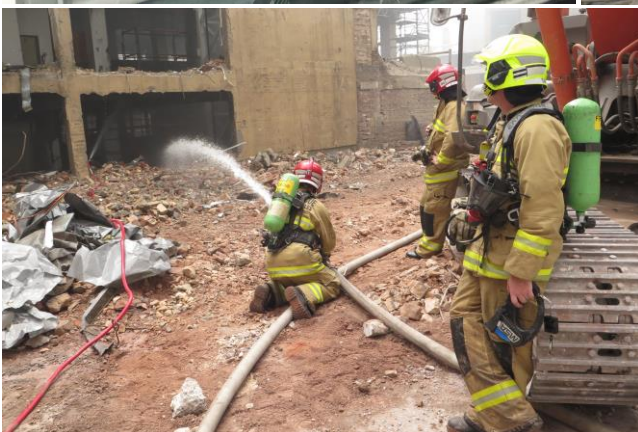
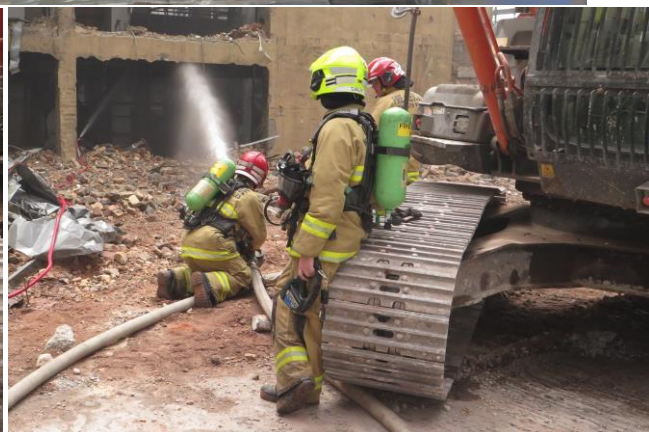
Top: Firefighters direct a cooling stream onto cylinders stored in the basement. Middle left: Black smoke vents from the burning polyurethane. Fire is spreading towards the tower crane. Middle Right: Ladder Platform directs an aerial stream onto the steel structure supporting the tower crane. Lower: Rescue Pumper 15 firefighters under the command of S.O. Stephen direct water onto an area of fire beyond the reach of the aerial appliance near the base of the tower crane.

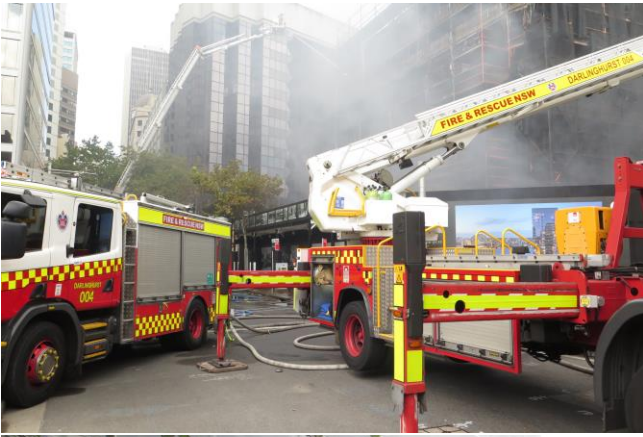
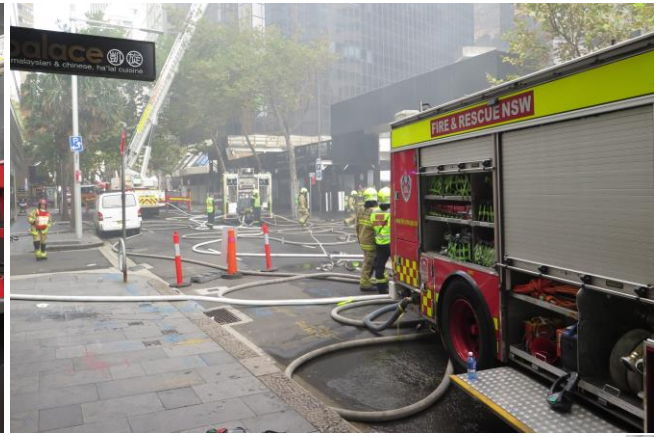
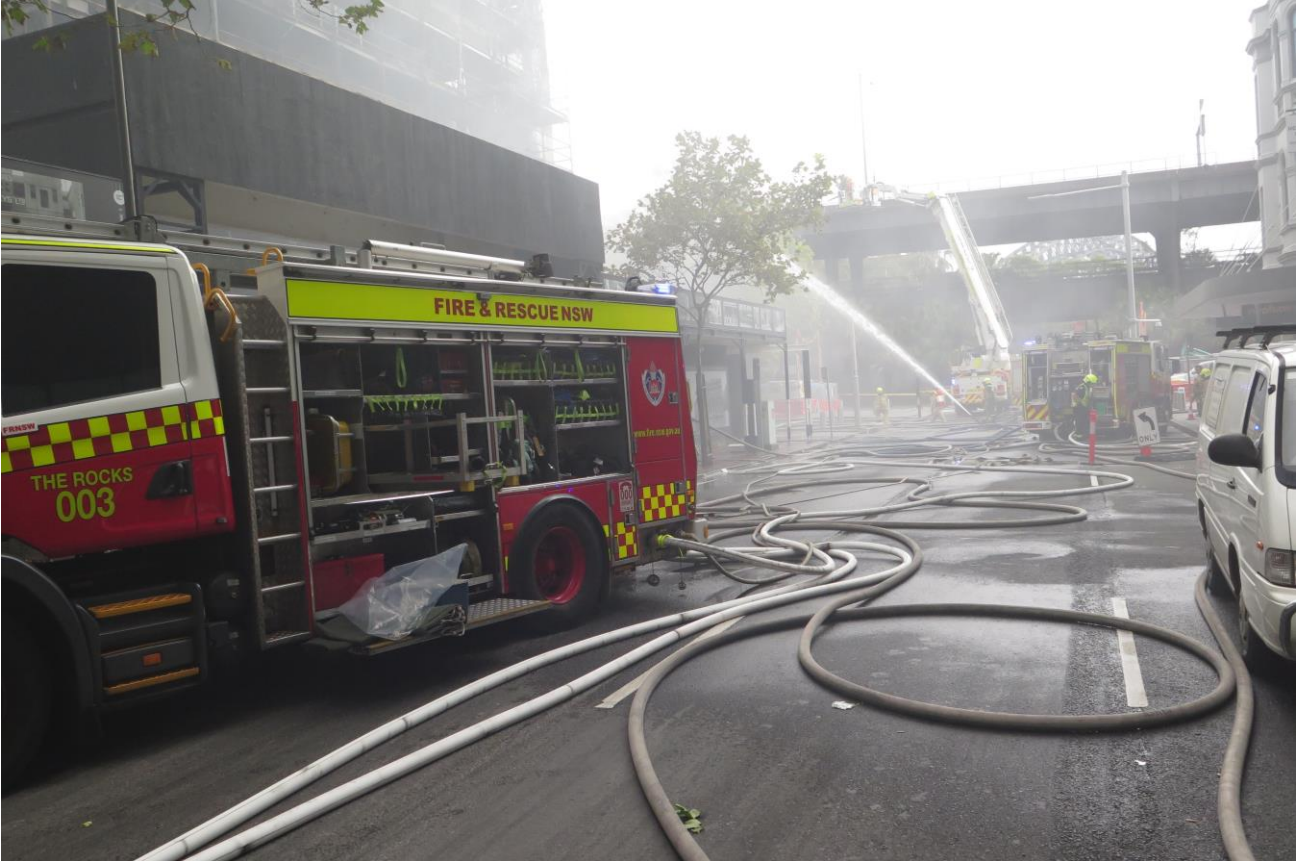
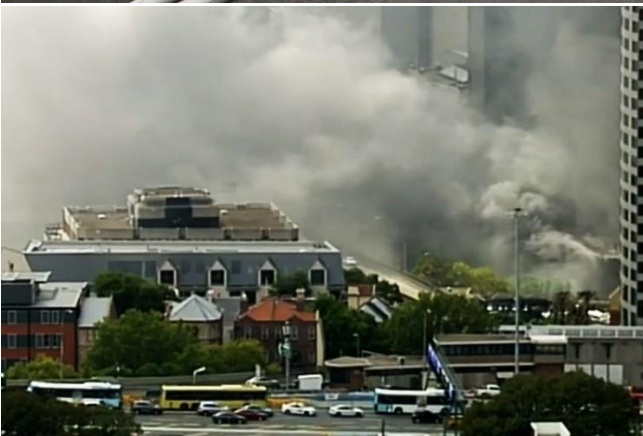
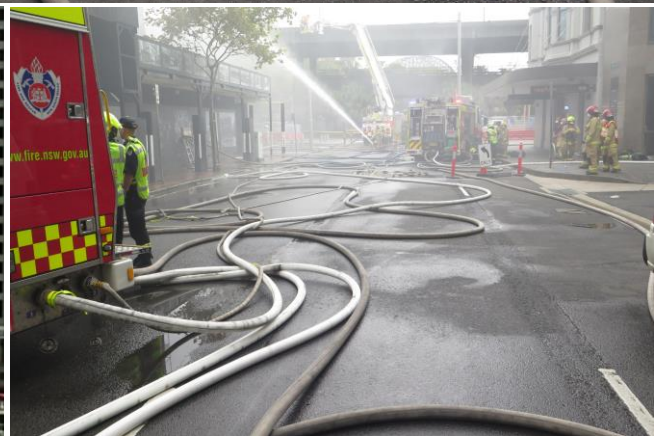
Top Left: Pitt Street – Pumper 4 supplies water to Ladder Platform 4. Ladder Platform 1 attacks the fire in the background. Top right: Runner 1 supplying water to a ground monitor in Pitt Street. Middle: First arriving Pumper 3 supplies attack lines to firefighters working in Alpha Sector. Lower left: Smoke billows over Pitt Street. Lower right: Pumper 3 and Runner 1 operate in Pitt Street.
