MW1 C STATION TRAINING AND INCIDENT CASE STUDIES

FILE NO. 2023 / 31.

**4th ALARM CIRCULAR QUAY HIGH-RISE
BUILDING UNDER DEMOLITION FIRE.**

Incident Type: Incident Type: High-Rise Office Building Fire (under demolition).

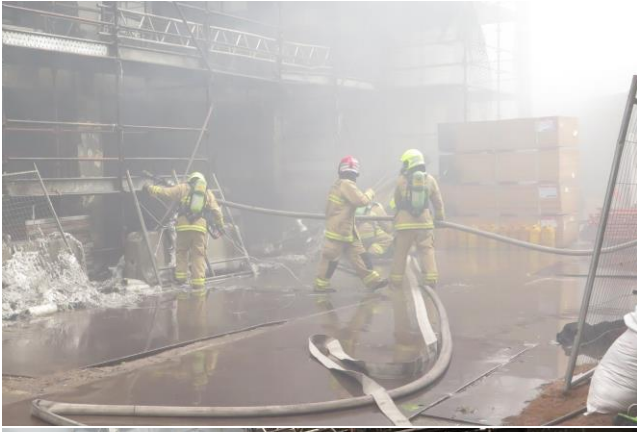
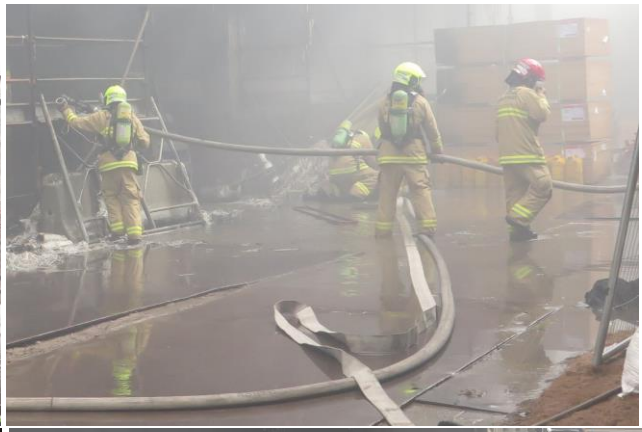
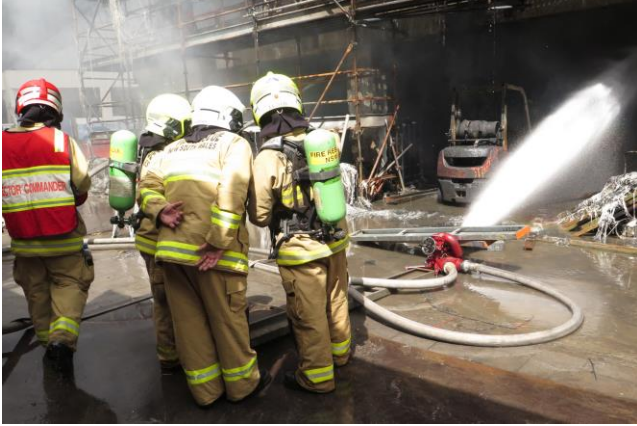
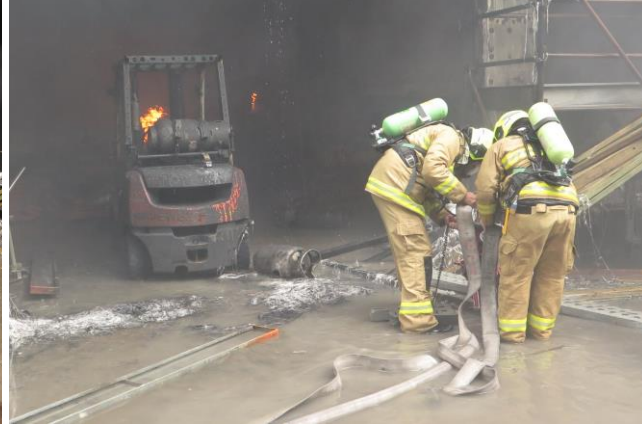
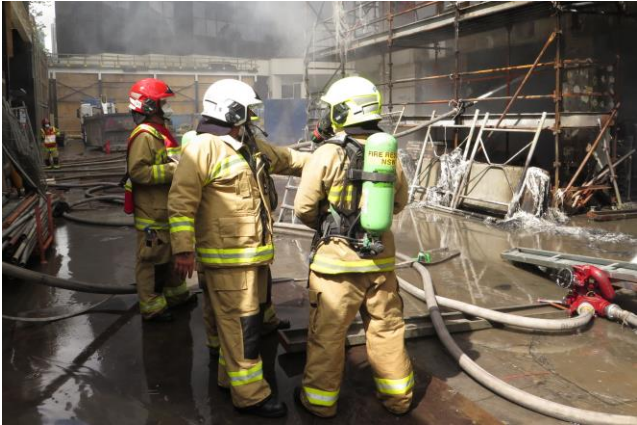
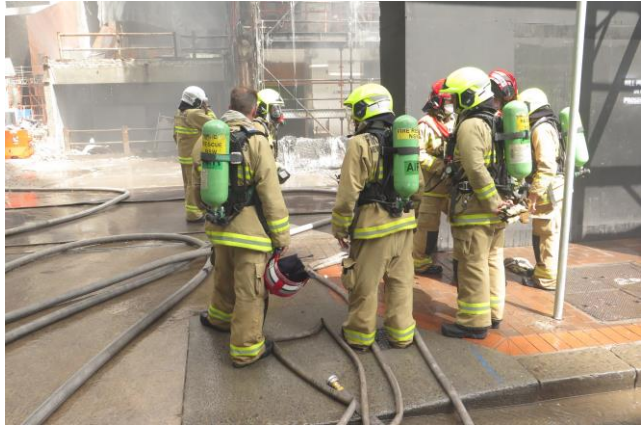
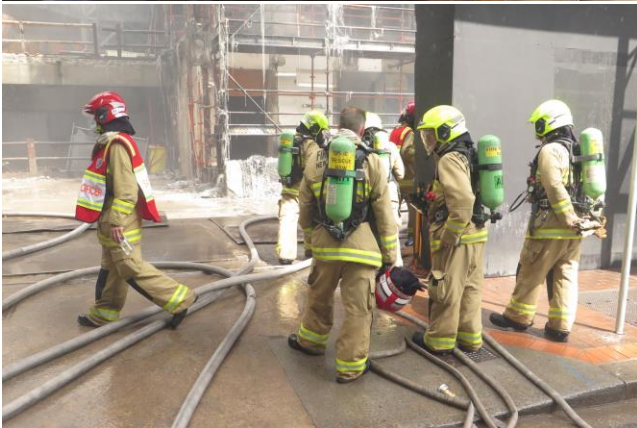
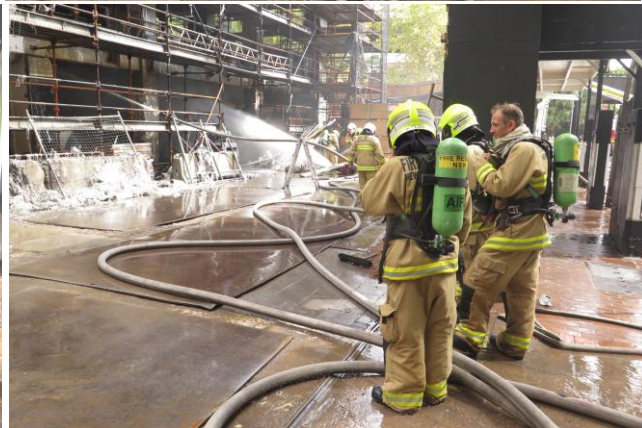
Upper: In Alpha Sector firefighters wearing SCBA establish cooling of the basement using a 70 mm line and ground monitor. Lower: SCBA on deck crews located at the entrance to Alpha Sector.

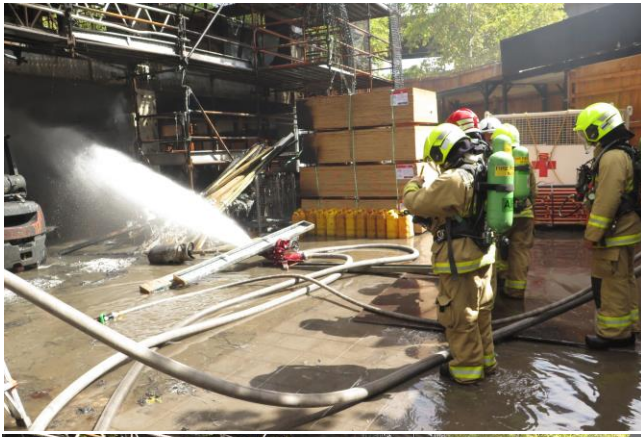
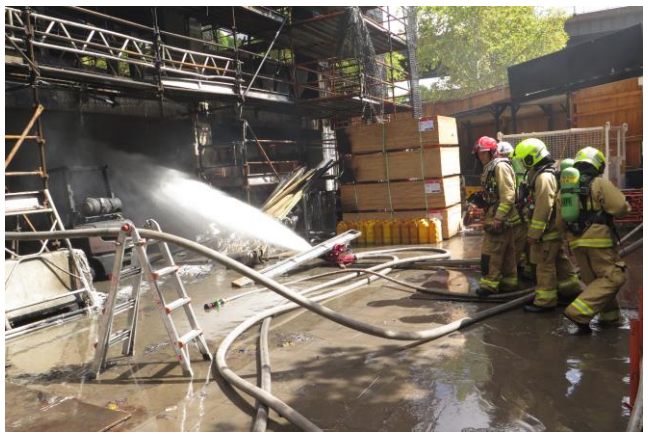
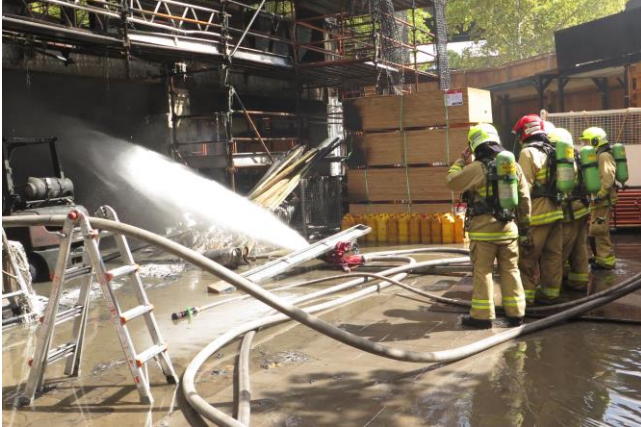
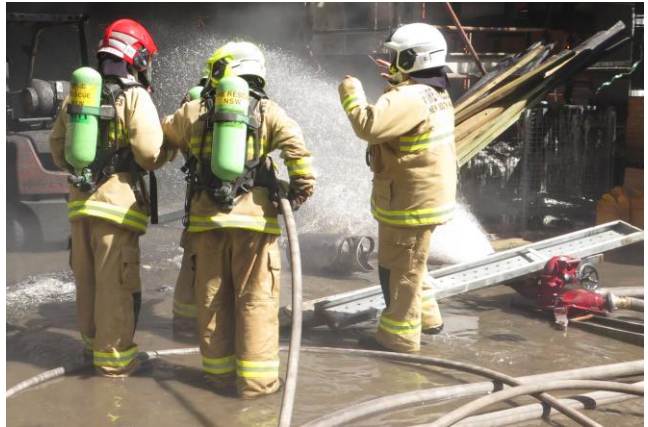
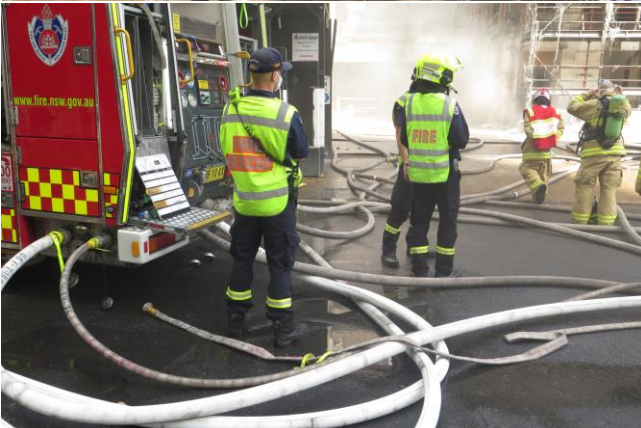
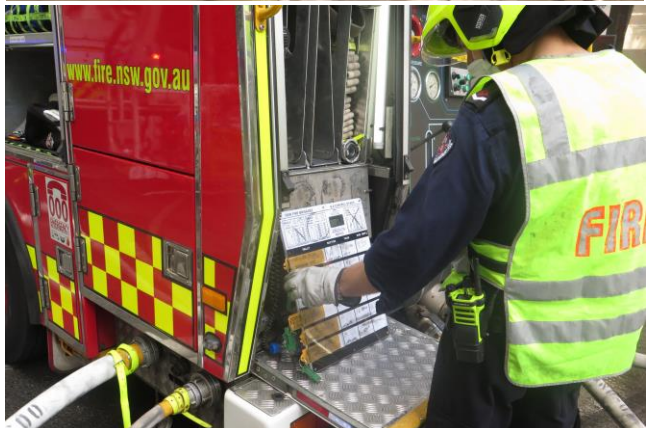
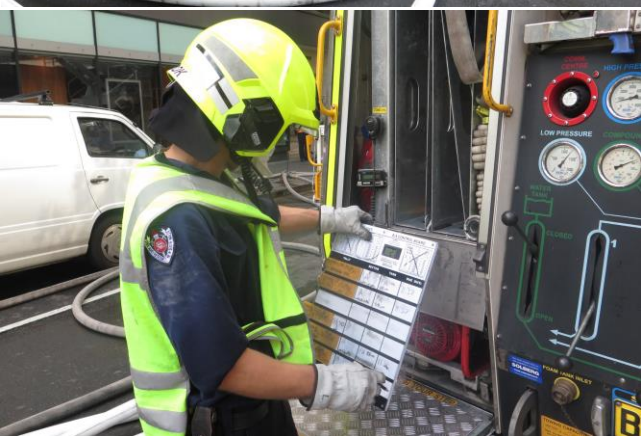
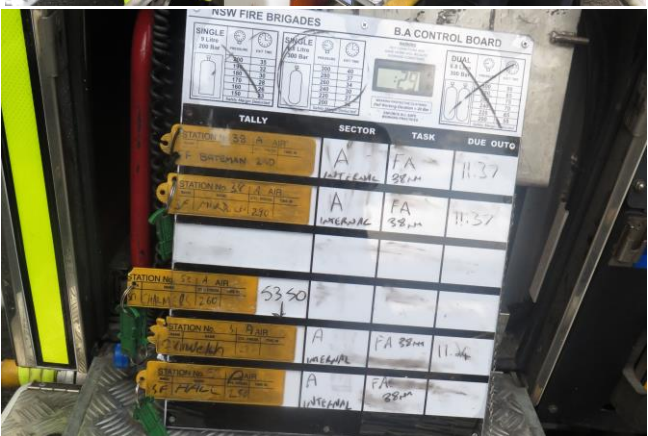
Firefighters continue to apply cooling streams onto gas cylinders located in the basement. Main B.A. Control is located at the rear of Pumper 3. A Stage I B.A. Control Board is in operation.

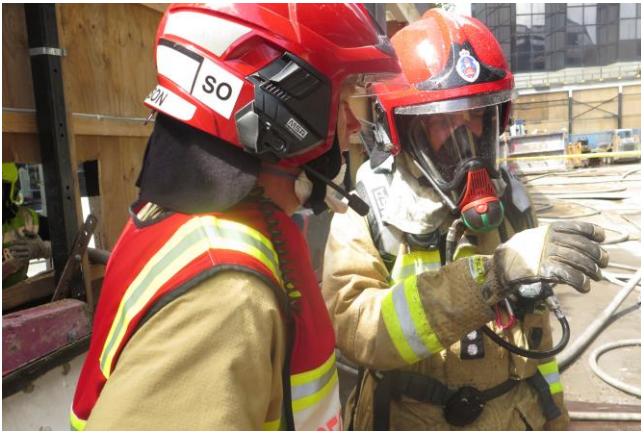
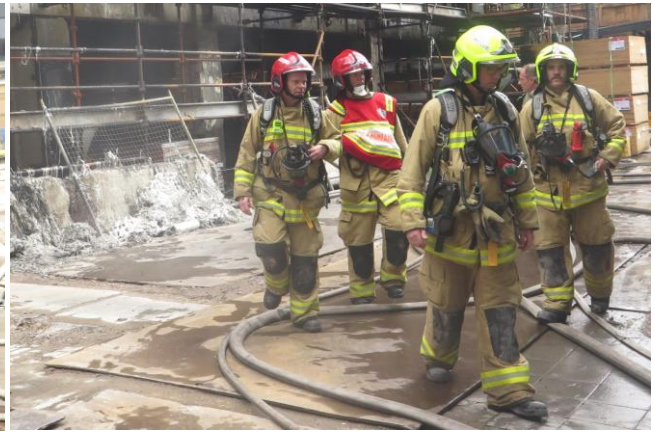
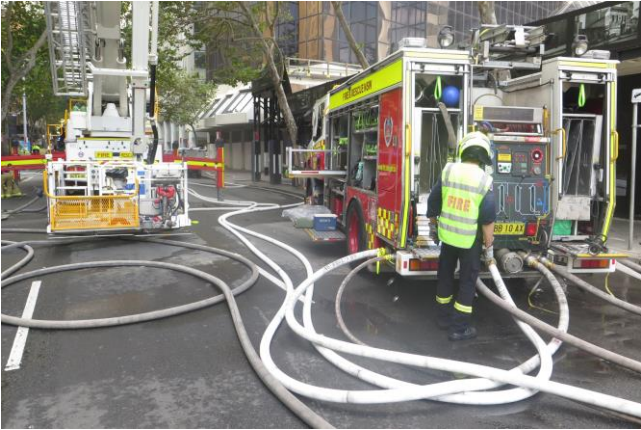
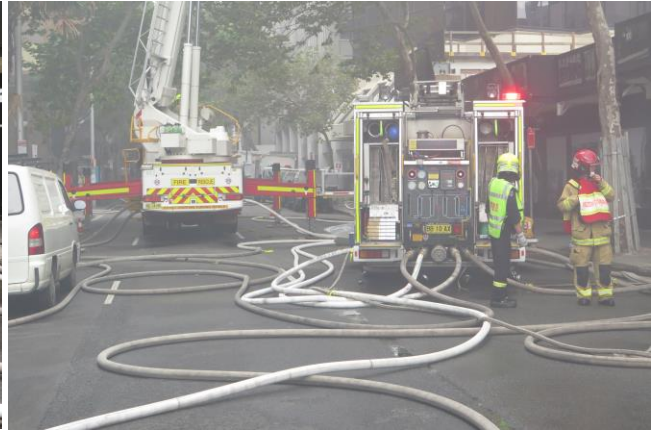
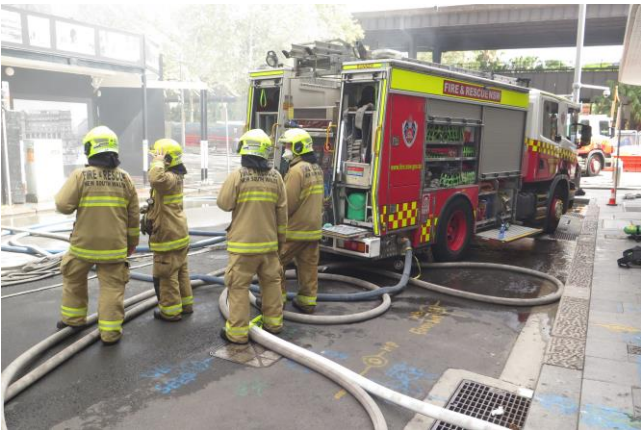
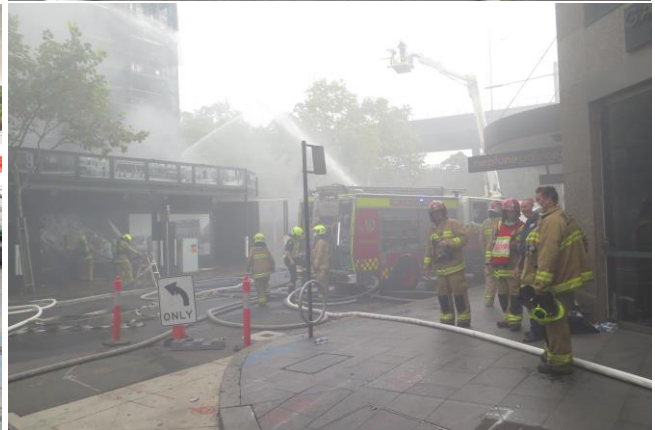
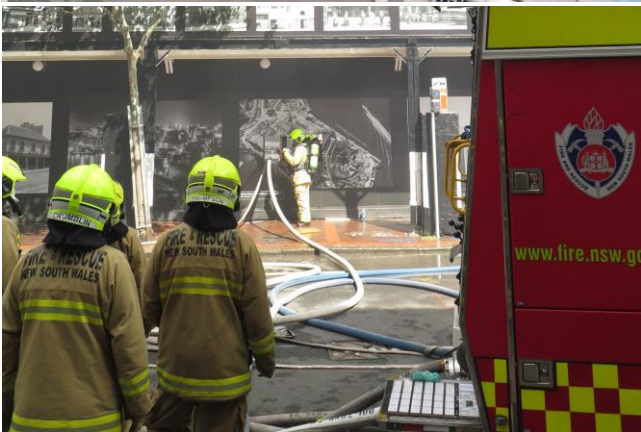
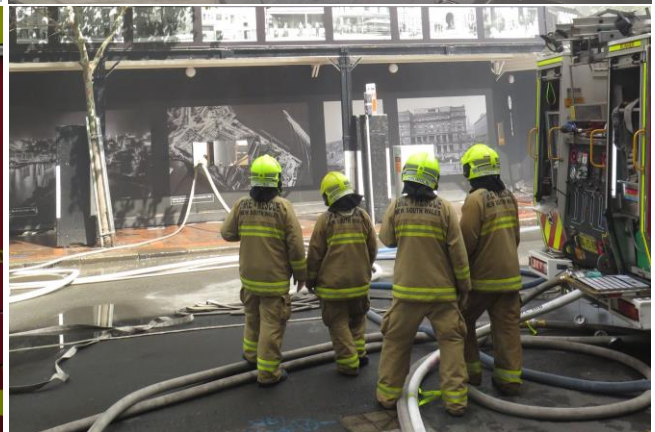
Top left: Sector Comamnder confers with fire attack commander. Top right: SCBA crews withdraw. Middle Upper: Pumper 3 supplying water to fire attack crews in Alpha Sector. Lower: Runner 1 supplies water to crews via an opening cut through the hoarding.

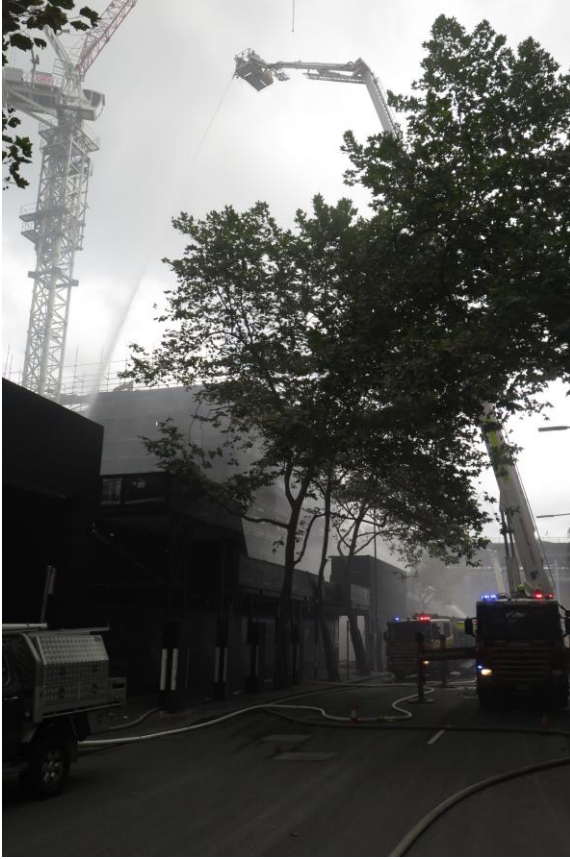
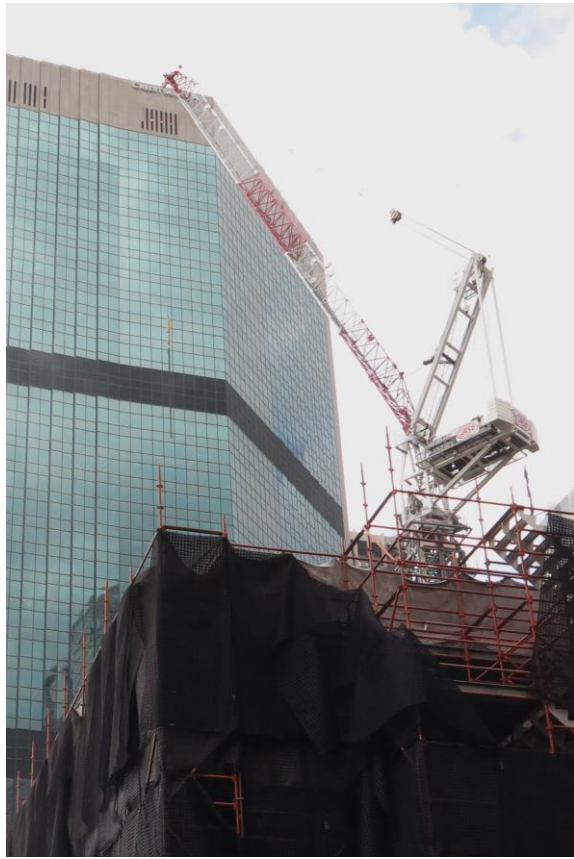
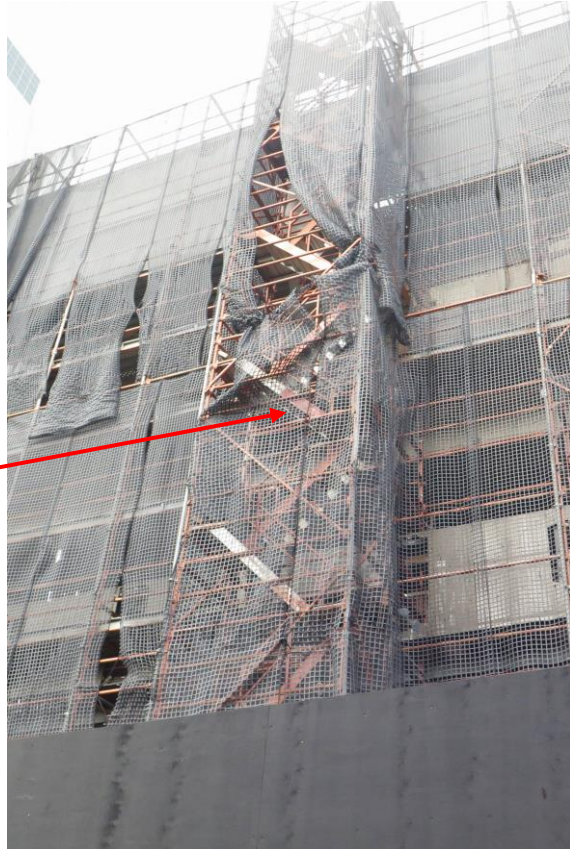
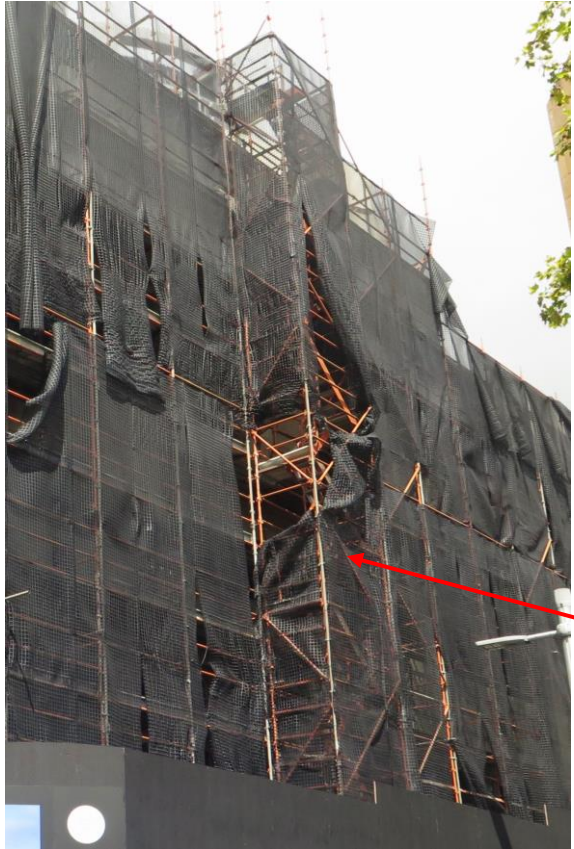
Upper: Ladder Platform 1 protected the structural steel that formed tower of the tower crane.
Lower: Scaffold stairs located on the side of the building that enabled the workers to escape (indicated by arrows).

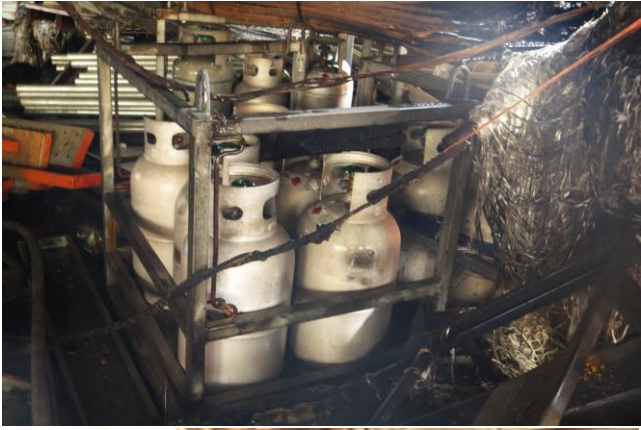
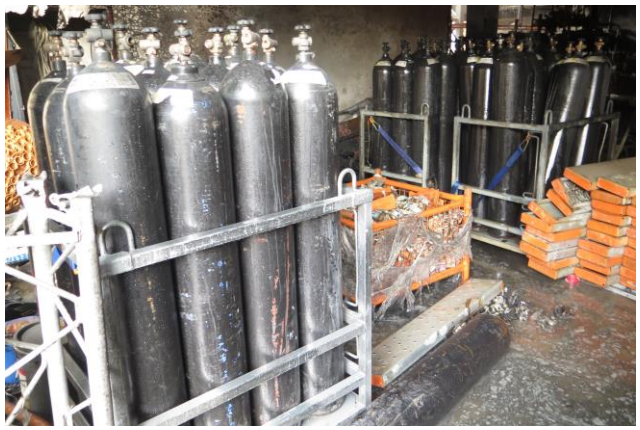
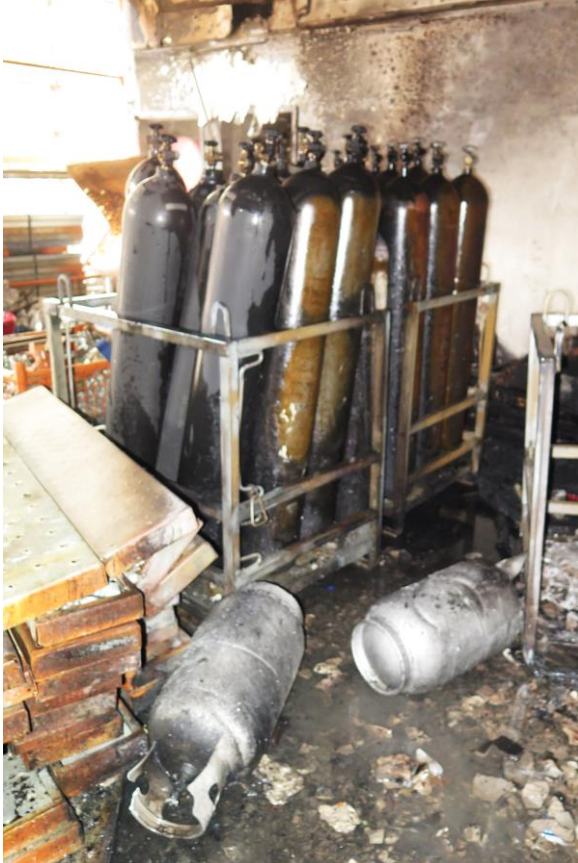
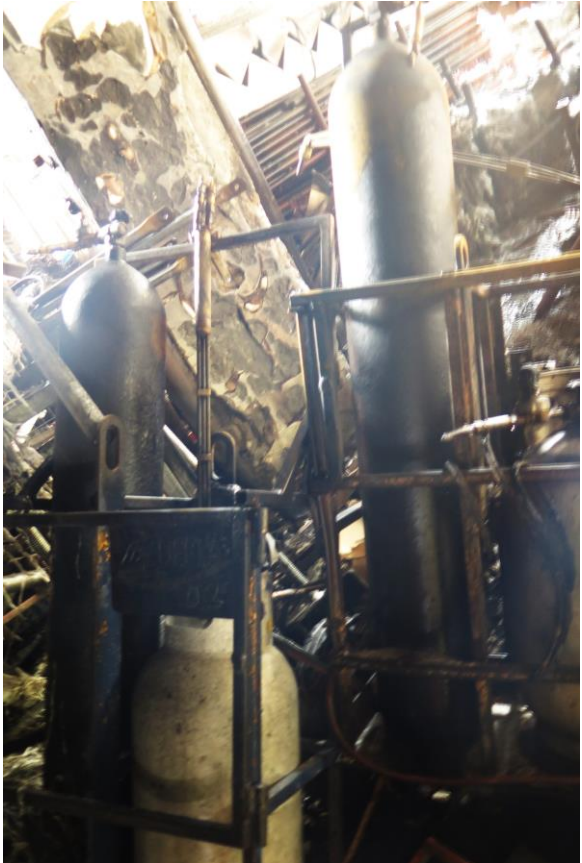
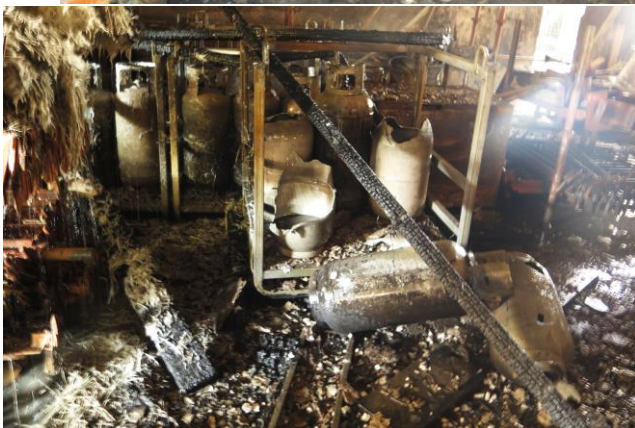
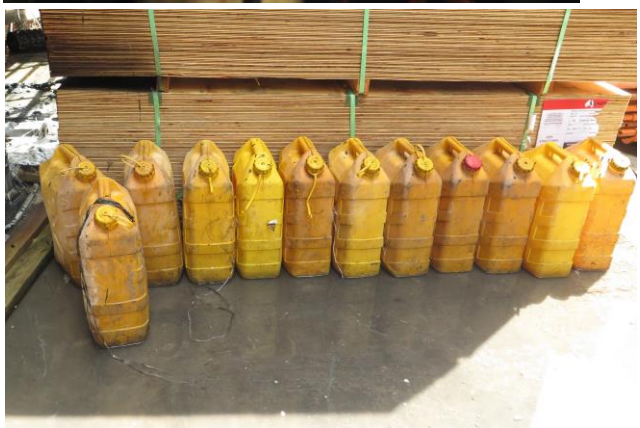
c. The lighter cylinder casings of some LPG cylinders exposed to flame impact burnt through, allowing gas to escape and rapidly burn.

Fire entered the basement where gas cylinders were stored. Top left: LPG cylinders. Top right: Oxygen cylinders. Middle left Oxygen cylinders and projected LPG cylinders. Middle right: Oxygen and LPG cylinders used for cutting. Lower left: Breached LPG cylinders. Lower right: Stored diesel fuel.

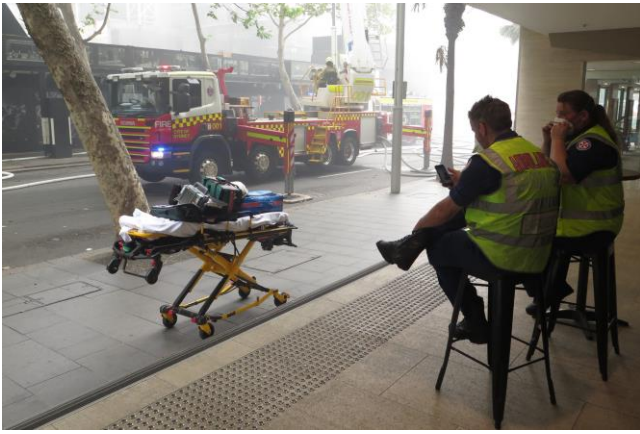
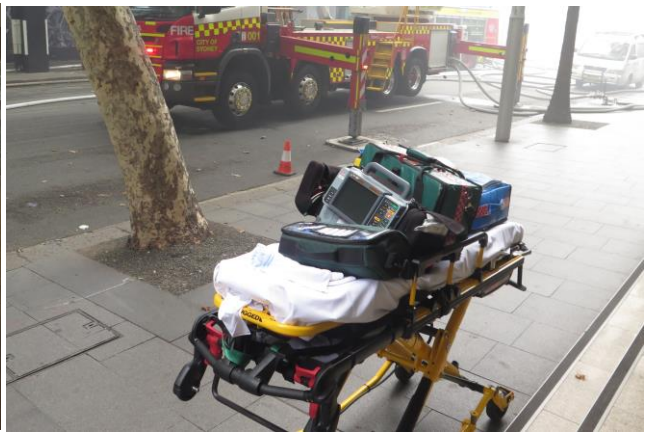
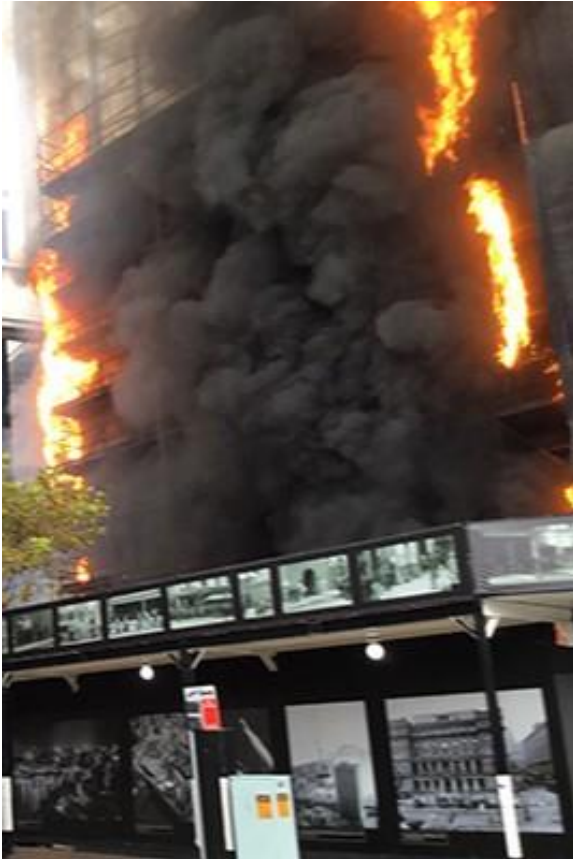
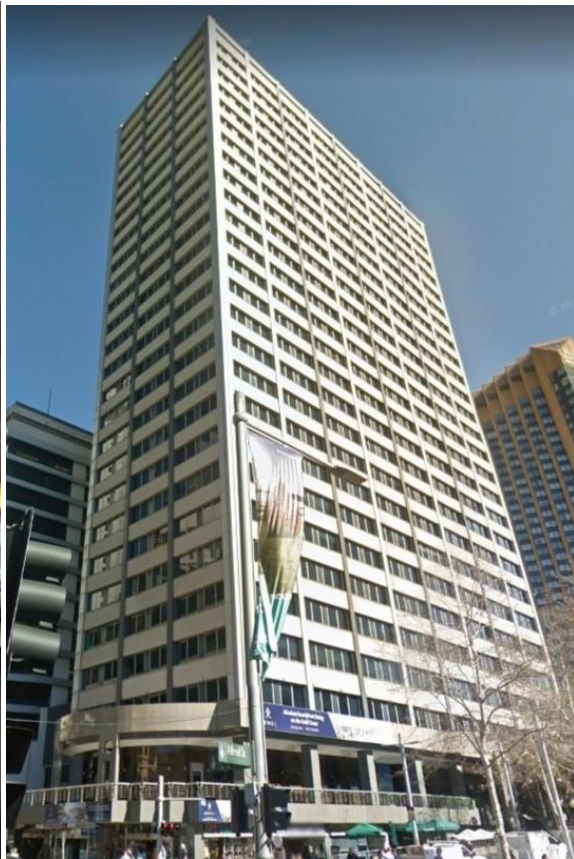
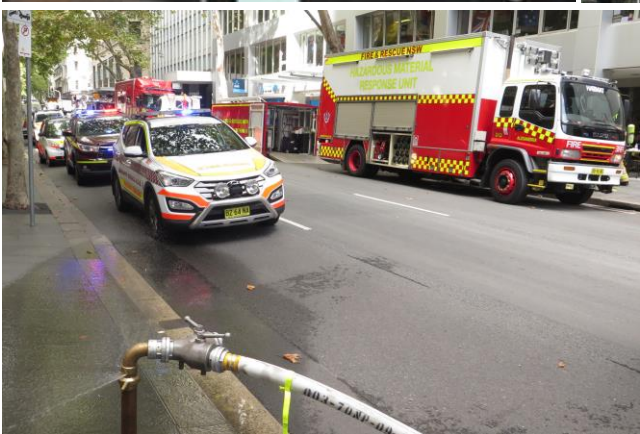
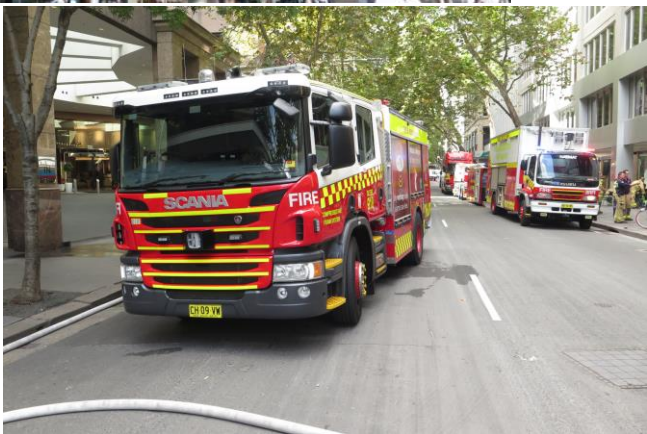
Top: As always, our colleagues from Ambulance provided fantastic support. Middle left: Fire ascends vertically through the scaffold mesh. The volumes of black smoke are being produced by rolls of polyurethane mesh burning in the basement, ignited by fire falling. Middle right: "Gold Fields House" in happier times prior to demolition commencing. Lower: Appliance staging area.

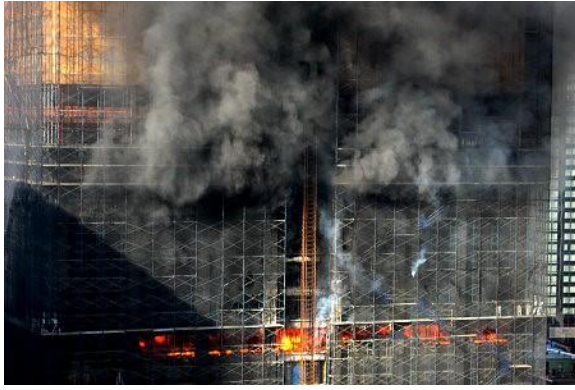
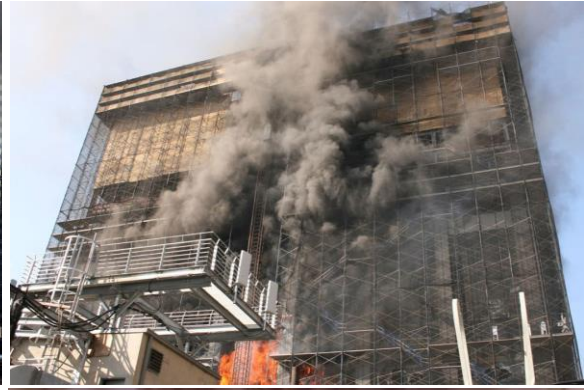
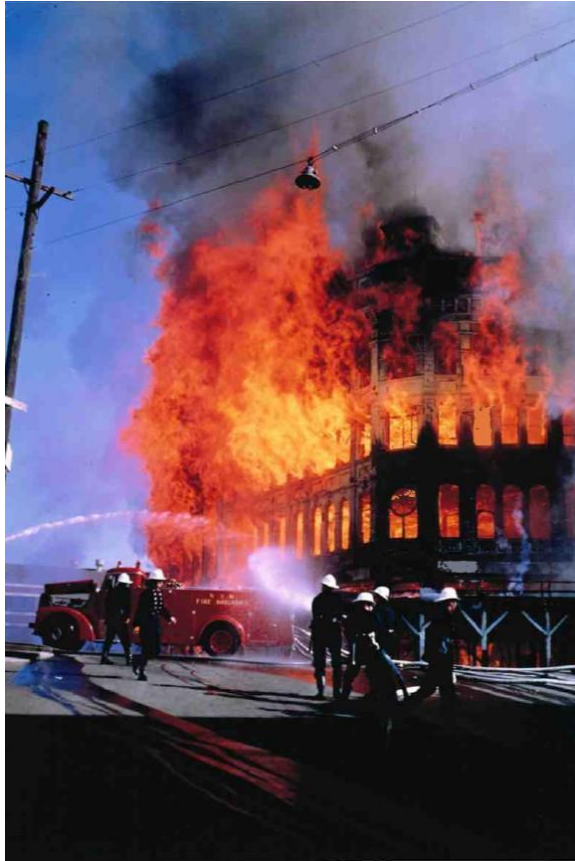
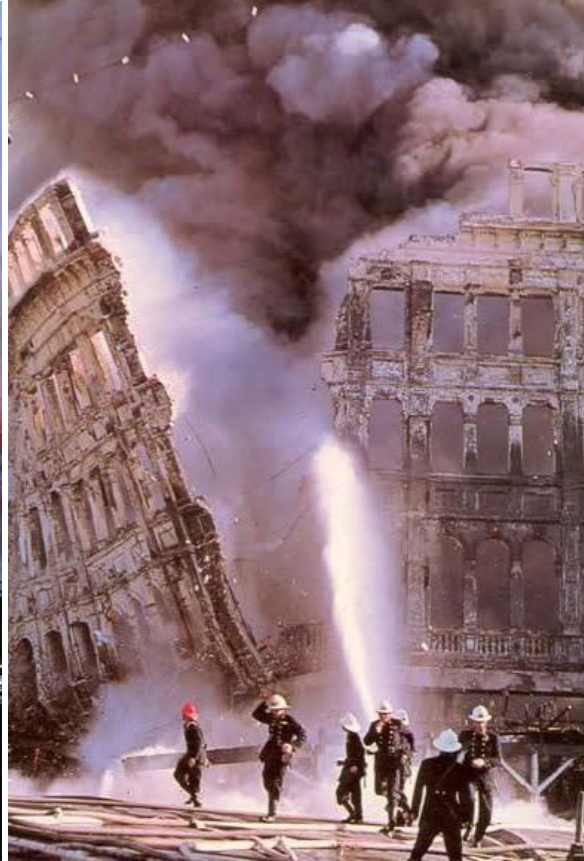
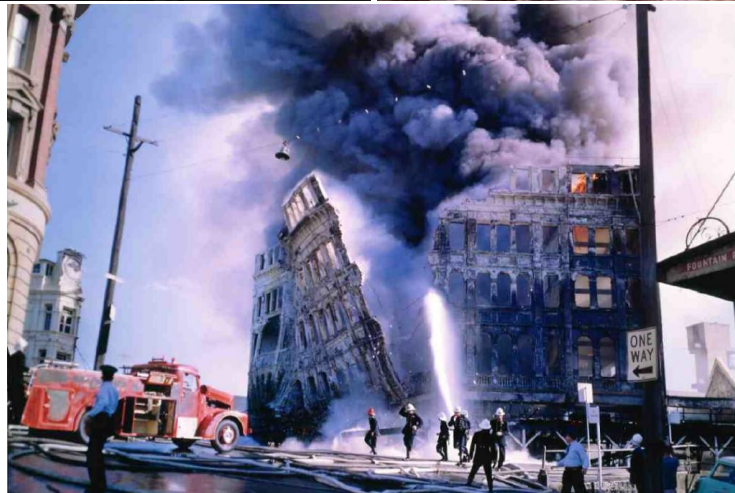
Notable fires involving buildings under demolition – Top: The Deutsche Bank building fire in New York City on 18th August 2007 killed two firefighters and injured a further 105. Lower: Buckingham's Department Store fire on Oxford Street Sydney, 25th April 1968 was as spectacular as it was dangerous. Fires involving building's under demolition have a dangerous history for firefighters and can never be underestimated.
