MW1 C STATION TRAINING AND INCIDENT CASE STUDIES

FILE NO. SR / 02.

**11th ALARM PORT KEMBLA ETHANOL BULK
STORAGE TANK FIRE**

Flammable Liquid Bulk Storage Tank Fire - Full Surface Fire.

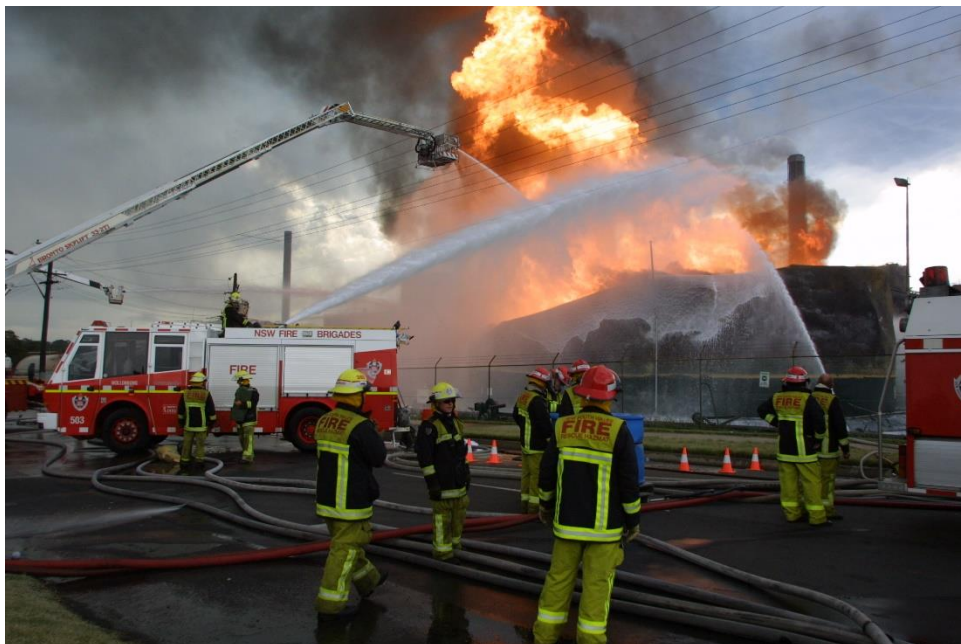
Cover photo: Numerous defensive master streams are in operation as firefighters establish protection of surrounding storage tanks.

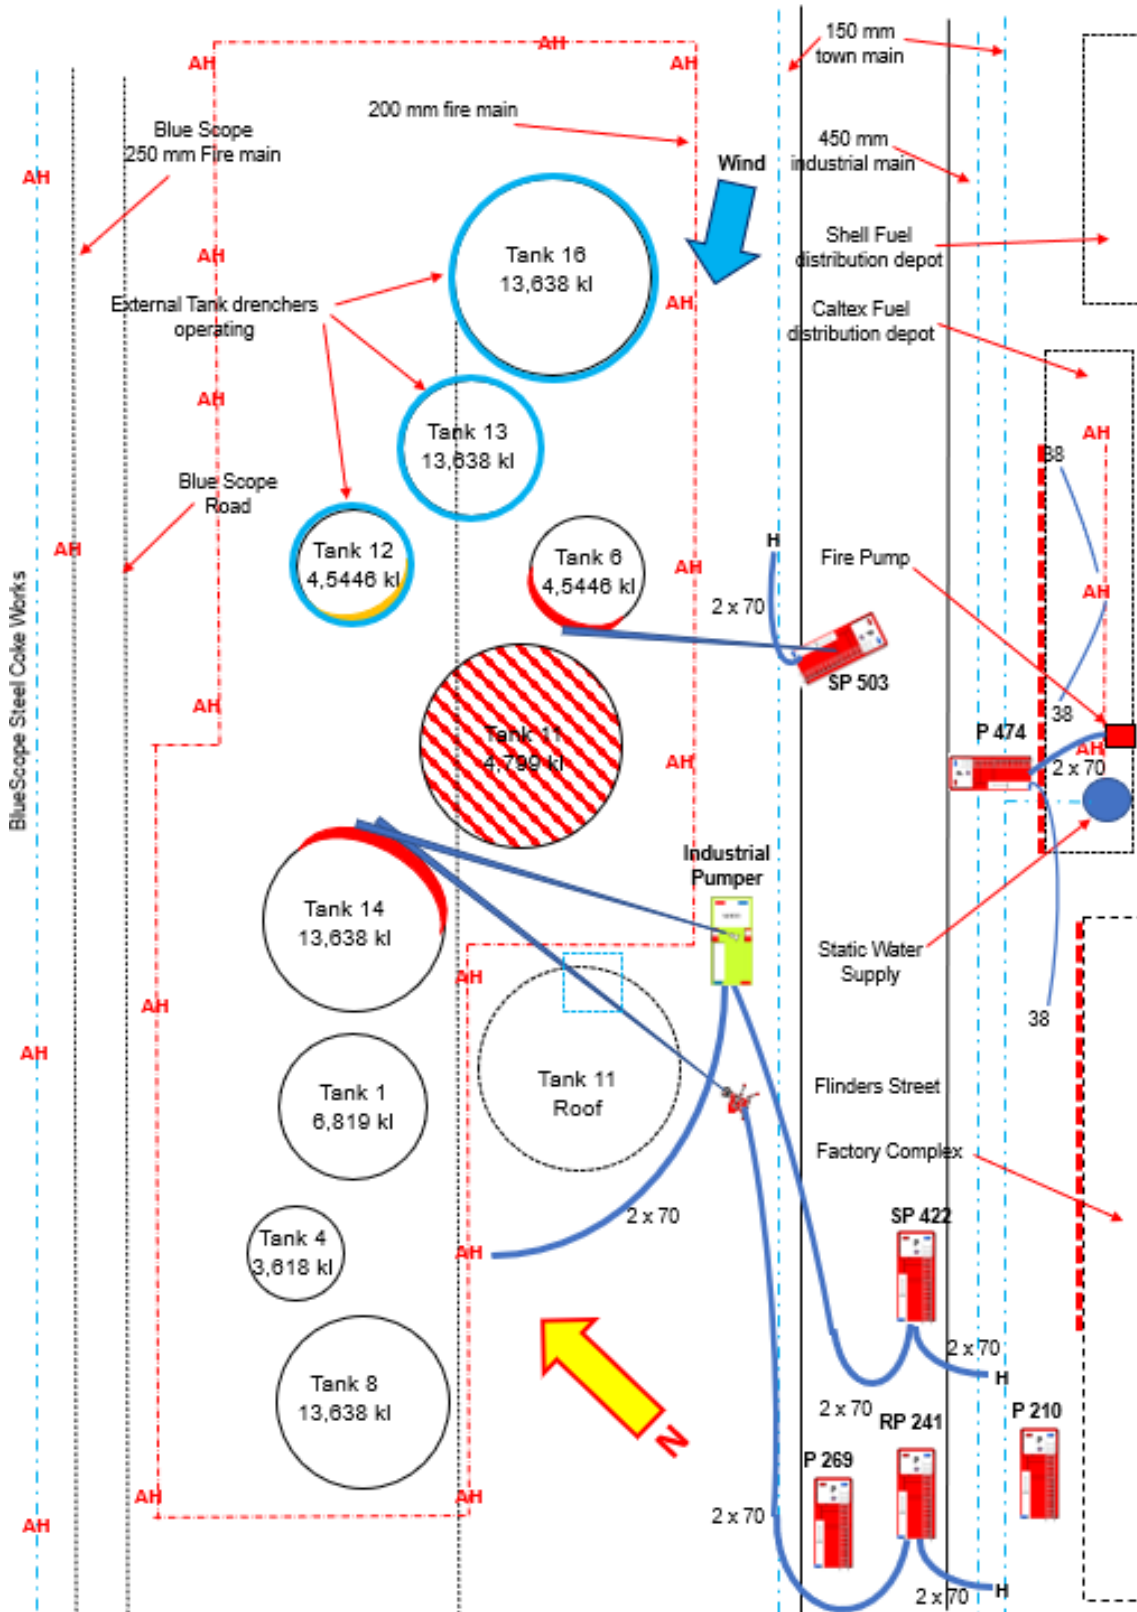
Fireground Drawing Initial Firefighting Operations

At the same time Pumper 474 firefighters were protecting the threatened fuel storage depots and factories opposite the burning ethanol tank, Firefighters from Super Pumper 422, Rescue Pumper 241 and Pumper 269 began to place a ground monitor in position, on a hardstand area within the site between the involved tank and Tank 14. Firefighters wanted to direct the monitor stream onto the upper wall of the tank facing the burning ethanol tank.

This part of the tank (known as the tank “head space”) contained no product and therefore was most vulnerable to failure (product within the tank was acting as a “heat sink”, able to absorb the radiant heat protecting the tank steel. Steel near the head space did not have this protection). Initially, the ground monitor stream would not reach the storage tank with the diffuser nozzle fitted. Firefighters then replaced the diffuser nozzle on the ground monitor with a stack tip nozzle, resulting in a solid stream that projected across a greater distance. An advantage of the solid stream compared to the diffuser nozzle stream was its ability to remain intact and not break up. The solid stream was able to travel a much greater distance and was delivering more water onto the surface of the tank and therefore was a much more effective stream than a hollow core stream.

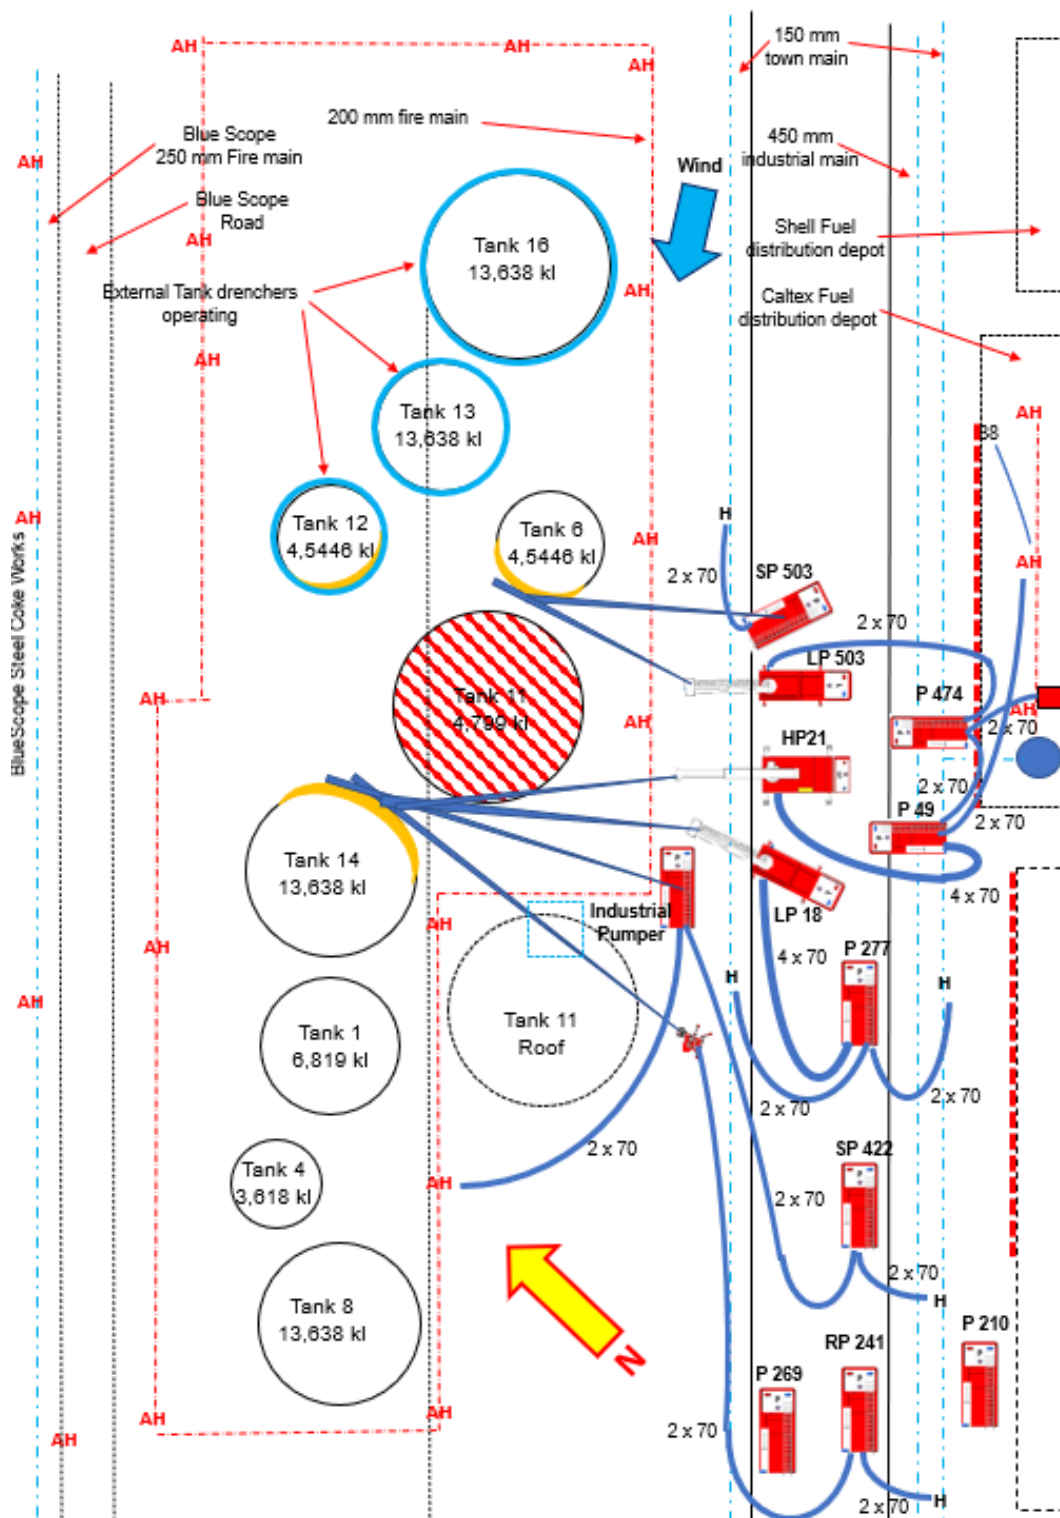
Expanded Division A Operations

“AT WORK ON SOUTHERN EXPOSURE OF TANK. THE TANK CONDITION IS DETERIORATING RAPIDLY”.

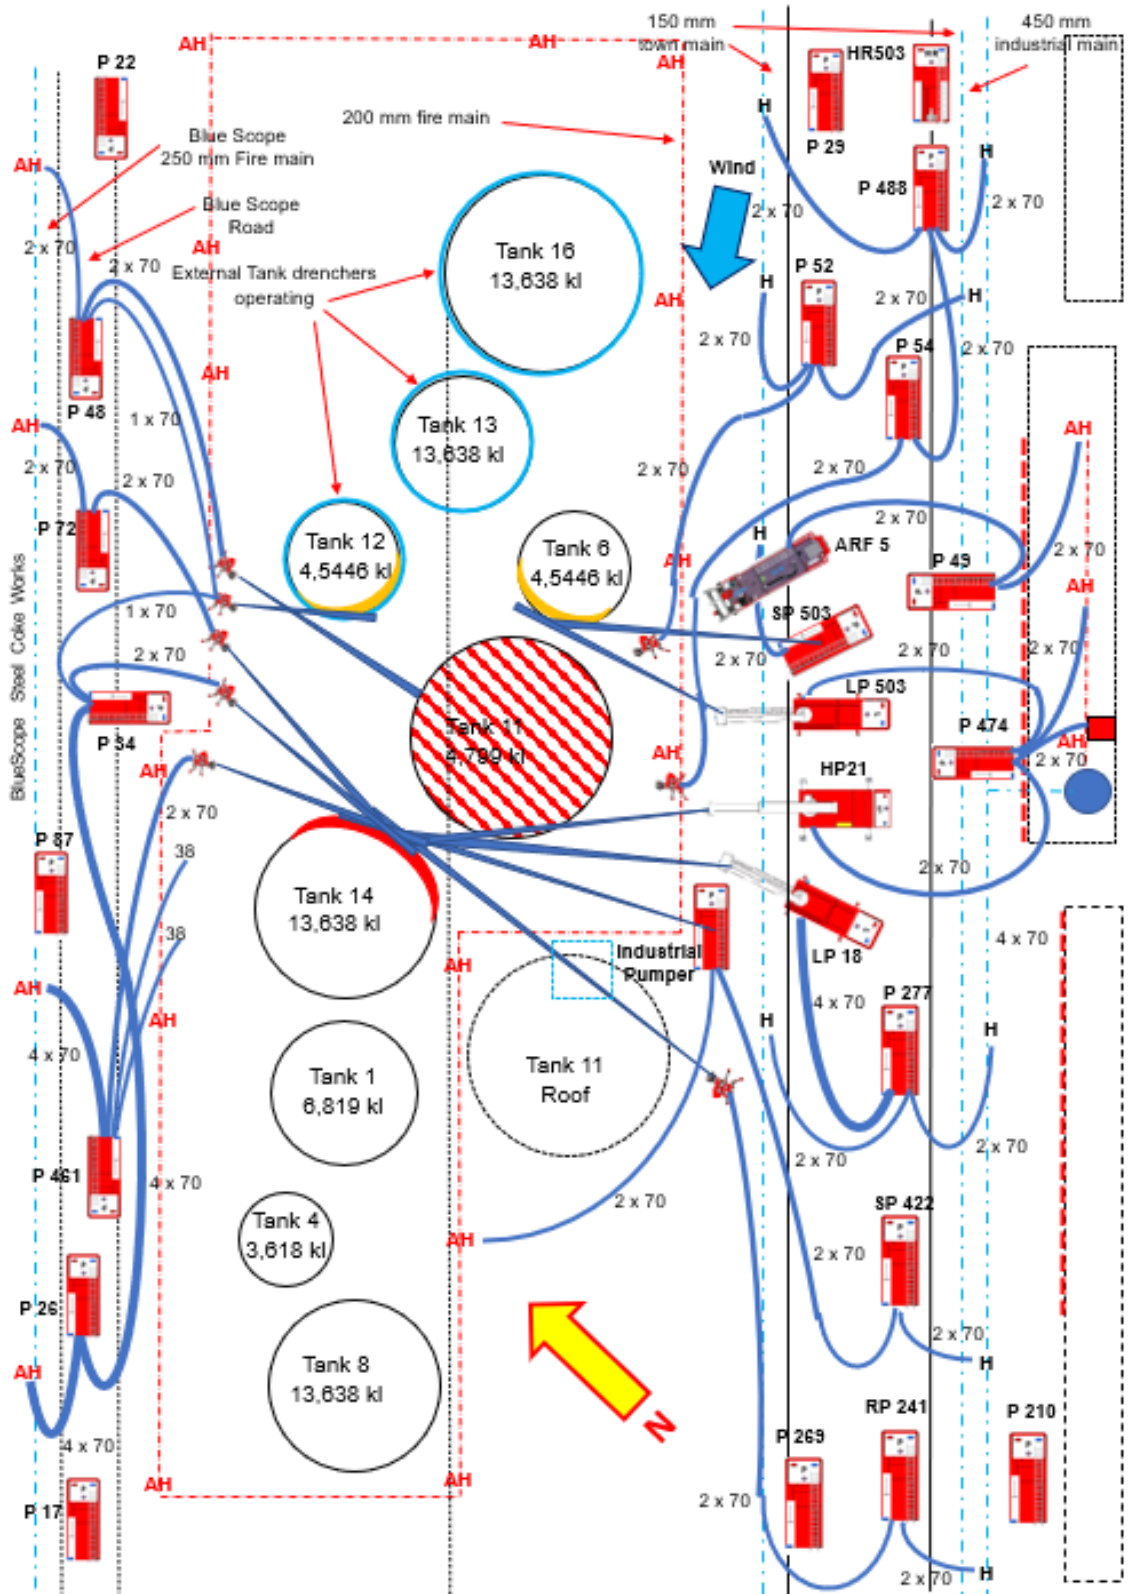
**Fireground Showing Additional Operations in Division B.
Crews in Division A are preparing for foam attack**

An air attack helicopter was providing guidance for the Aircrane. The air attack commander was in radio communications with the Incident Controller and the Aircrane crew. The Aircrane was carrying a load of 90 litres of foam concentrate (PF70+ FluoroProtein) mixed with 6,000 litres of water. The Aircrane approached from the north and dropped the water/foam load from a height of 800 feet (240 metres) upwind of the burning tank. The air attack commander, Ian Harris, made the following comments on the effectiveness of the attack:

“Flames were initially 60 to 70 metres high. After the initial attack, the flame height diminished. The water drop took the heat out of the centre of the fire. The attack produced a lot of steam and the flame height reduced by half. We were also hitting the northern side of the tank, where the tank had buckled, trying to cool the tank wall, to stop the tank from failing. There were nearby thunderstorms in the area and the drafts associated with these storms were starting to disrupt the water/foam drops.”

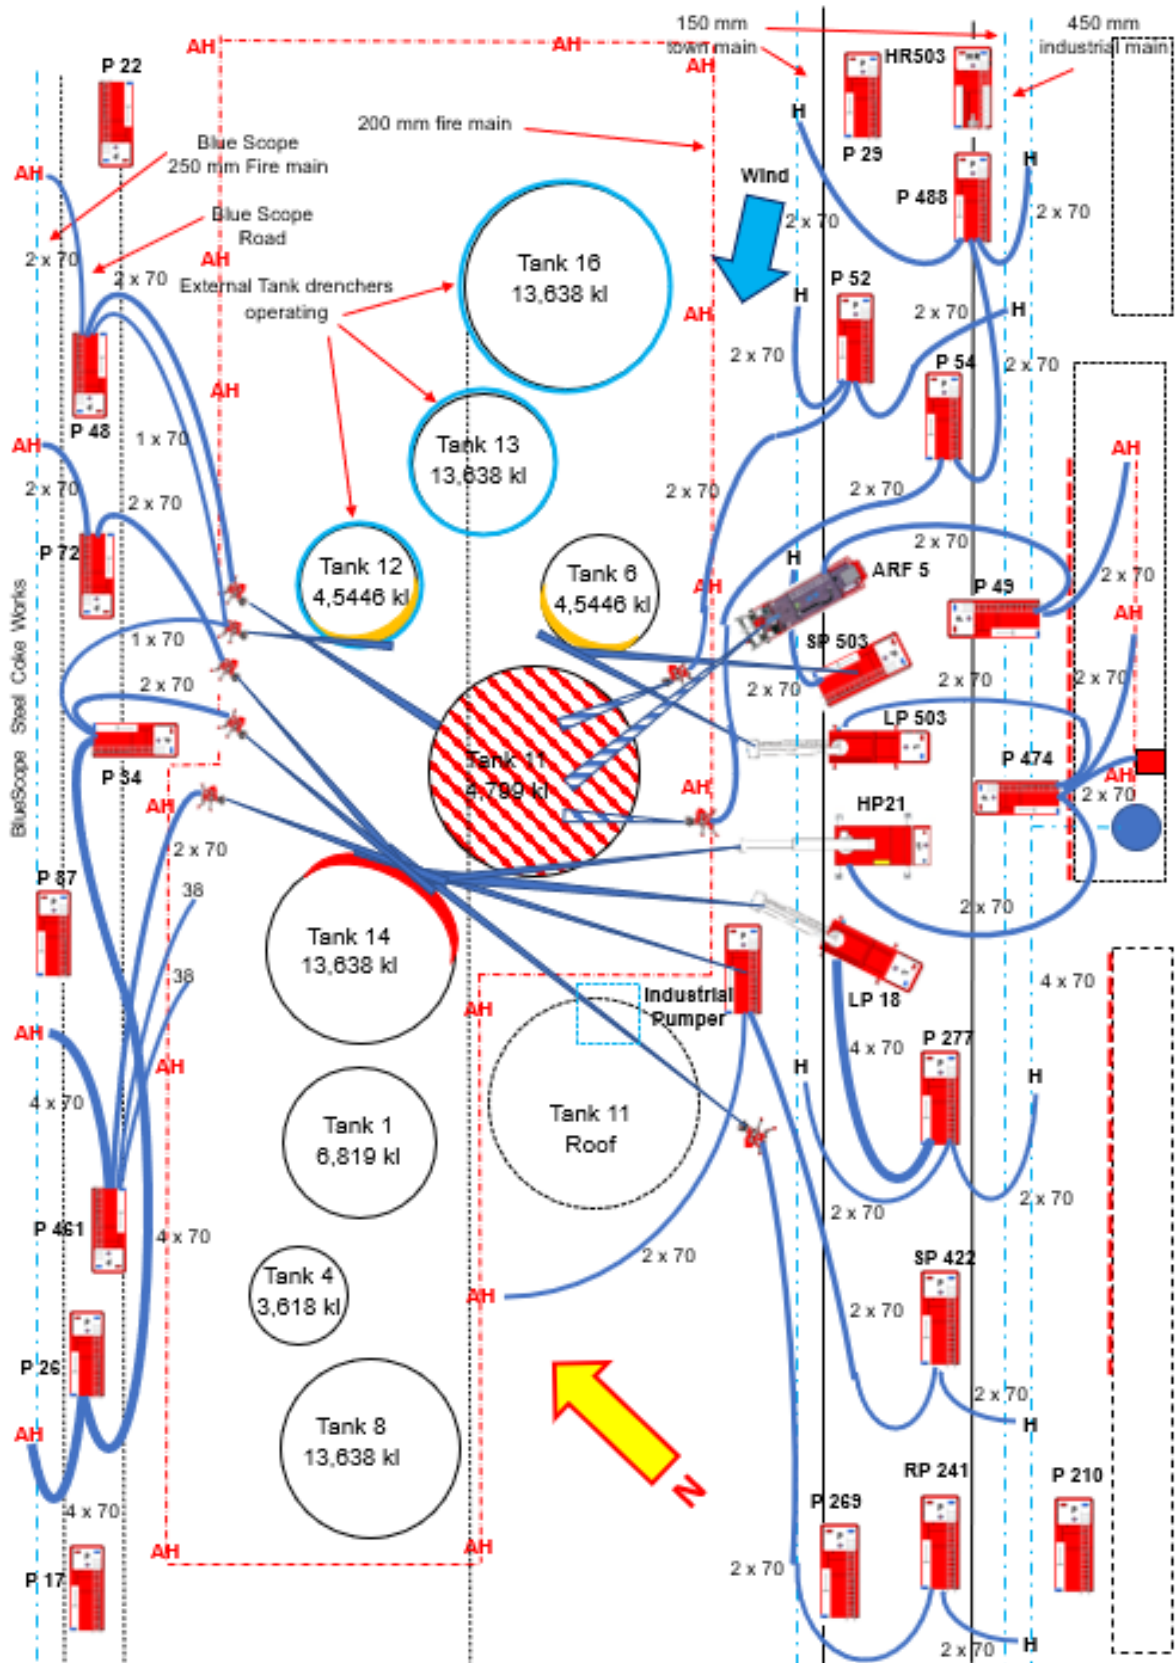
Fireground Showing Major foam attack

Despite the best efforts of a coordinated foam attack, too many variables were adversely impacting the attempted foam application, including strong winds that were breaking up foam streams, severe thermal turbulence above the tank due to intense fire activity resulting in foam streams being drafted upwards and away from the tank and the turbulent surface of the burning ethanol preventing what little foam did reach the surface from forming any sort of cover. Incident Controller Assistant Commissioner Kear advised there were a number of factors adversely affecting the application of foam:

“The fire was extremely hot. The thermal updraft from the burning ethanol was impacting the foam streams, lessening their ability to penetrate through to the surface of the burning ethanol. The heat intensity was so severe it was destroying the foam streams. A severe weather change impacted just as we were starting the foam attack. Strong winds were blowing the foam off course and causing foam streams to breakup. The burning ethanol was extremely turbulent, making it extremely problematic to lay a foam blanket on it. A further problem was the folding inwards of the upper wall of the ethanol tank, shielding fire from the foam streams.”

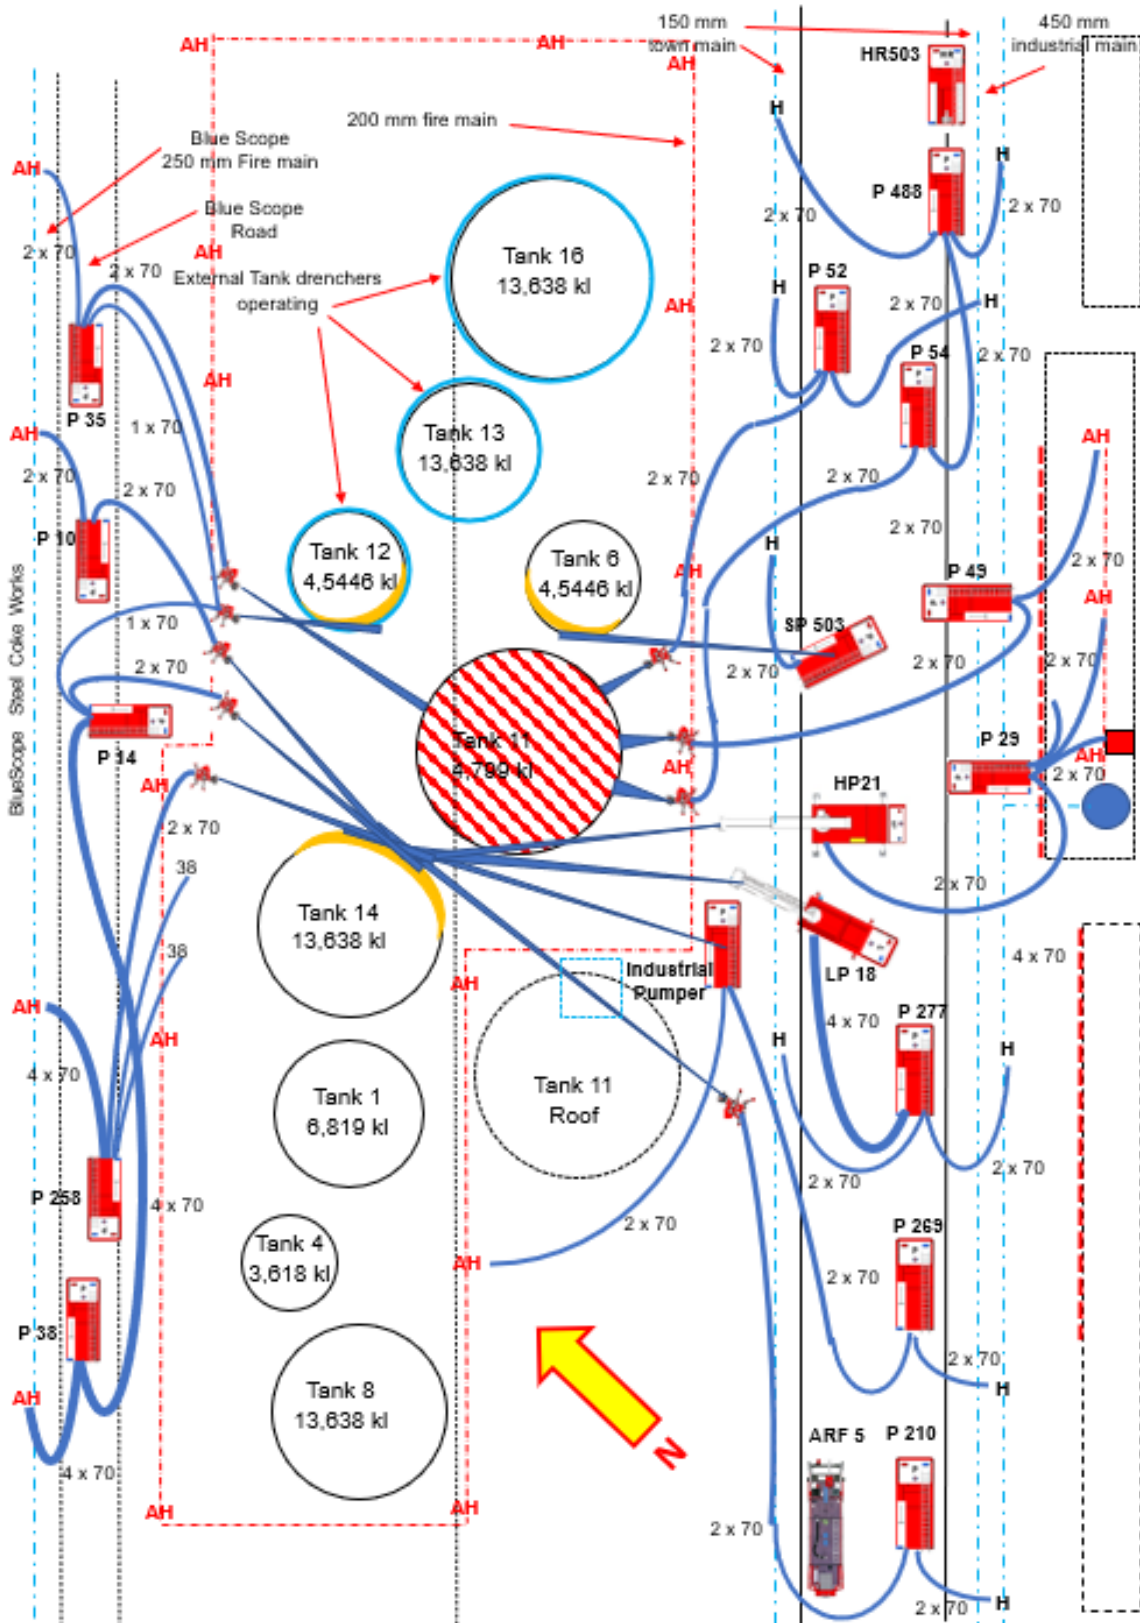
Fireground Showing Firefighting Operations Into the Evening

At 0200 hours Incident Control was transferred from Assistant Commissioner Bryant to Chief Superintendent Roger Bucholz. The Incident Controller maintained the firefighting plan that was in place, which consisted of:

1. Maintaining cooling of storage tanks under threat.
2. Continue to cool the burning ethanol tank top maintain the integrity of the tank and prevent tank failure.
3. Continue to monitor the ethanol level within the tank and the temperature of the tank.
4. Prepare for a major foam attack once the ethanol level and tank temperatures had reached appropriate levels.

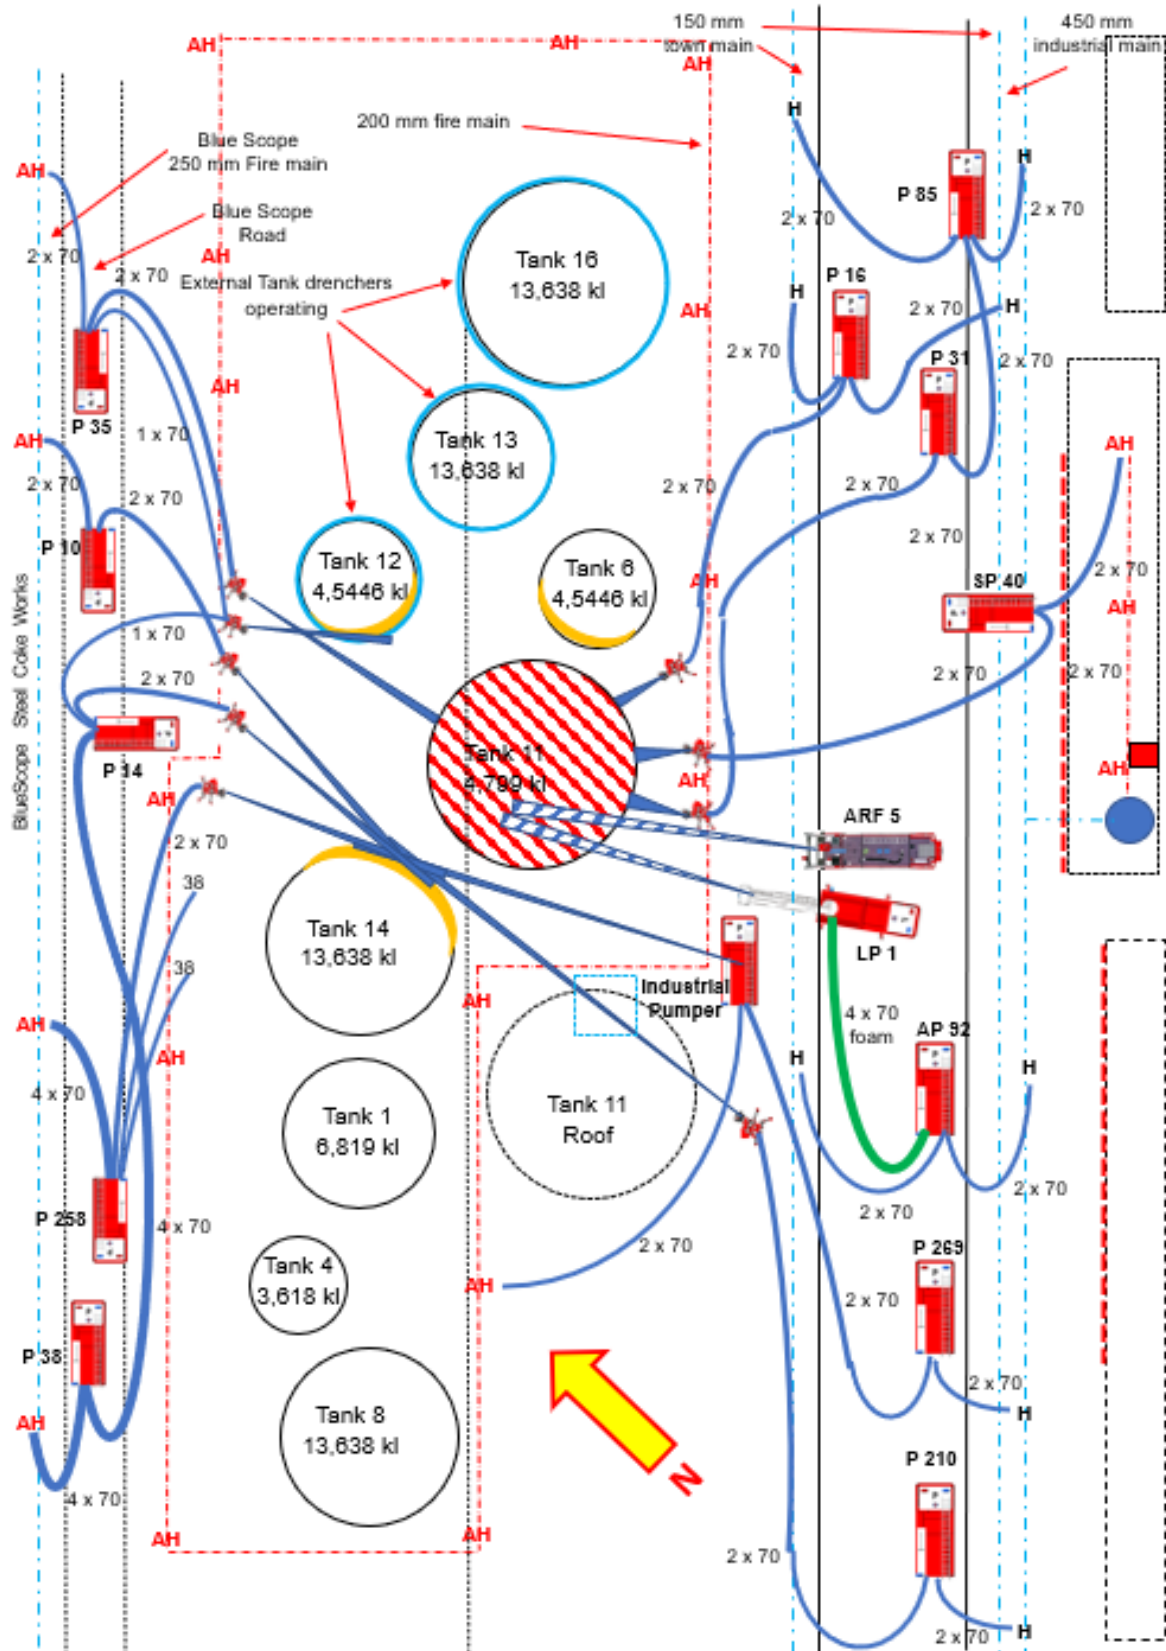
Fireground Showing Final Extinguishment Operations

Following the initial application of foam, the blanket began to break-up after 20 minutes of initial application. Aerial Pumper 92 continued to pump foam to Ladder Platform 1, enabling the foam cover to be maintained. Following the second foam application, cooling streams continued to be applied to the sides of the ethanol tank, to reduce the possibility of a further breakdown of the foam blanket and re-ignition of the ethanol. Firefighters continued to apply foam onto the surface of the ethanol for a further four hours, ensuring the foam cover remained intact.

At 0630 hours, Sector Commander A reported a distinct decrease in heat emission from Tank 11 was being detected using a thermal imaging camera. At 0701 hours Hazmat officers reported the highest temperature reading they were recording was 53°C.

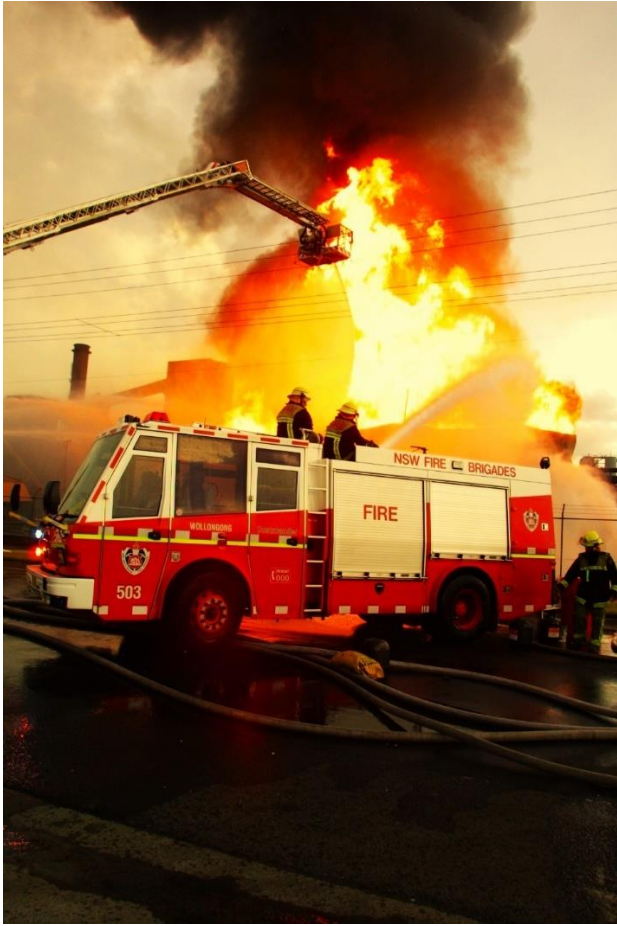
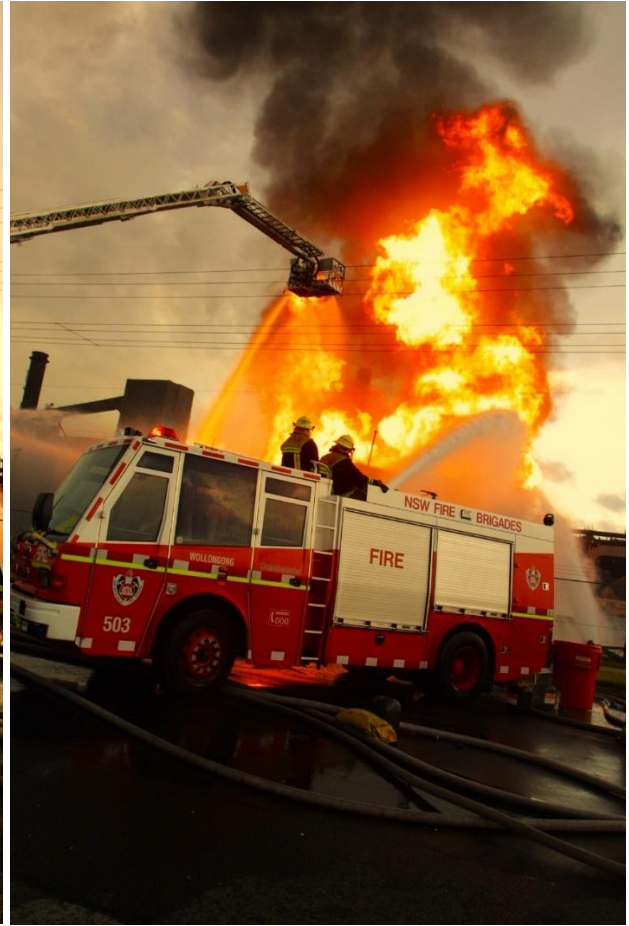
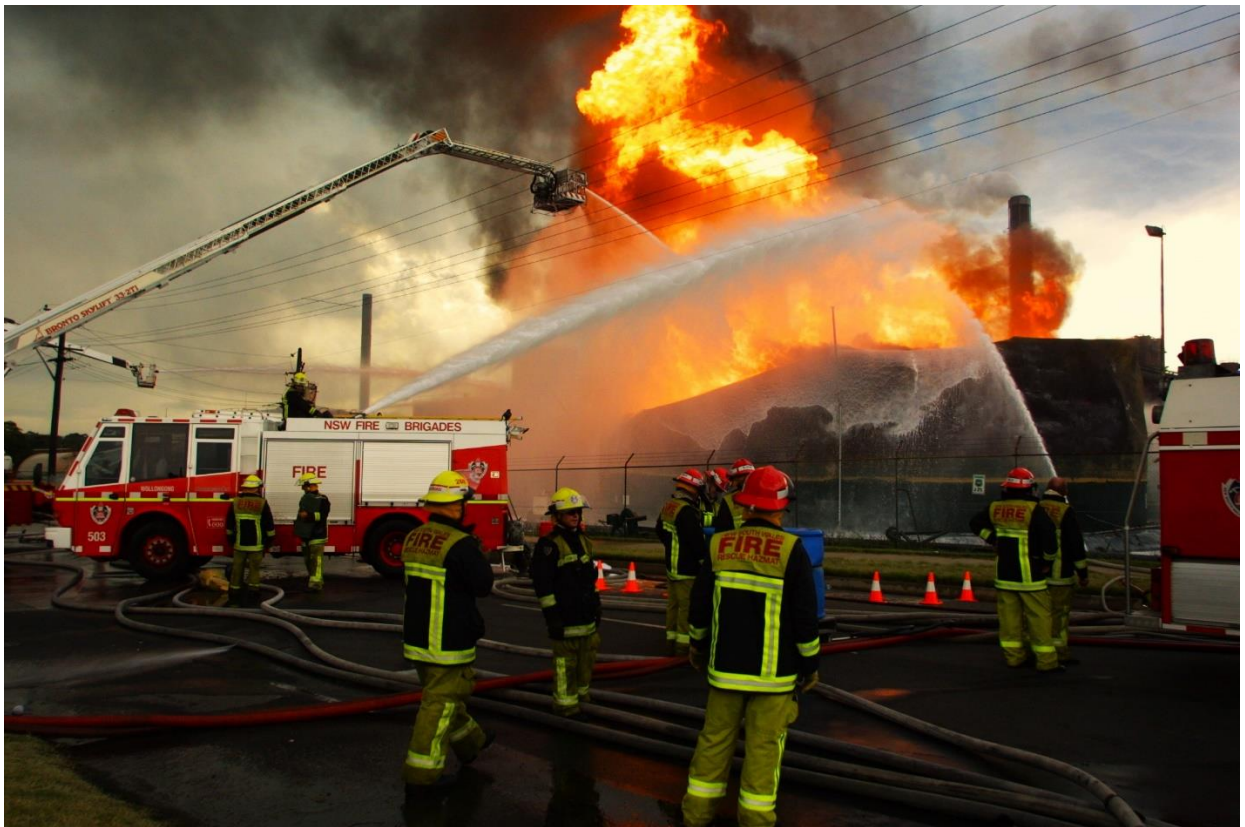
From Division A Ladder Platform 503 and Super Pumper 503 firefighters direct master streams onto the wall of the burning ethanol tank, to cool the tank wall and maintain the integrity of the tank. Enormous flames erupt from the surface of the burning ethanol tank.

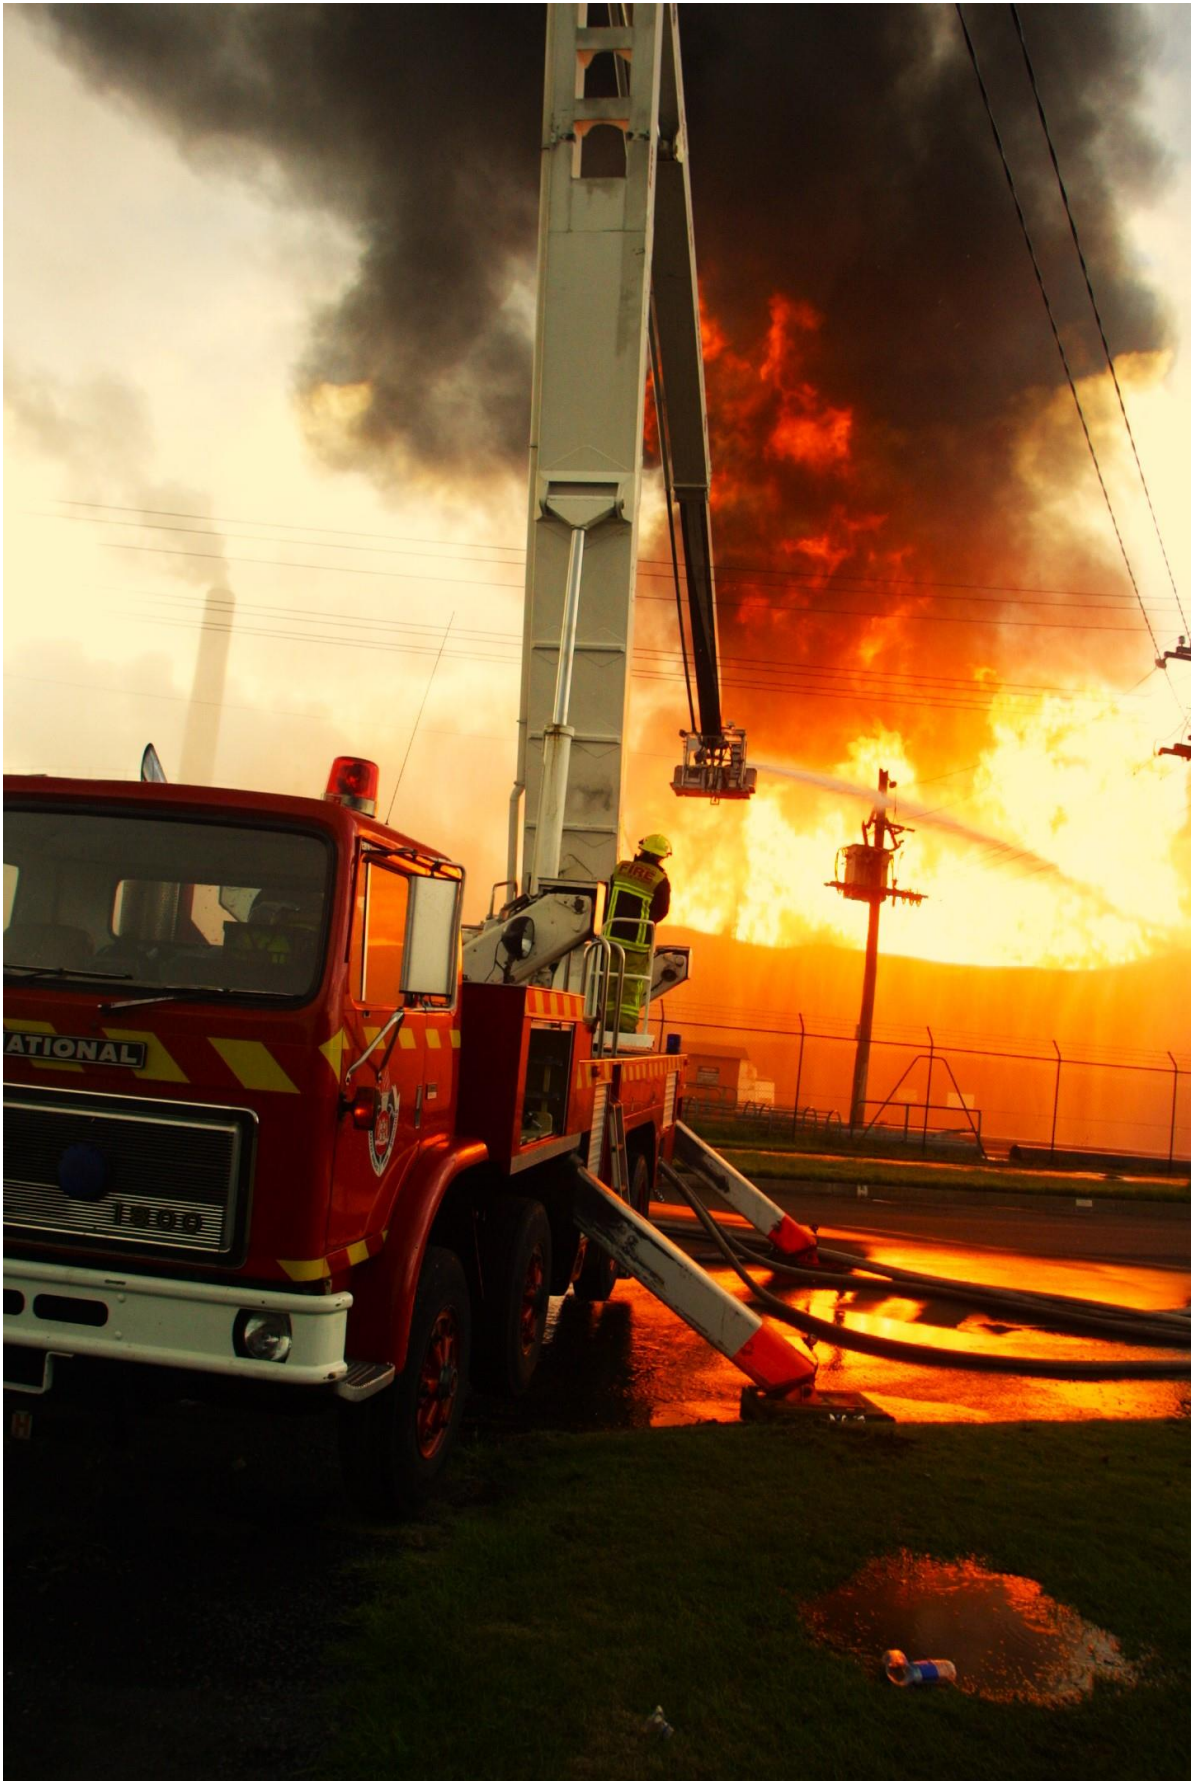
Hydraulic Platform 21 operated by Senior Firefighters Dave Phillips and Jeff Wilson alternated the aerial stream between Tank 14 and the wall of the burning ethanol tank.

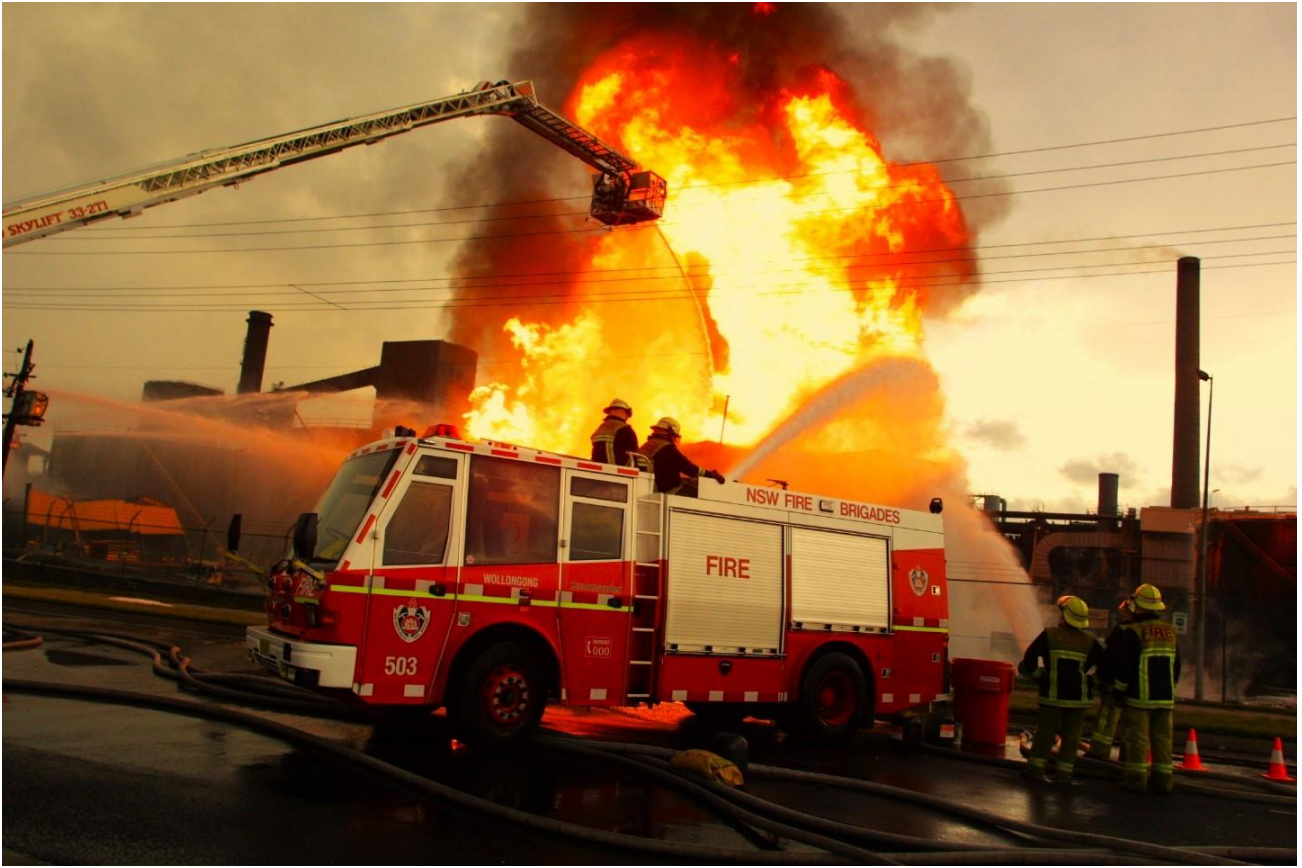
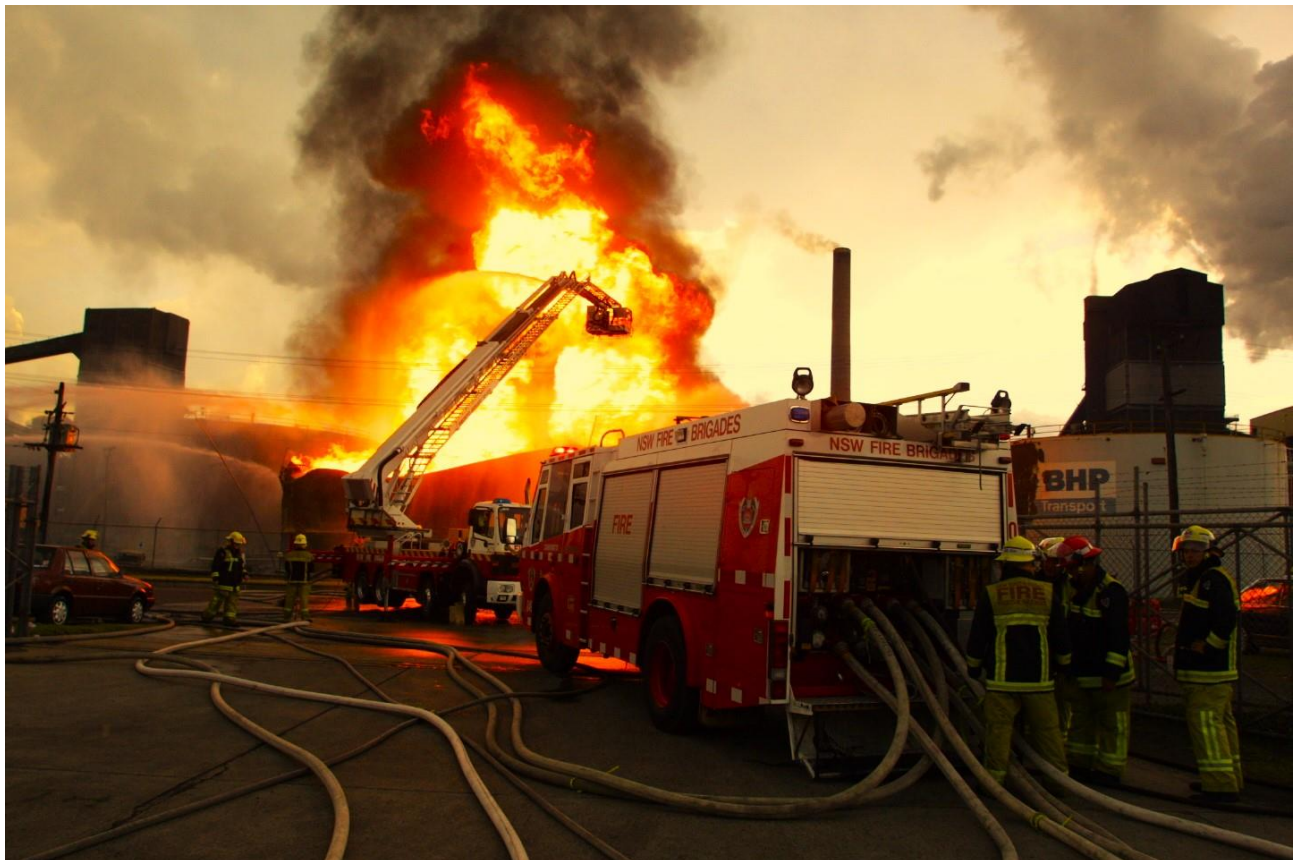
Upper: Super Pumper 503 firefighters direct the roof monitor stream between the wall of the burning ethanol tank and threatened Tank 8. Lower: Pumper 49 supplies water to Ladder Platform 503 as fierce flames erupt from the burning ethanol tank.

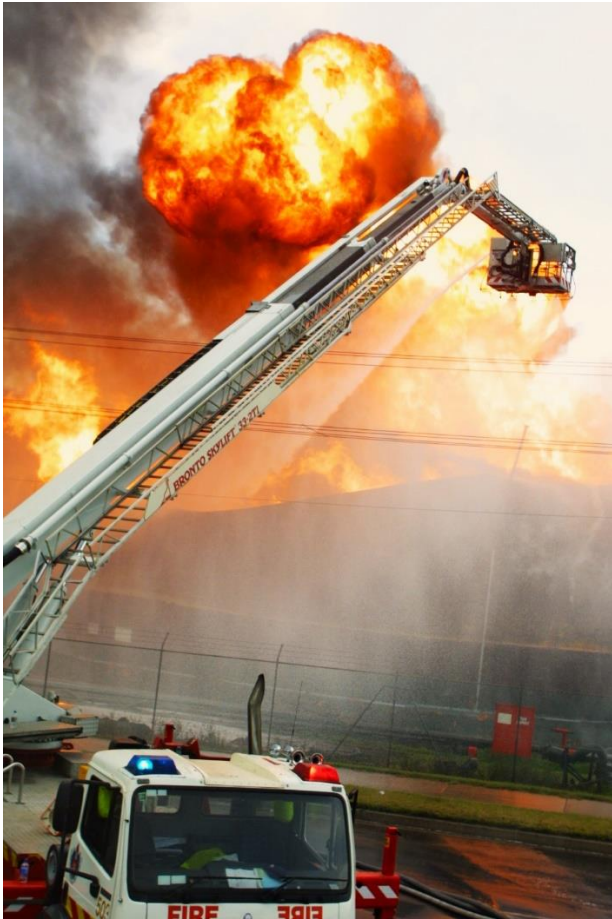
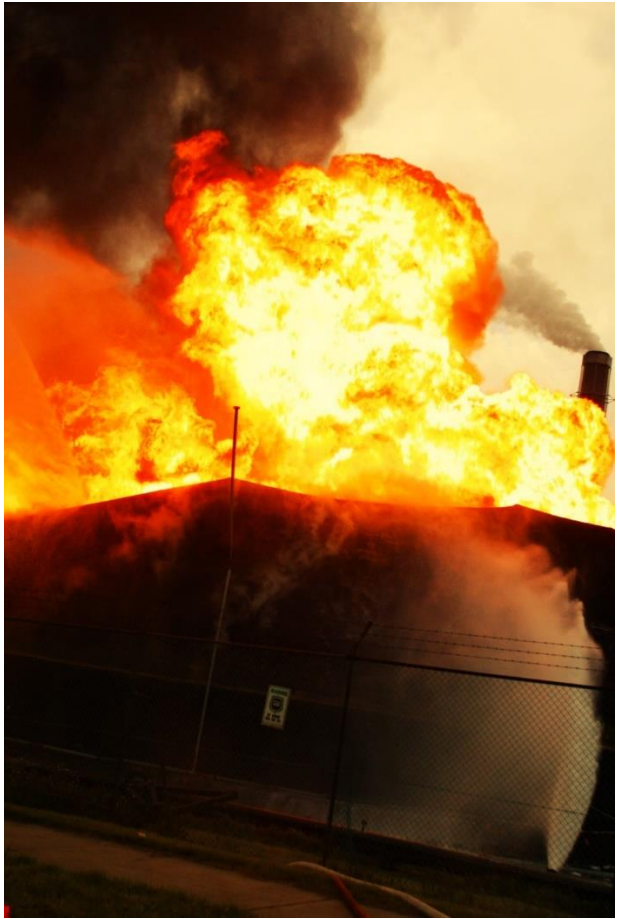
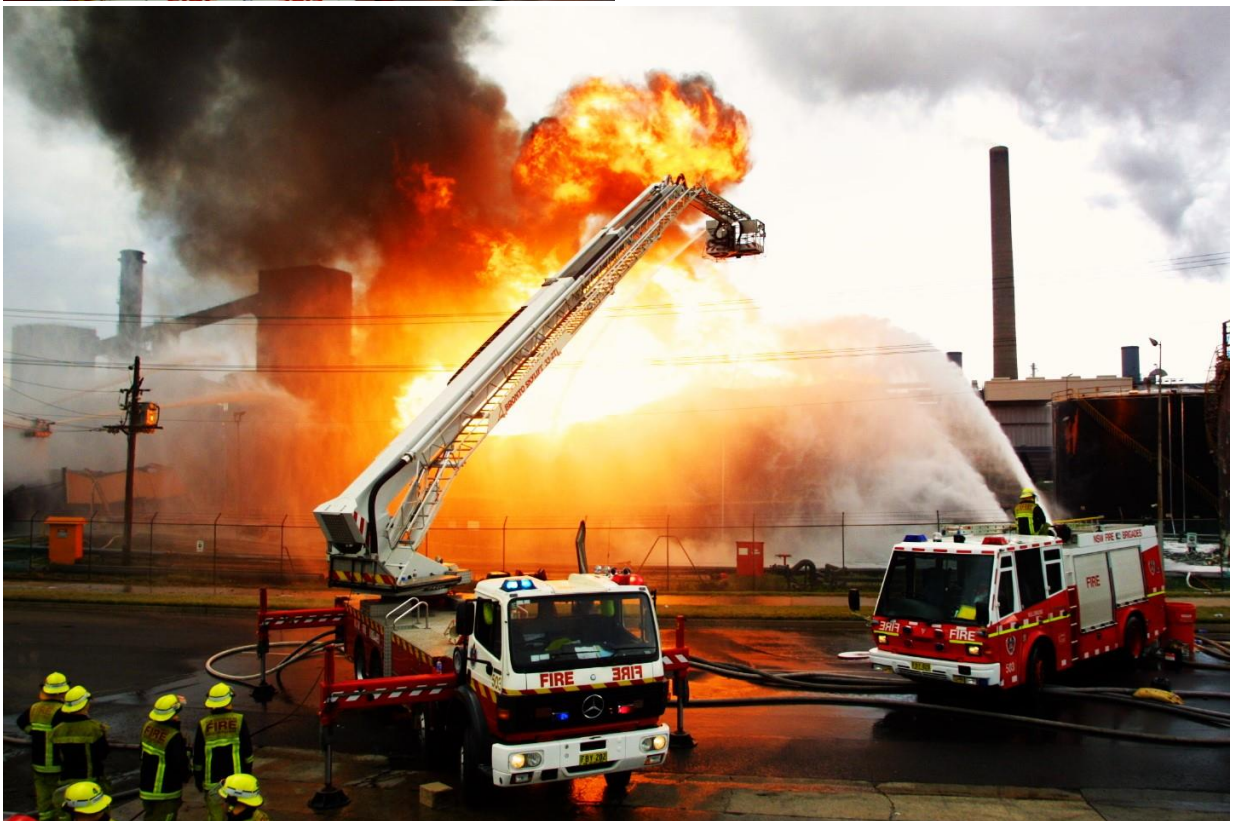
The burning ethanol produced ferocious fire behaviour as large flames erupt above the storage tank. Firefighters directed cooling streams onto the ethanol tank and surrounding storage tanks for hours, containing the enormous fire.
