MW1 C STATION TRAINING AND INCIDENT CASE STUDIES

FILE NO. SR / 02.

**11th ALARM PORT KEMBLA ETHANOL BULK
STORAGE TANK FIRE**

Flammable Liquid Bulk Storage Tank Fire - Full Surface Fire.

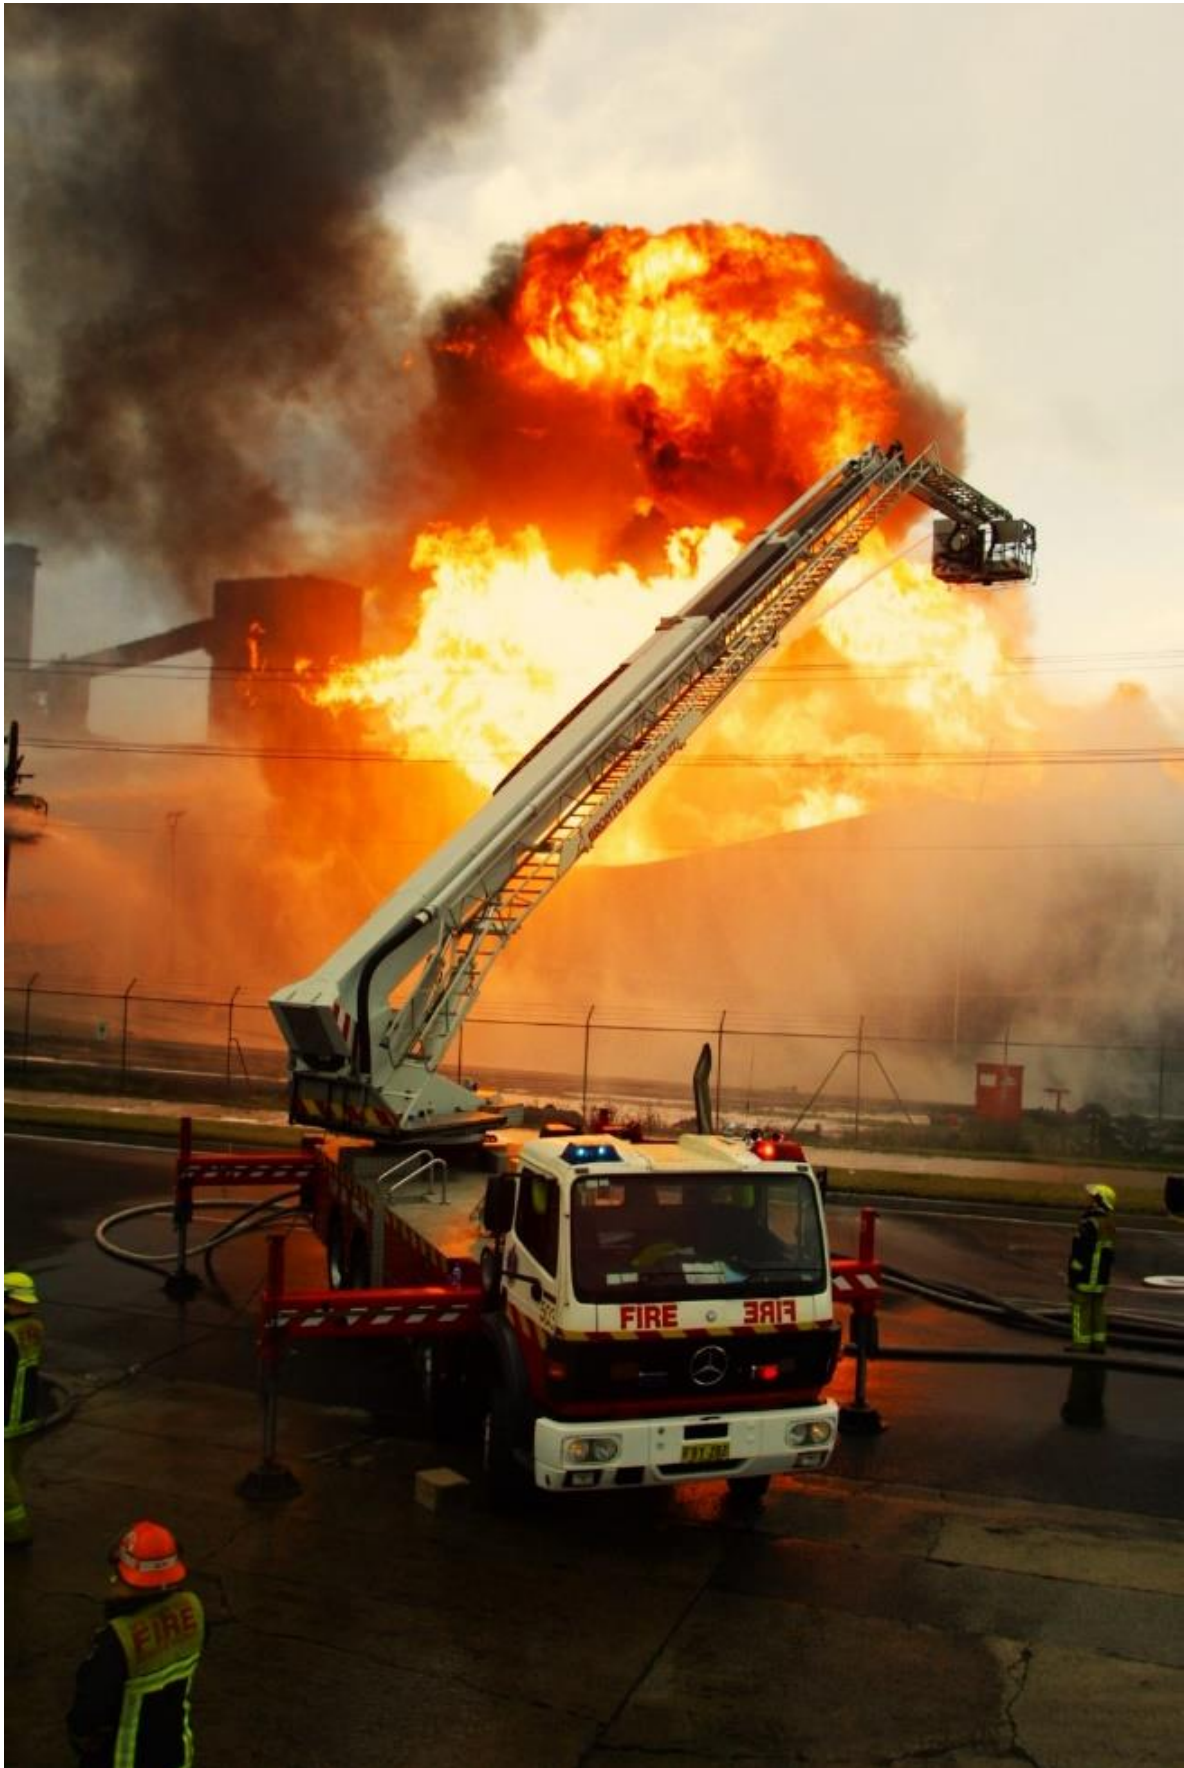
Ladder Platform 503 firefighters direct the aerial master stream onto the wall of the involved ethanol tank, protecting the integrity of the steel wall of the tank. These operations assisted to prevent tank failure.

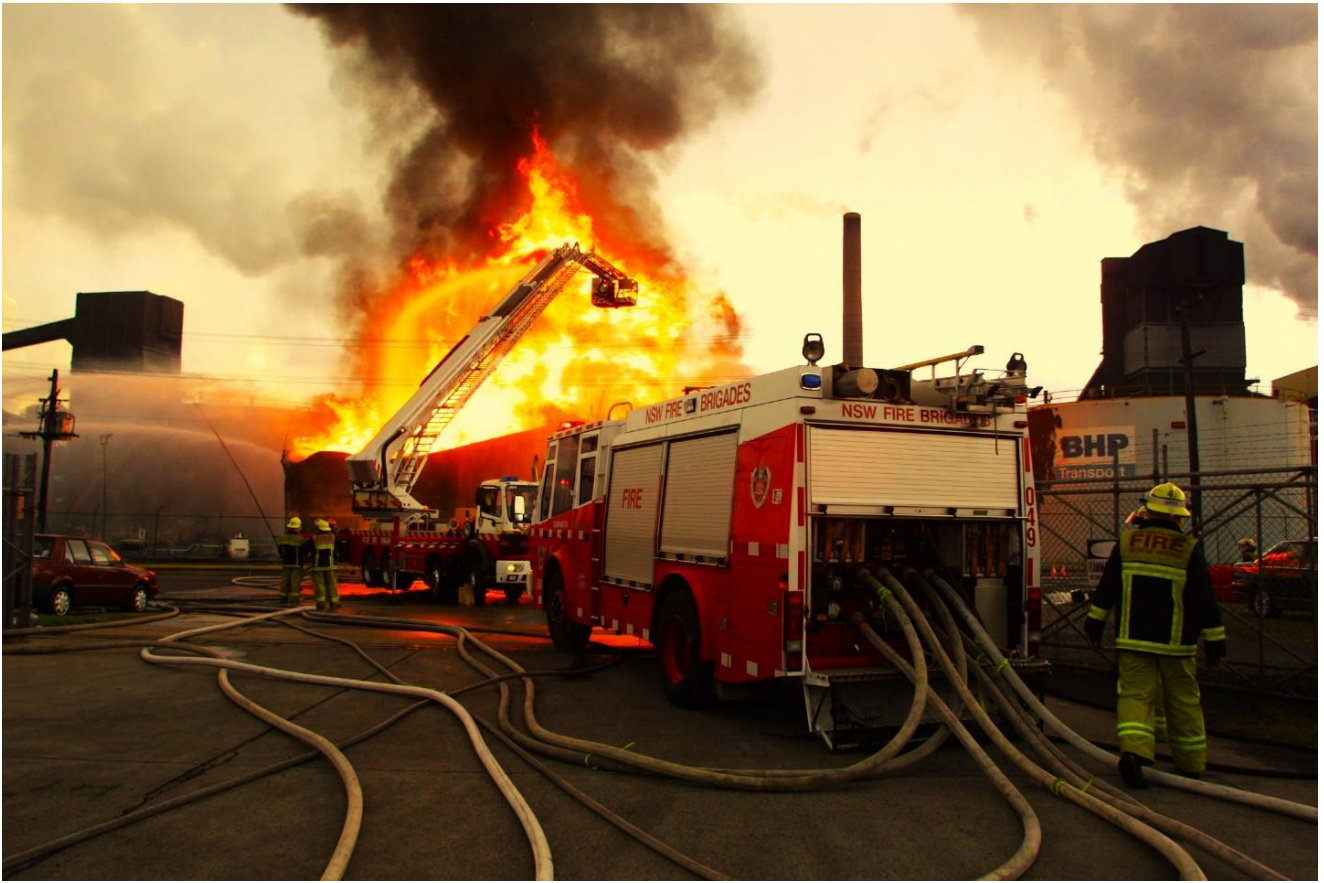
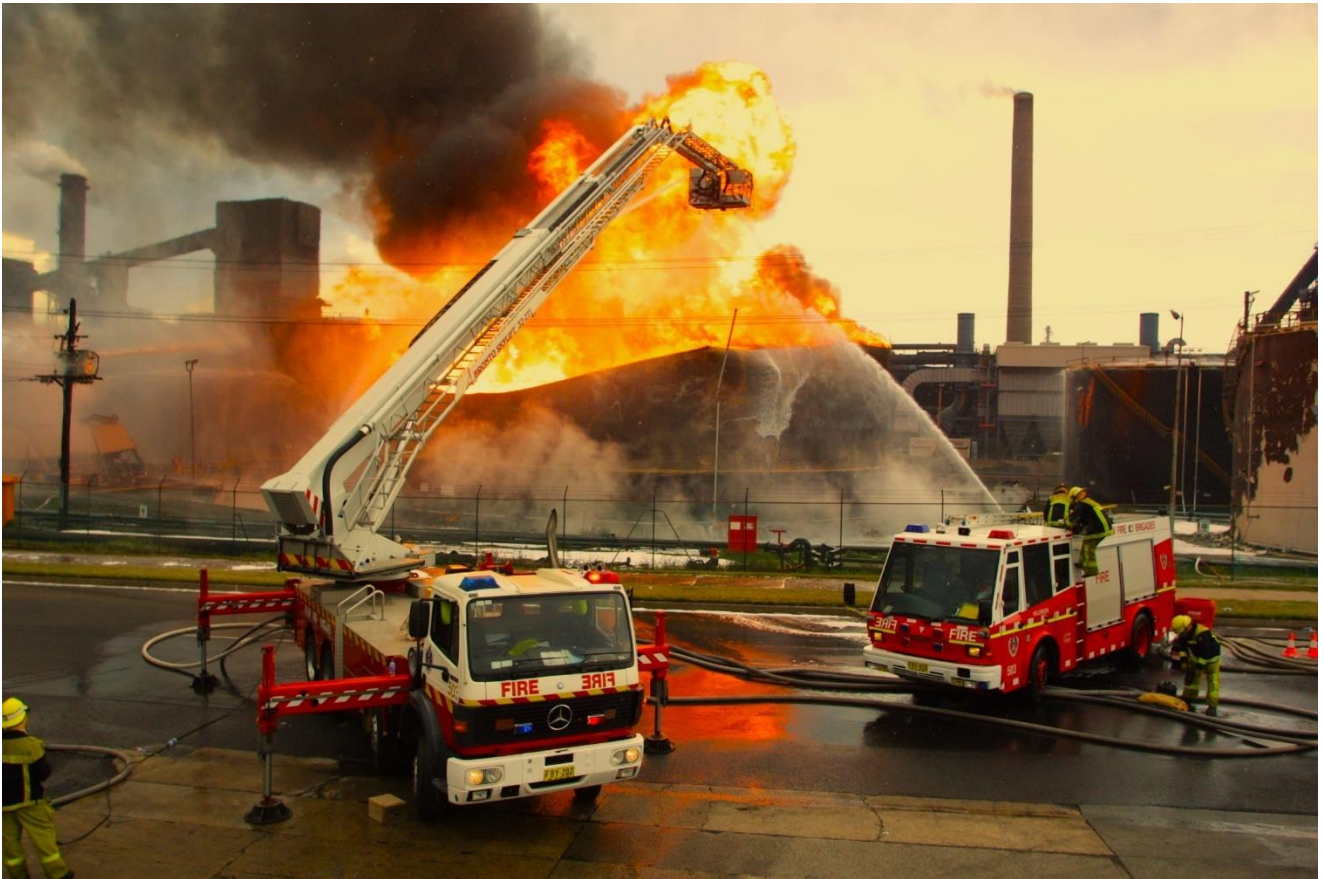
Upper: Pumper 49 supplies water to Ladder Platform 503. Lower: Ladder Platform 503 and Super Pumper 503 direct cooling streams onto the wall of the burning ethanol tank.

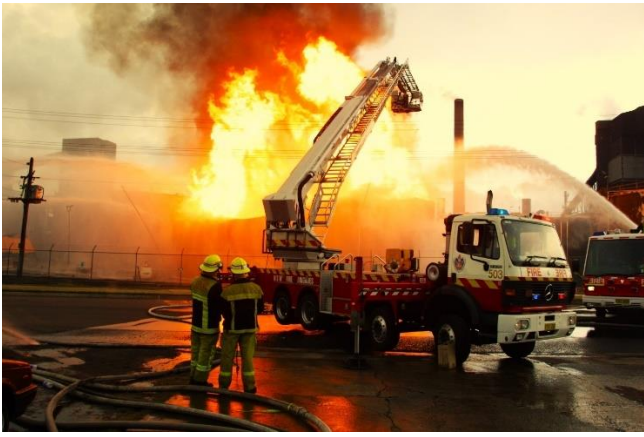
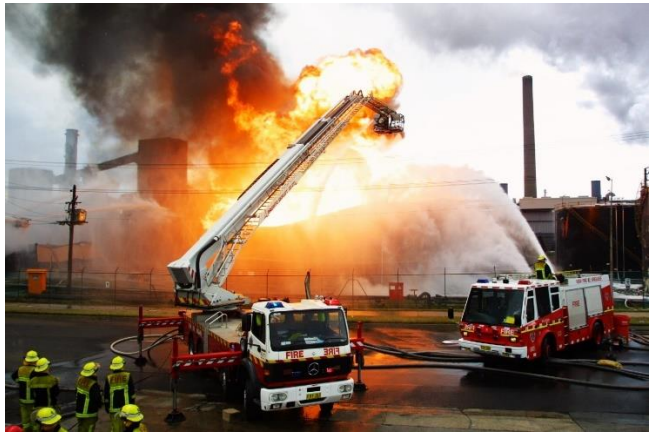
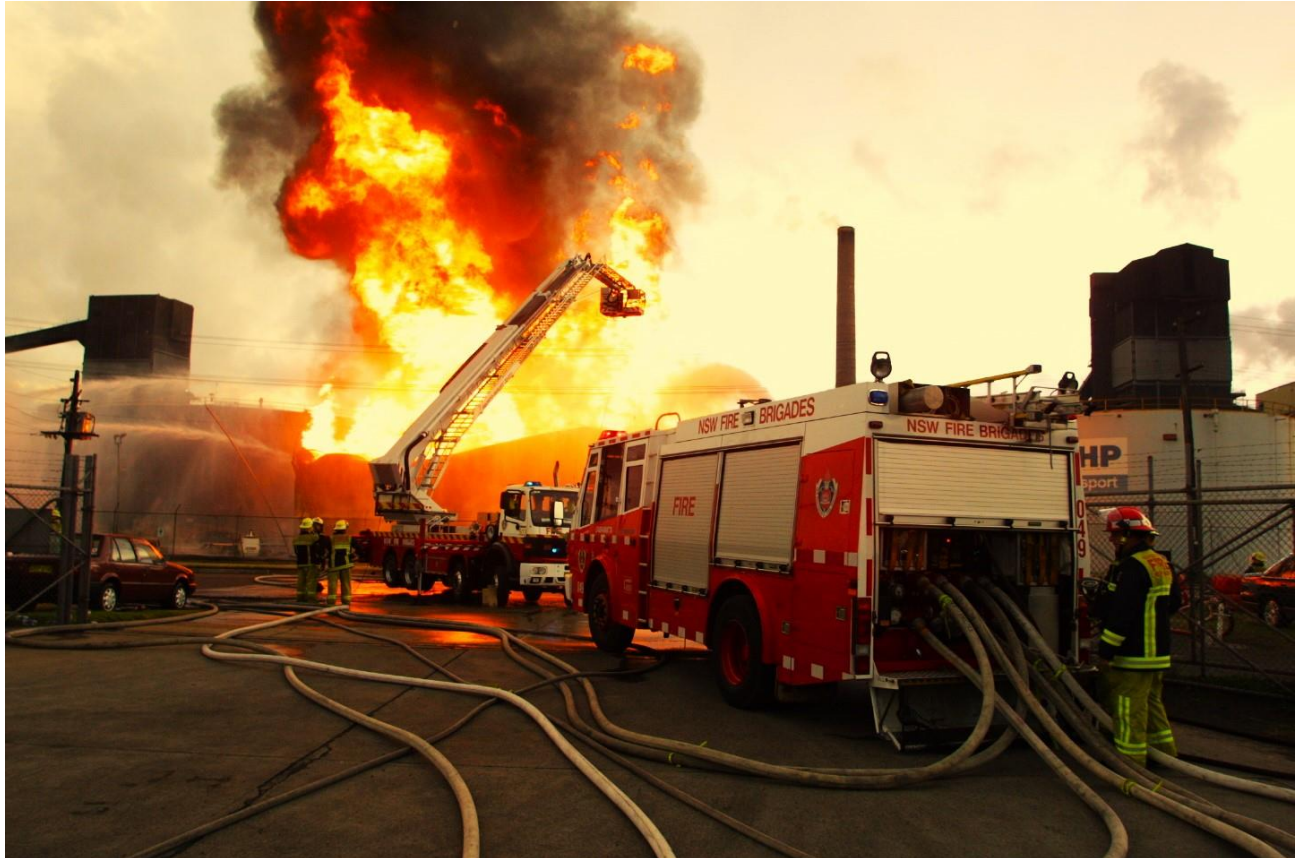
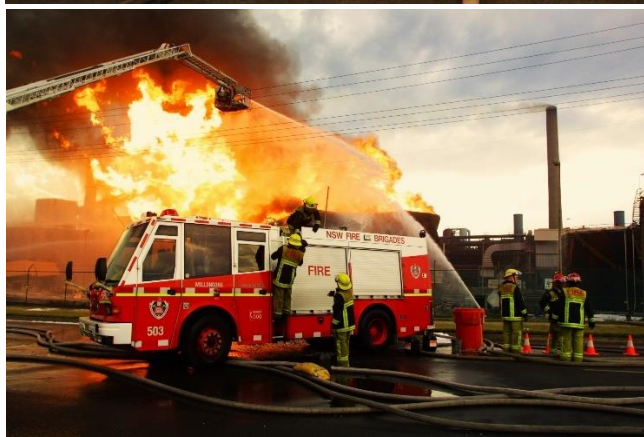
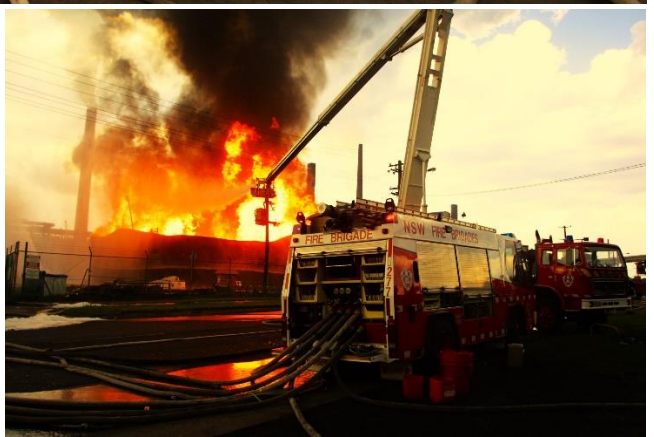
From Division A Firefighters operate multiple master streams, protecting heavily threatened Tank 14 and cooling the steel wall of the burning ethanol tank.

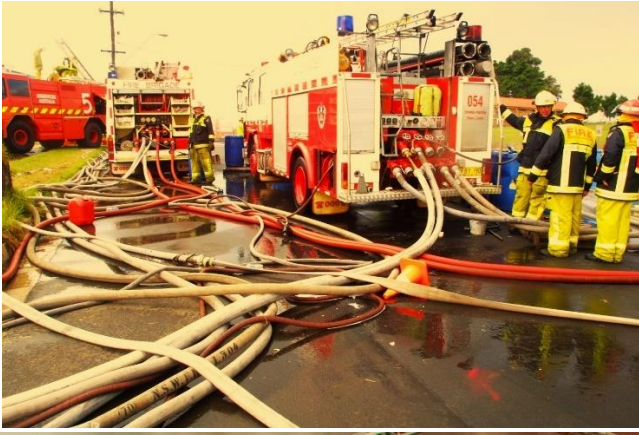
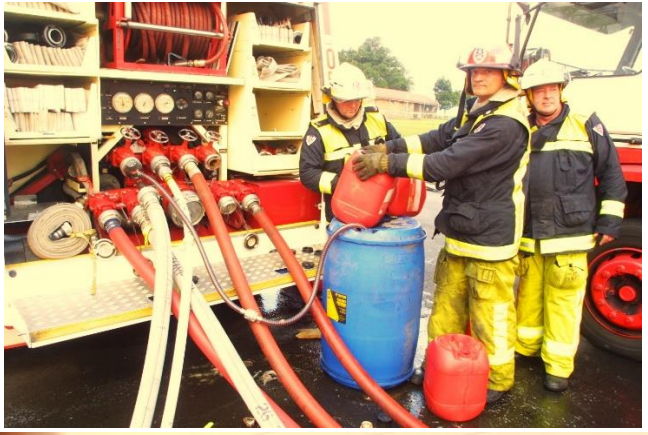
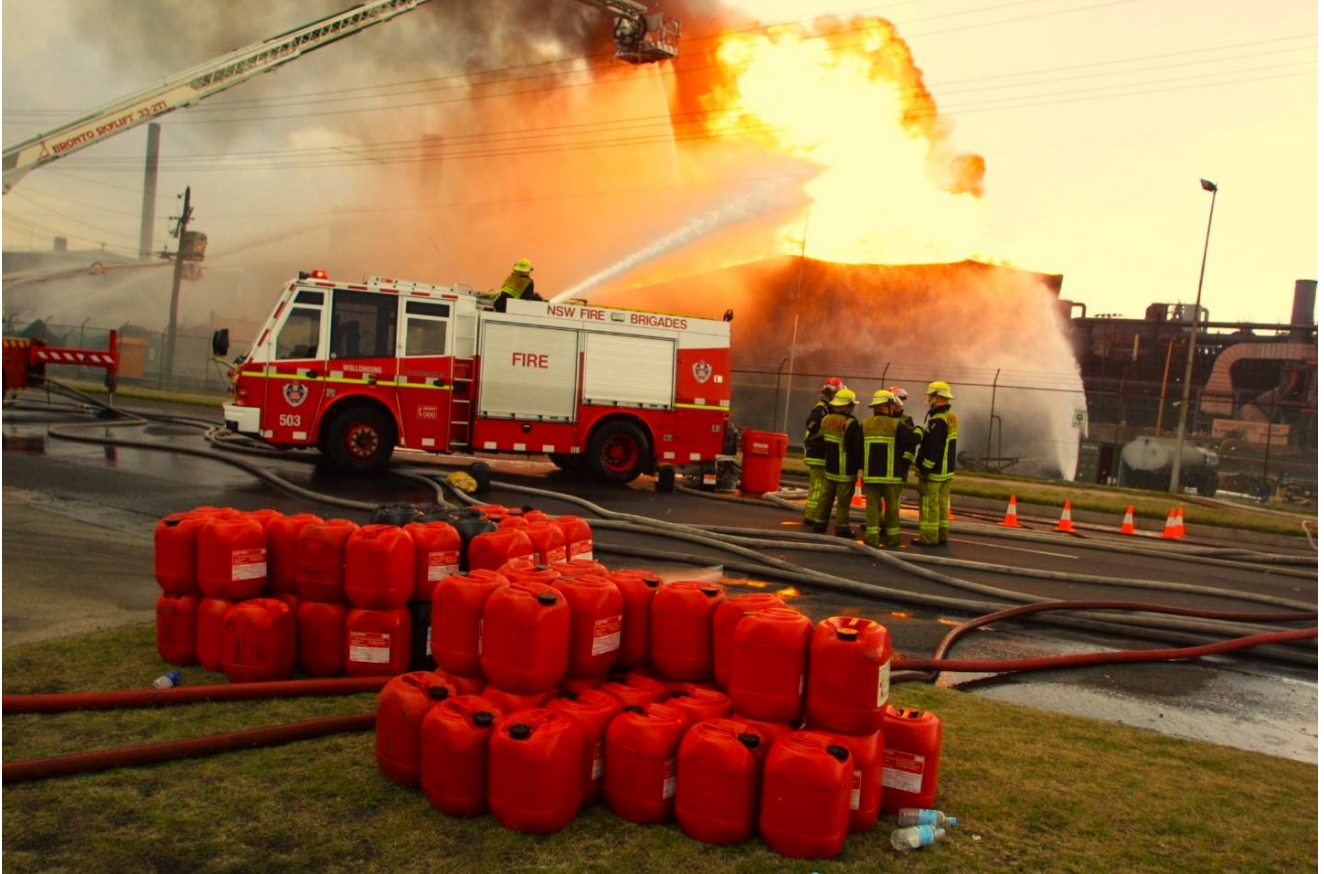
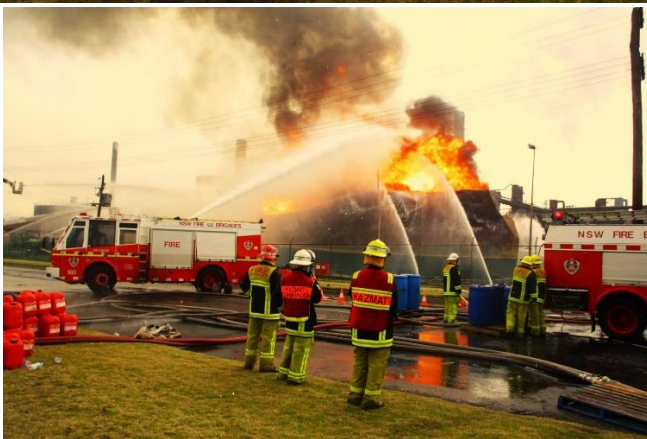
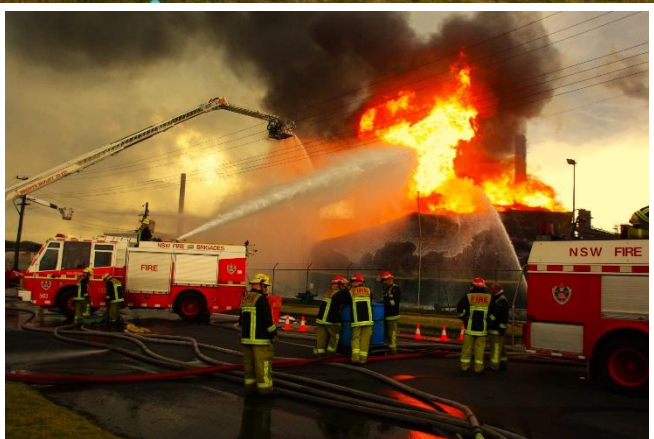
Foam Operations in Division A - Pumpers 52 and 54 supply foam to ground monitors positioned at the front of the storage tank. Firefighters were using ATC (Alcohol Type Concentrate) foam.

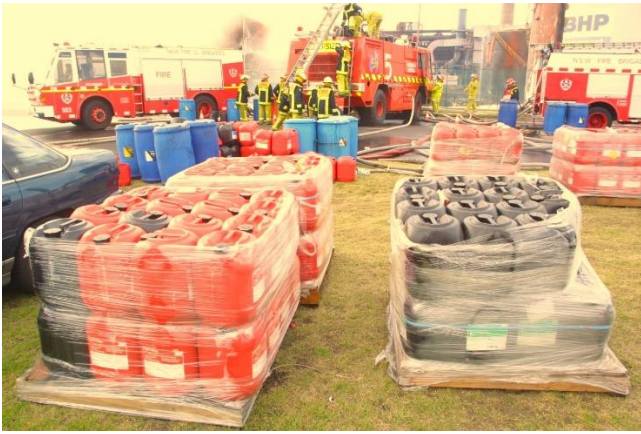
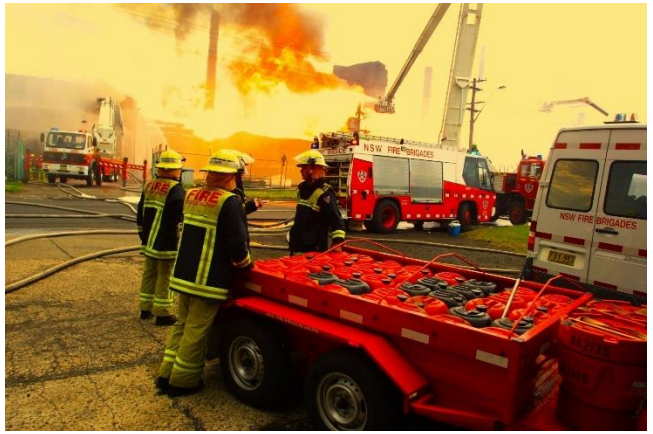
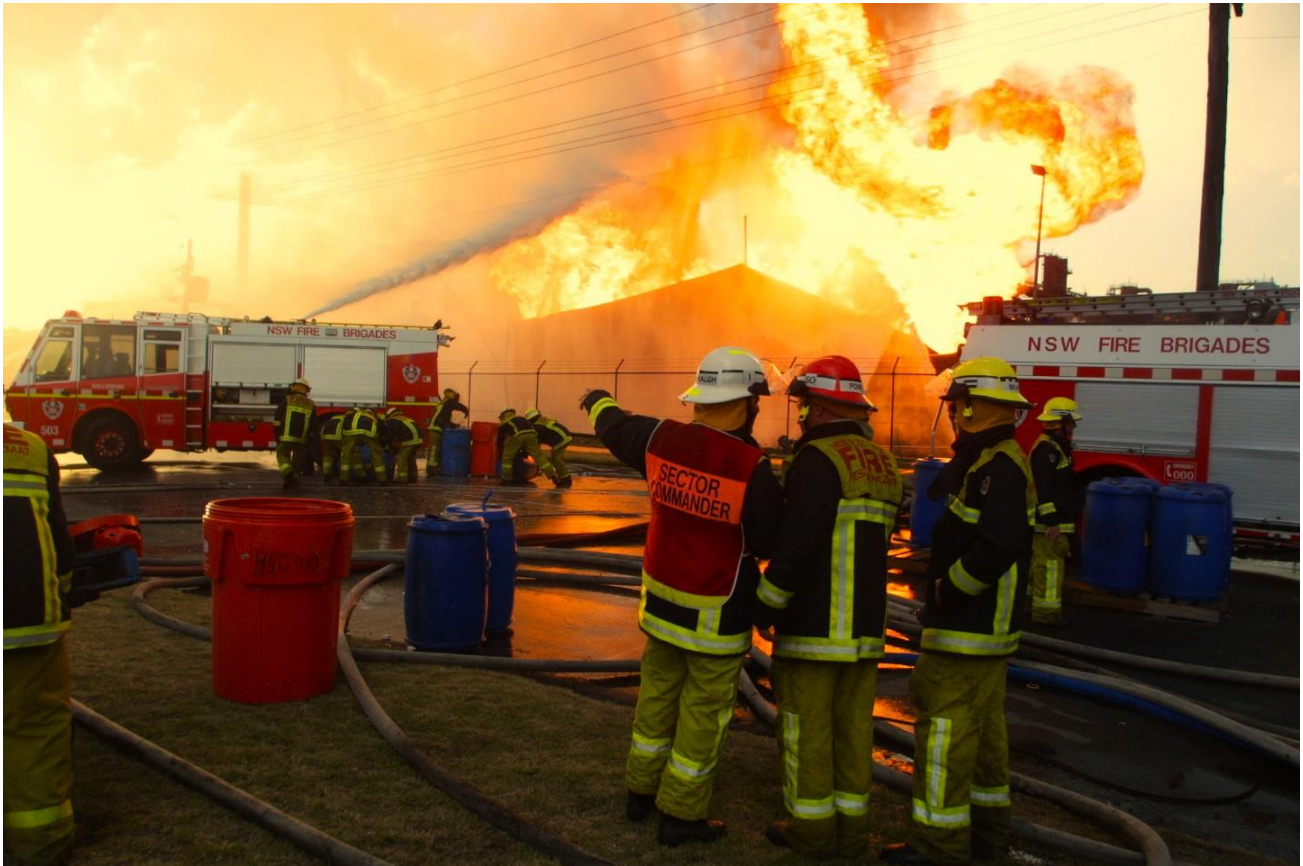
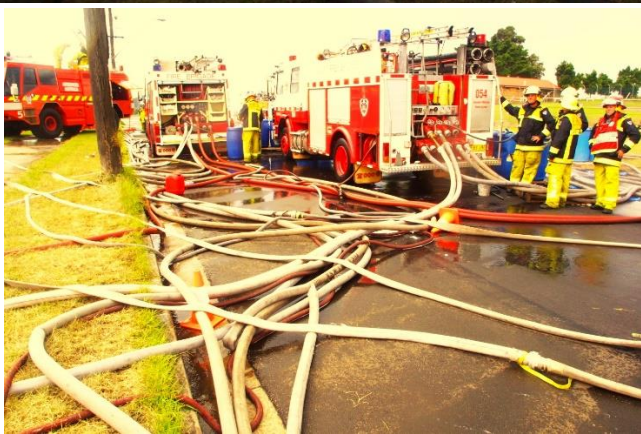
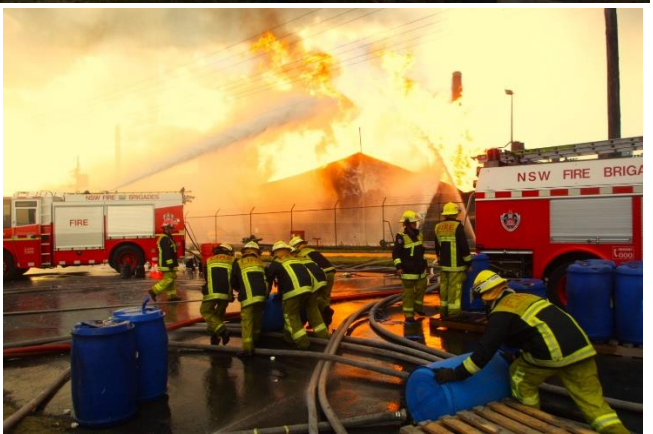
Upper: 20 litre drums of foam concentrate were being stockpiled at the scene. Middle and Lower: Foam operations in Division A. Firefighters move 200 litre drums of ATC (Alcohol Type Concentrate) foam to Pumps 52 and 54, in preparation for the planned major foam attack.

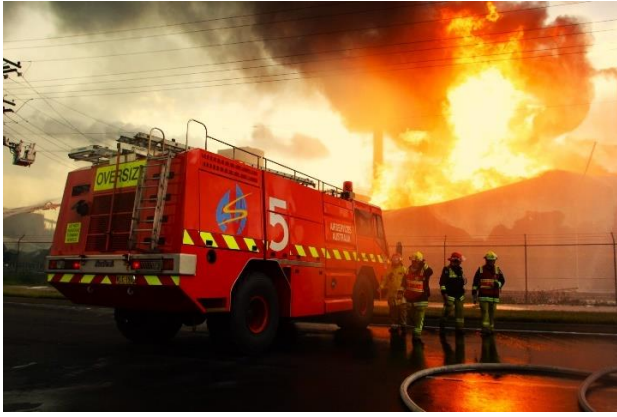
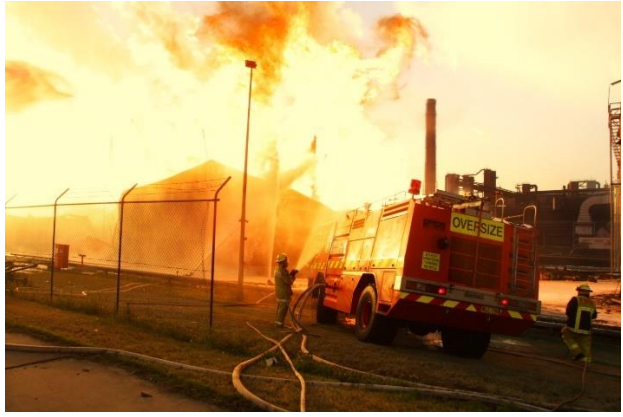
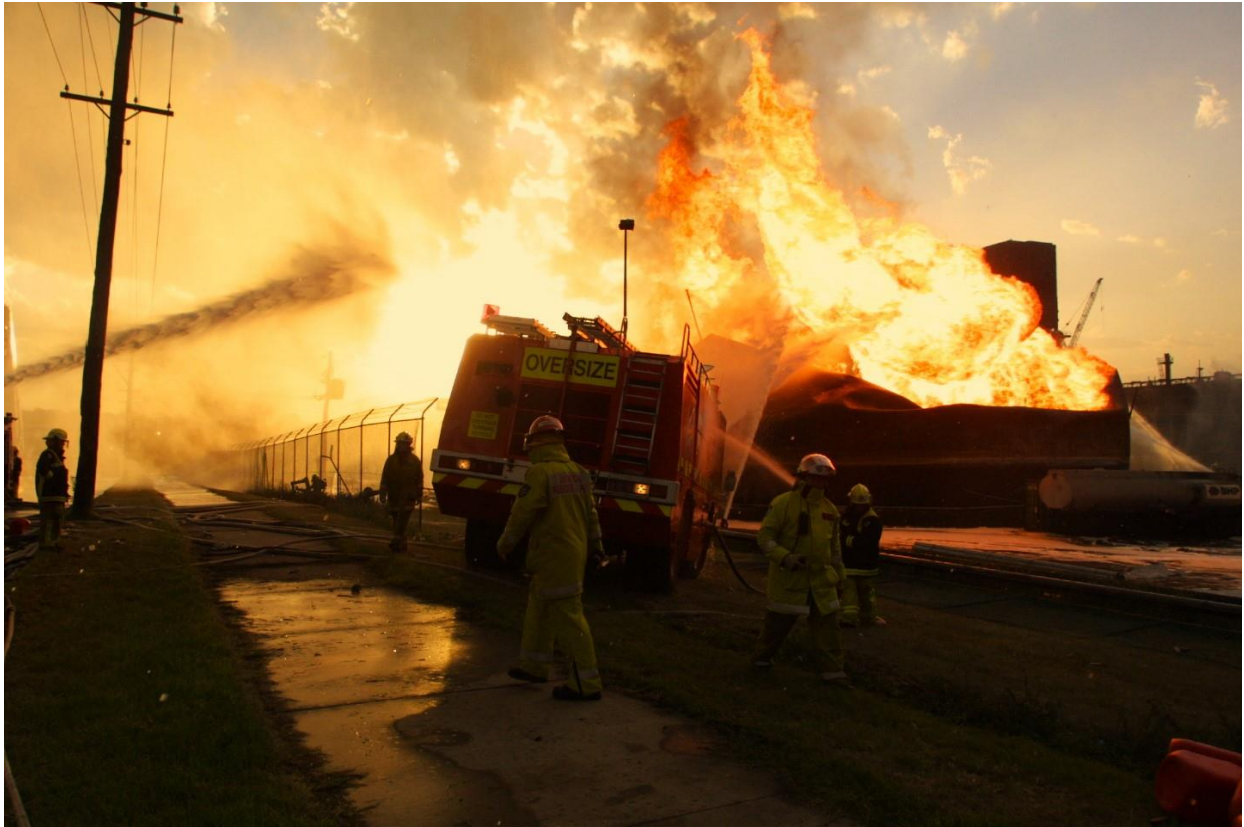
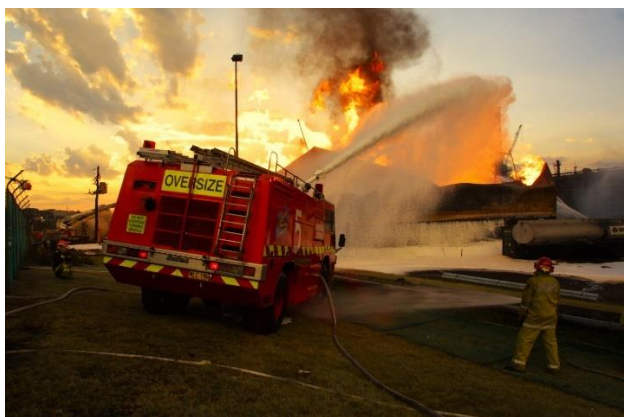
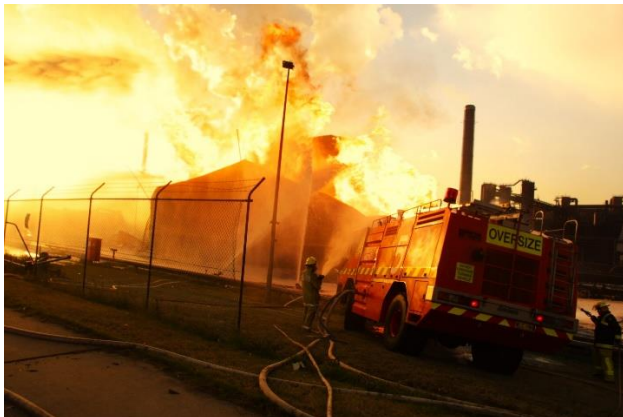
Aviation Rescue and Fire Fighting (ARFF) firefighters commence to attack the fire with the appliance monitor foam stream, delivering 7,000 litres of finished foam solution onto the fire at a rate of 3,600 litres per minute. Just as the foam attack was commencing strong winds impacted the fireground, greatly intensifying fire conditions. Note fire activity on the right side of the tank in the middle photograph. These flames were impacting Tank 14. The ARFF crews provided extremely professional support to operations.

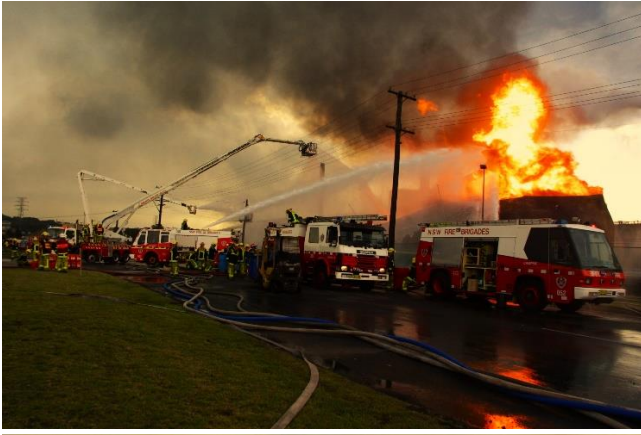
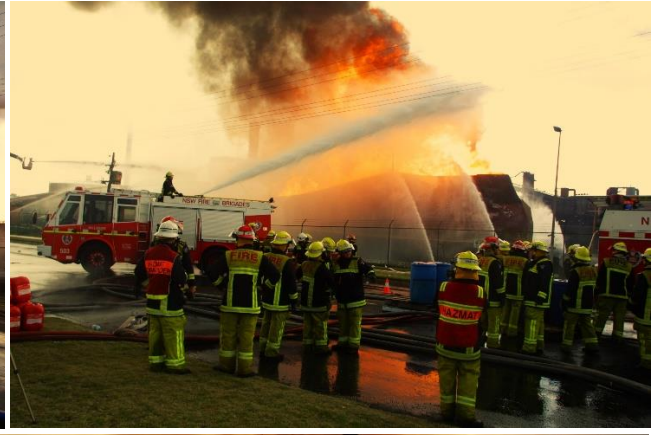
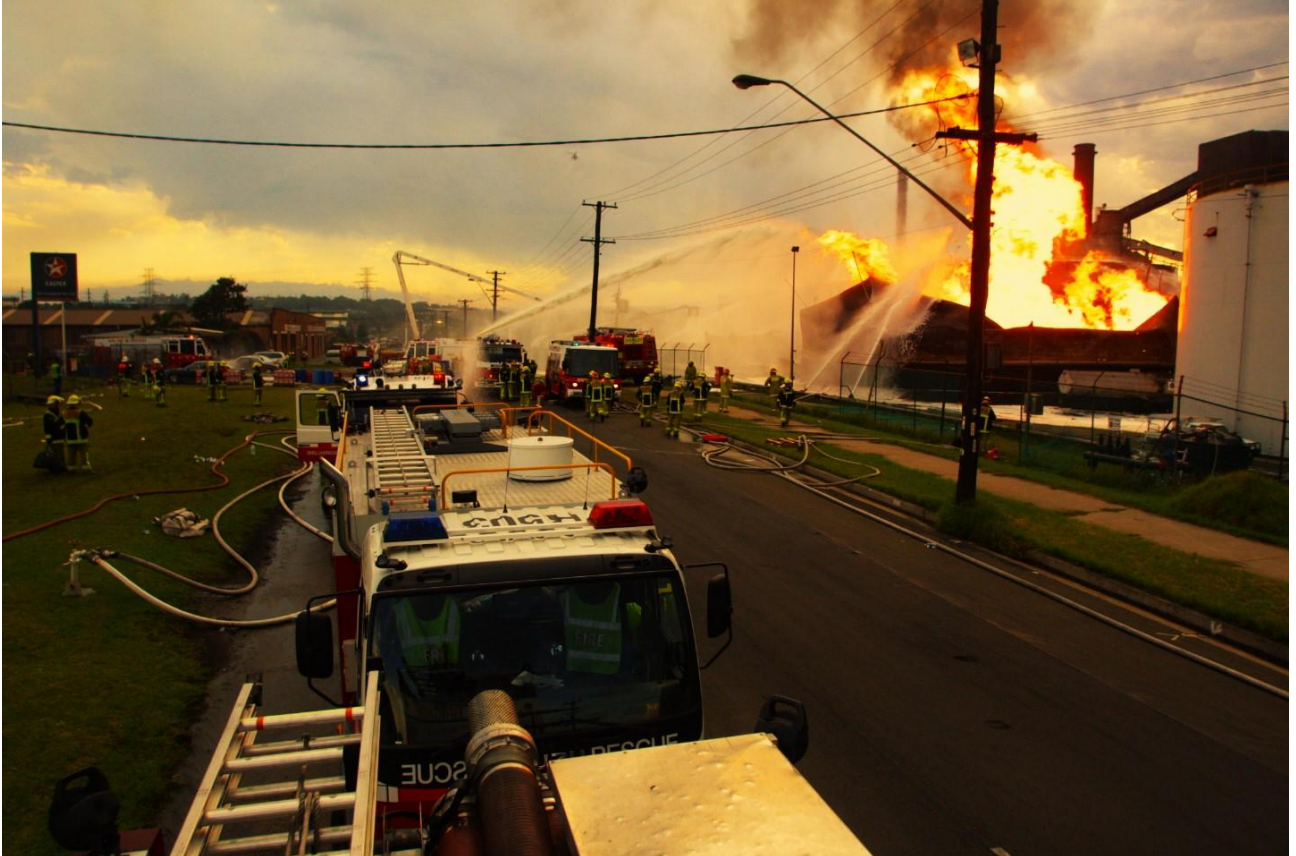
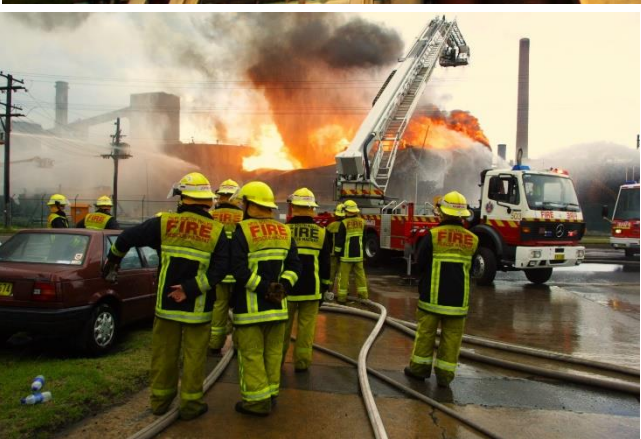
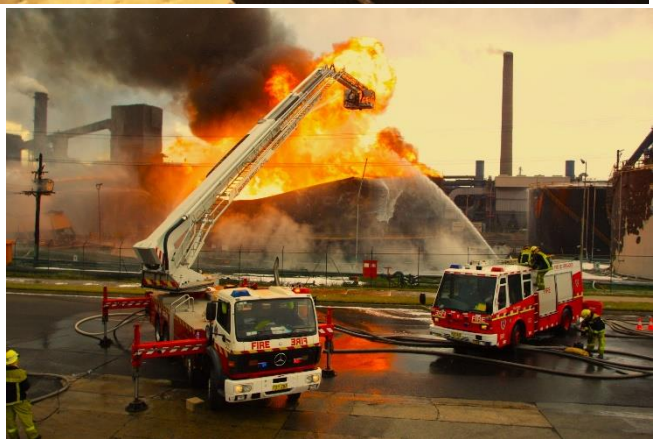
Upper and Middle: As the incident progressed additional protection streams were placed in operation, securing exposure tanks under threat. Lower: Ladder Platform 503 and Super Pumper 503 alternate master streams Between the burning tank wall and exposure tanks.

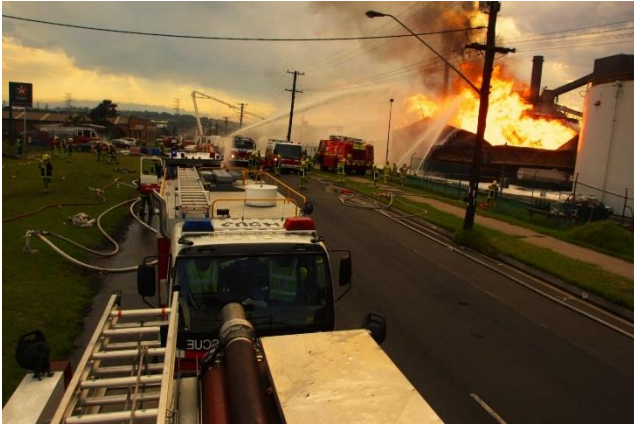
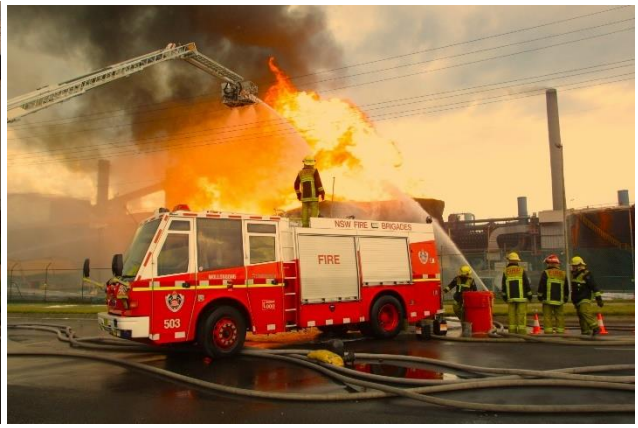
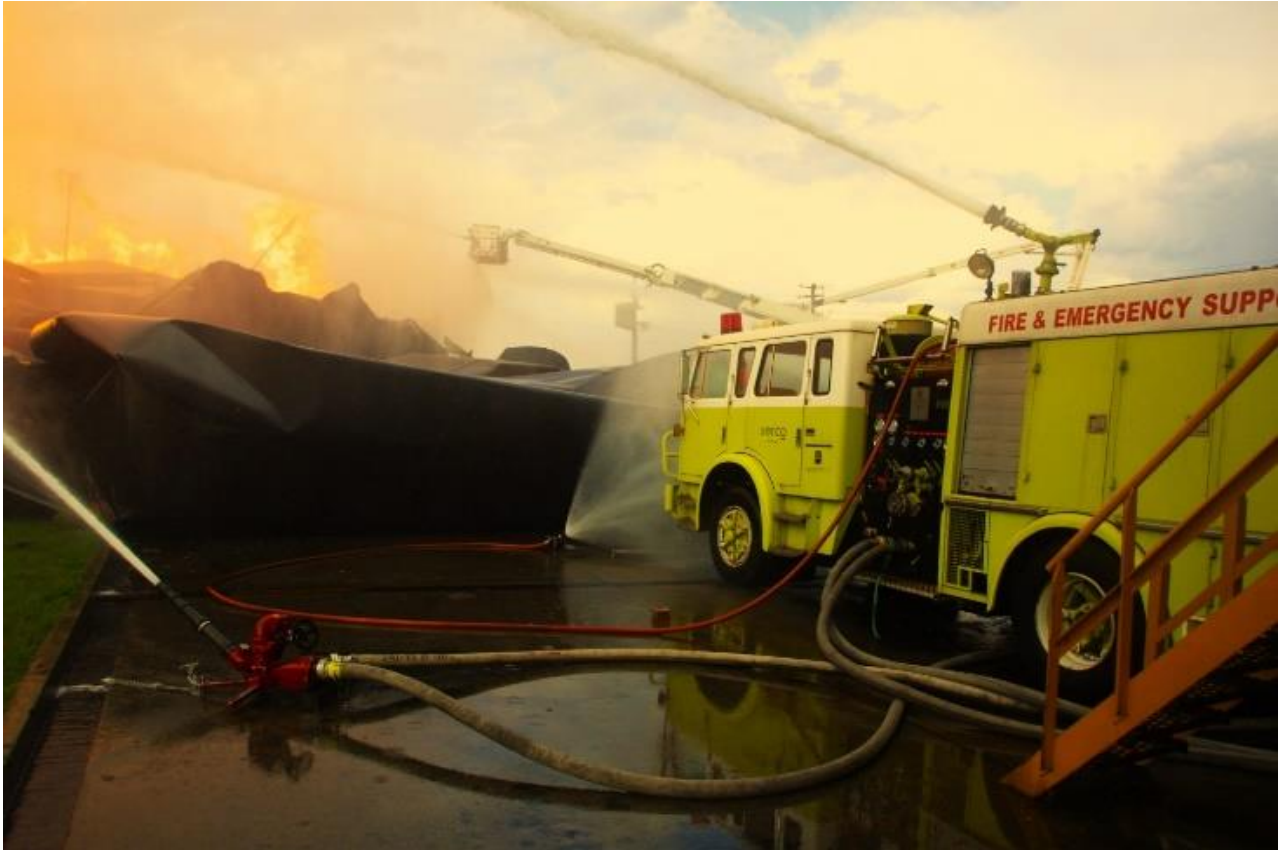
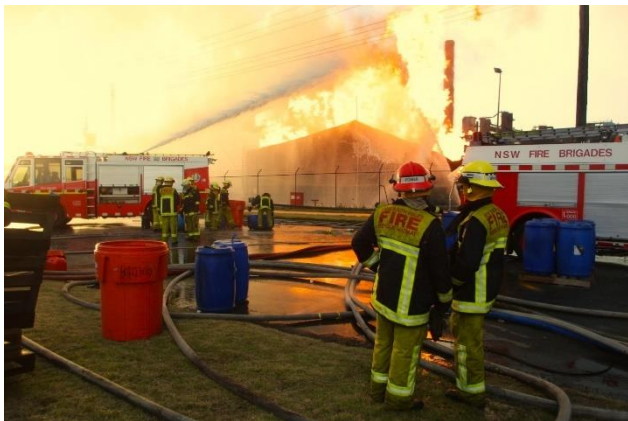
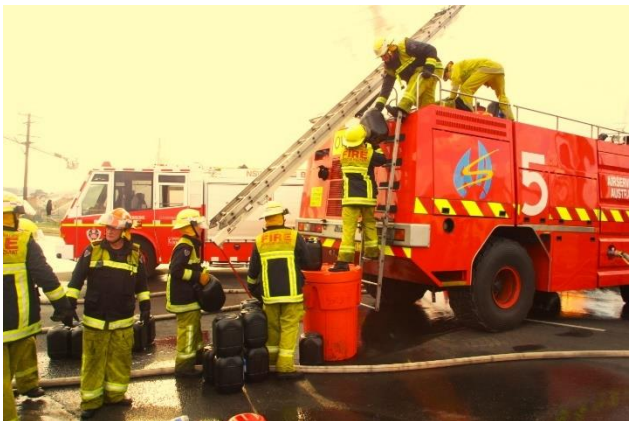
Upper: Firefighters direct master streams onto the wall of the burning storage tank.

Middle: The initial fire attack: Ground monitor and Blue Scope Steel appliance roof monitor stream used to protect Tank 14. Lower: 200 litre drums of foam are delivered to the site (left). Firefighters load alcohol type concentrate into the ARFF fire appliance.

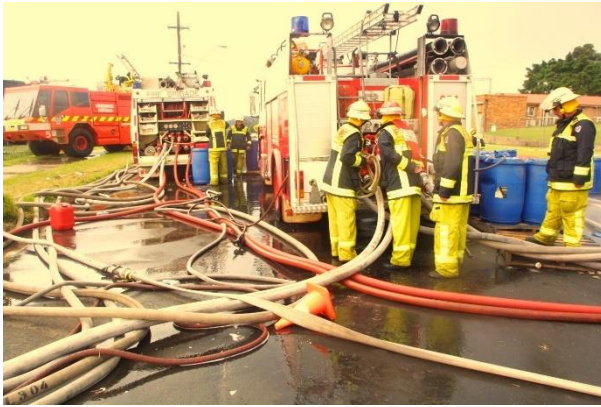
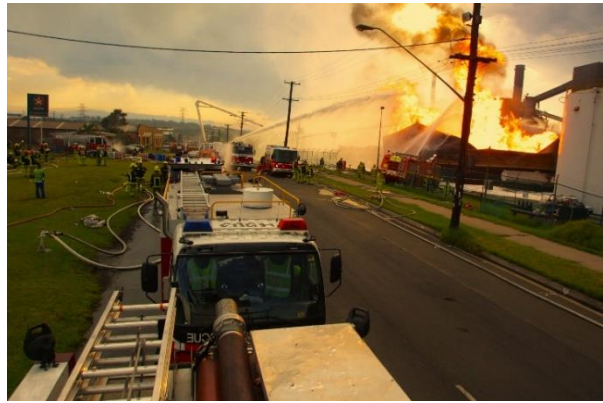
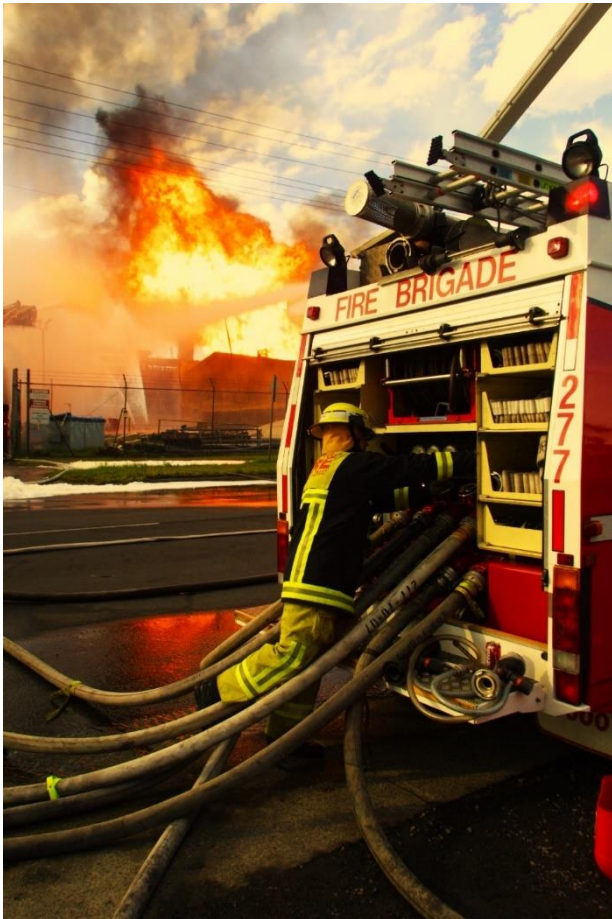
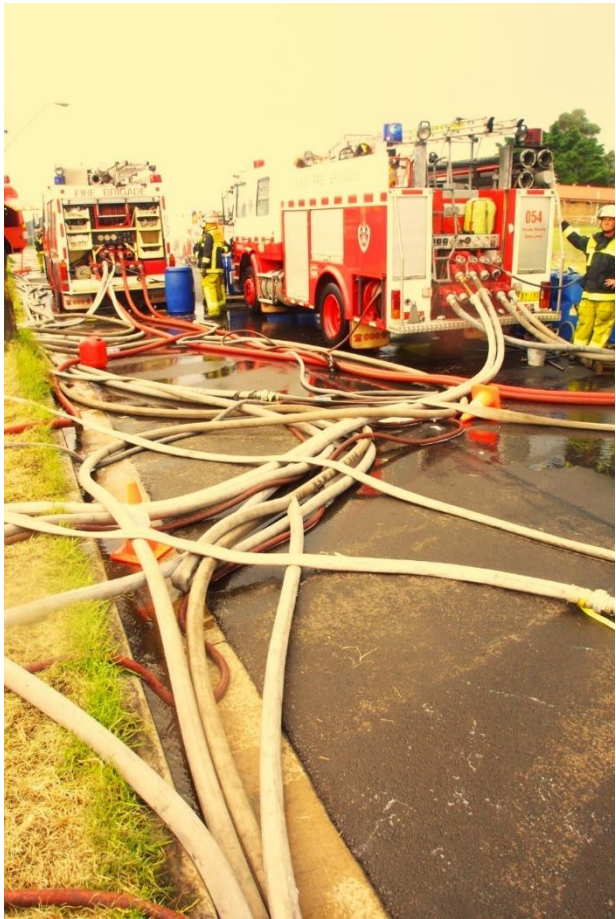
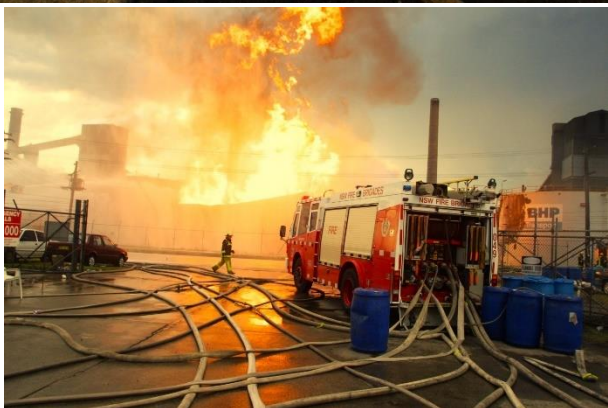
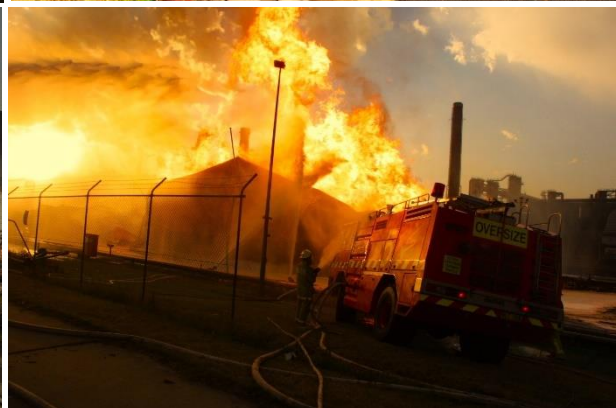
Upper and middle right: Appliances at the northern end of Division A pump foam to ground monitors middle left: Pumper 277 supplies water to Ladder Platform 18. Lower: Pumper 49 (left) supplies water to the ARFF appliance (right).

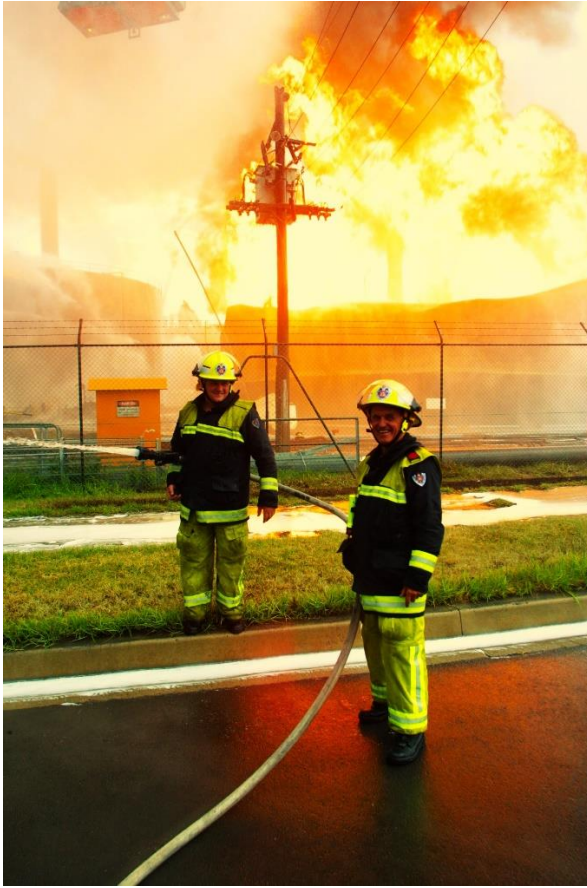
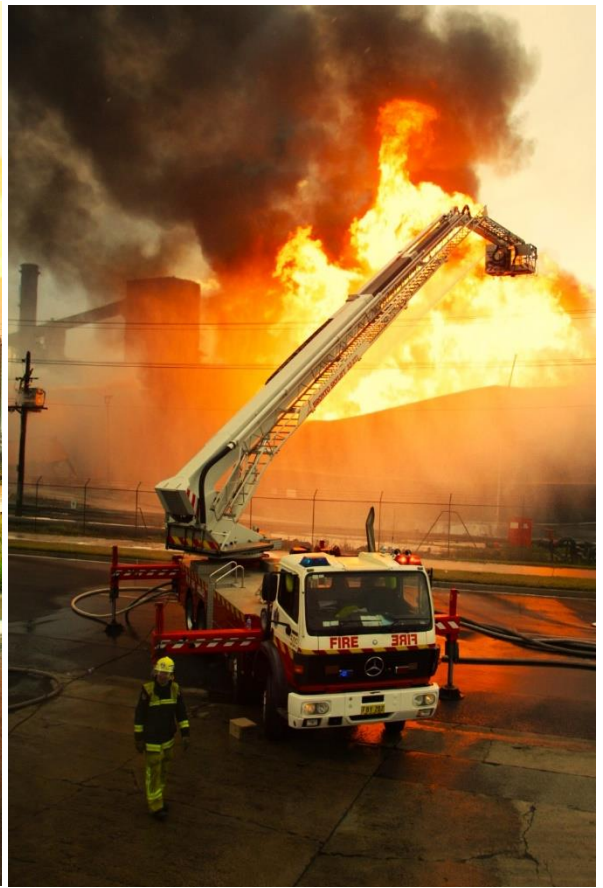
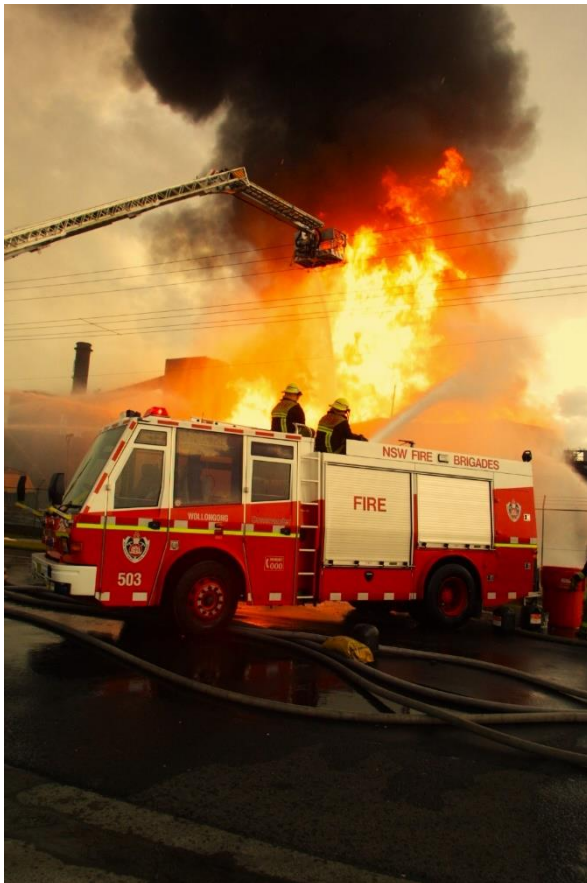
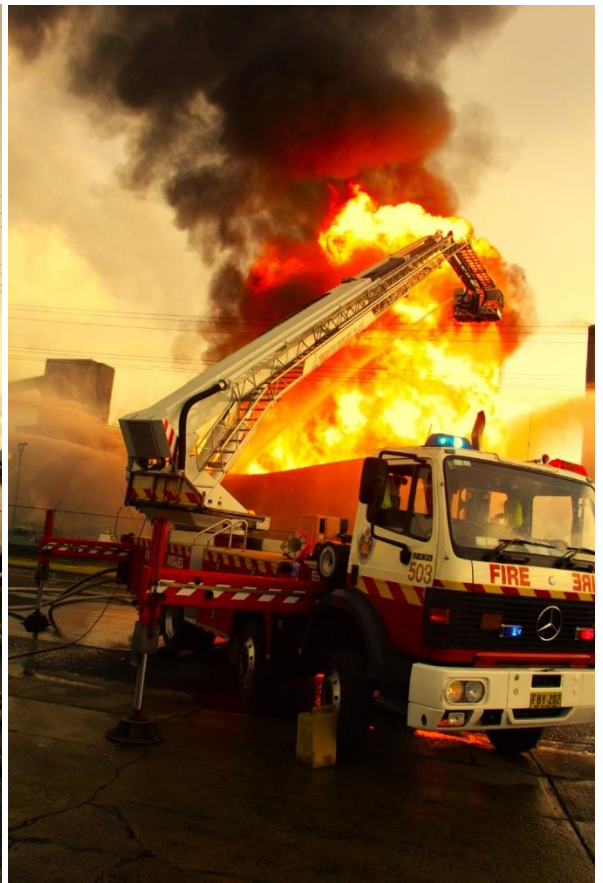
Upper left: 210 Station firefighters direct a protective stream onto the cage of Hydraulic Platform 21 and a pole mounted electricity transformer. Ladder Platform 503 and Super Pumper 503 direct large diameter cooling streams onto the sides of the involved tank and Tank 8.
