MW1 C STATION TRAINING AND INCIDENT CASE STUDIES

FILE NO. SR / 02.

**11th ALARM PORT KEMBLA ETHANOL BULK
STORAGE TANK FIRE**

Flammable Liquid Bulk Storage Tank Fire - Full Surface Fire.

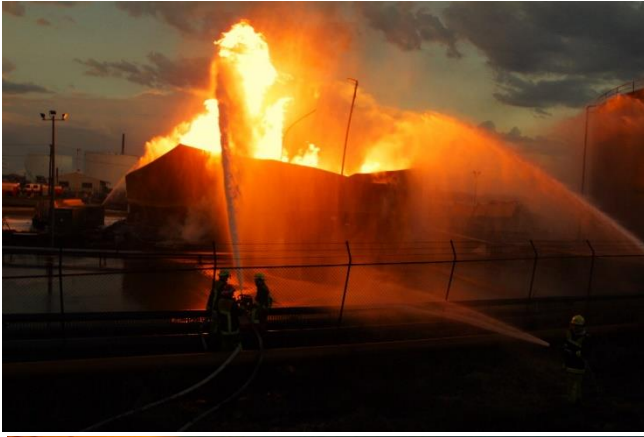
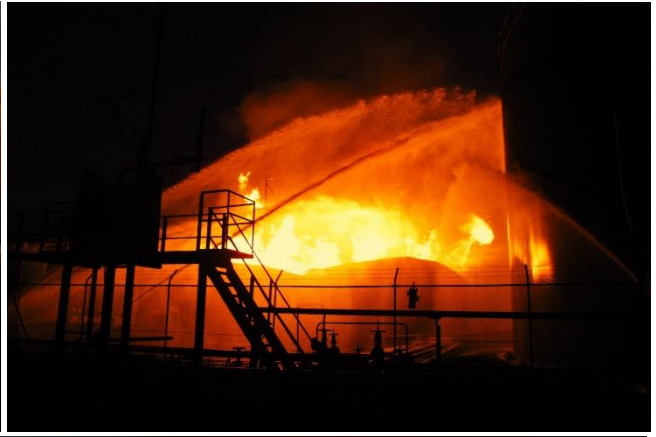
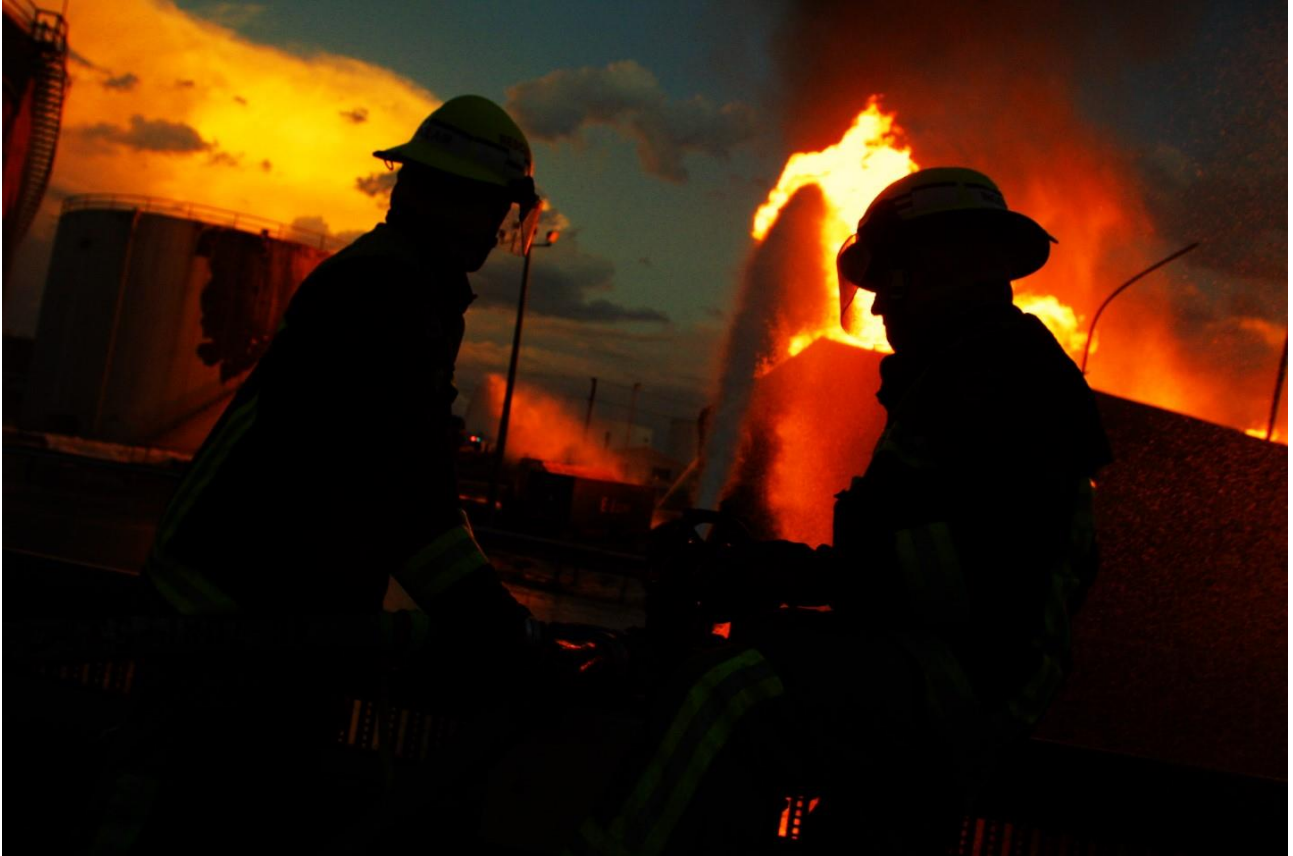
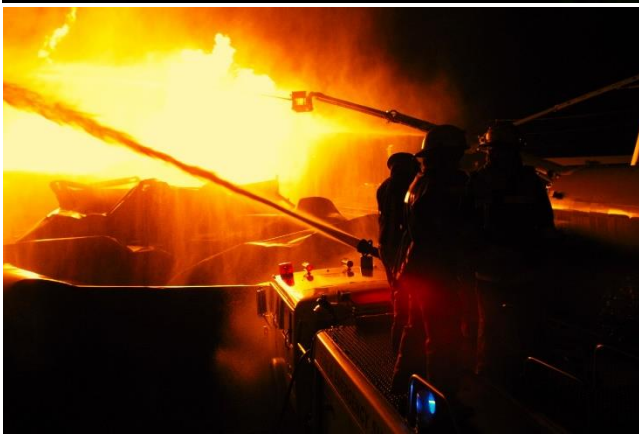
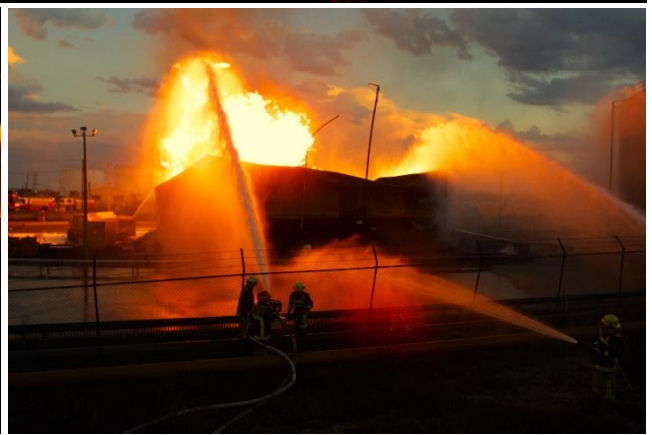
Upper, Middle and lower right: Firefighters working in Division B direct multiple ground monitor streams onto the walls of threatened Tanks 12 and 14. Lower right: Firefighters reposition the roof monitor of the BlueScope Steel industrial appliance protecting Tank 14

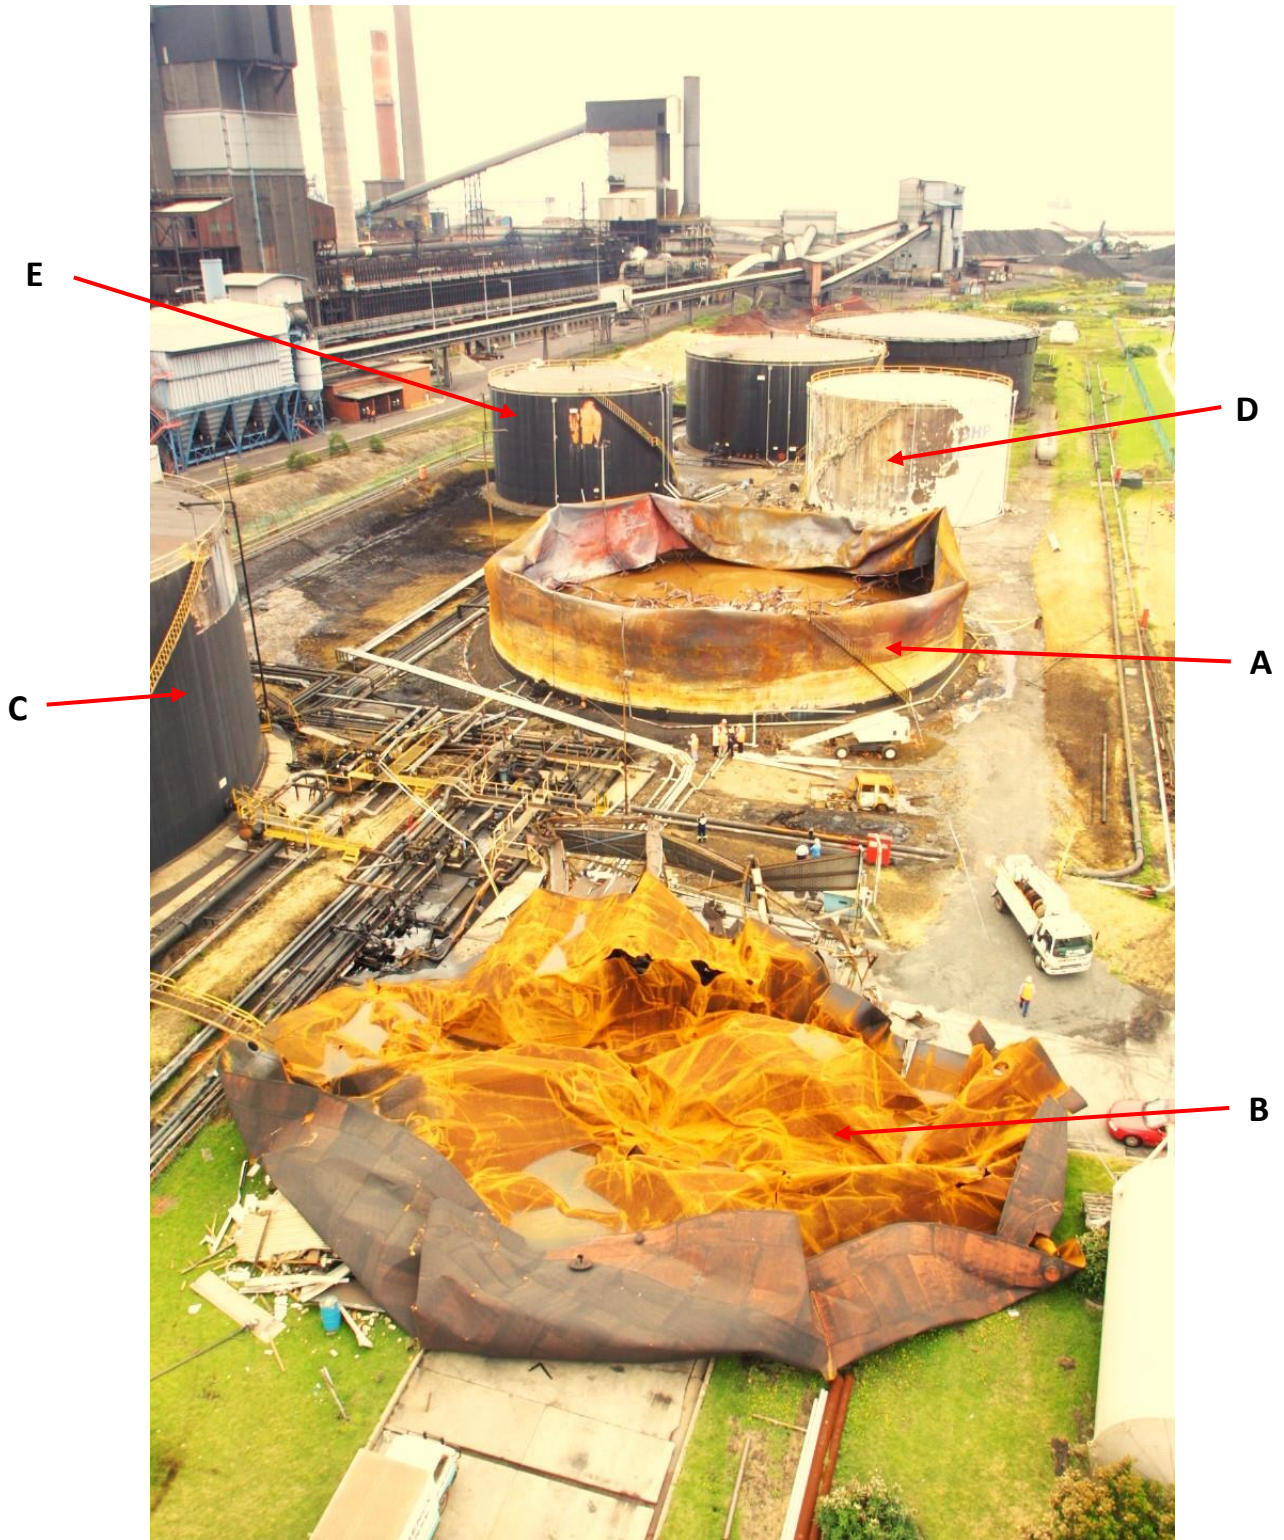
Post fire: **A** Ethanol tank (Tank 11), **B** Displaced lid of ethanol tank, **C** Tank 14, **D** Tank 6, **E** Tank 12.

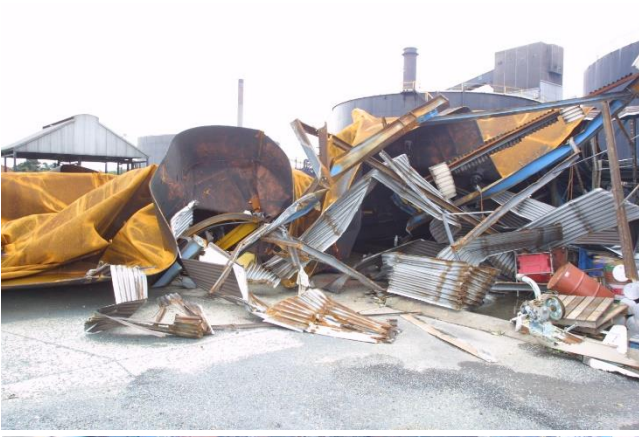
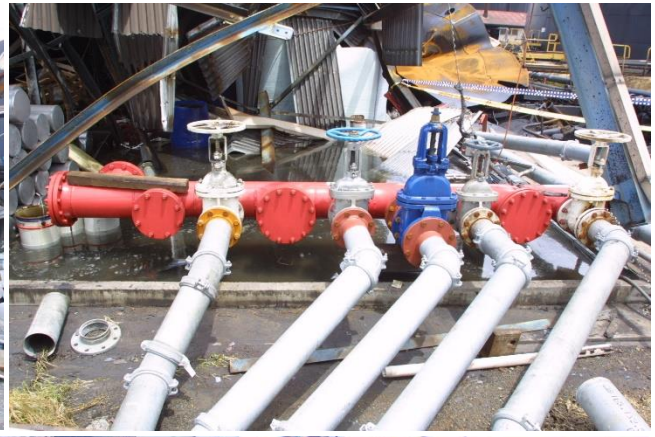
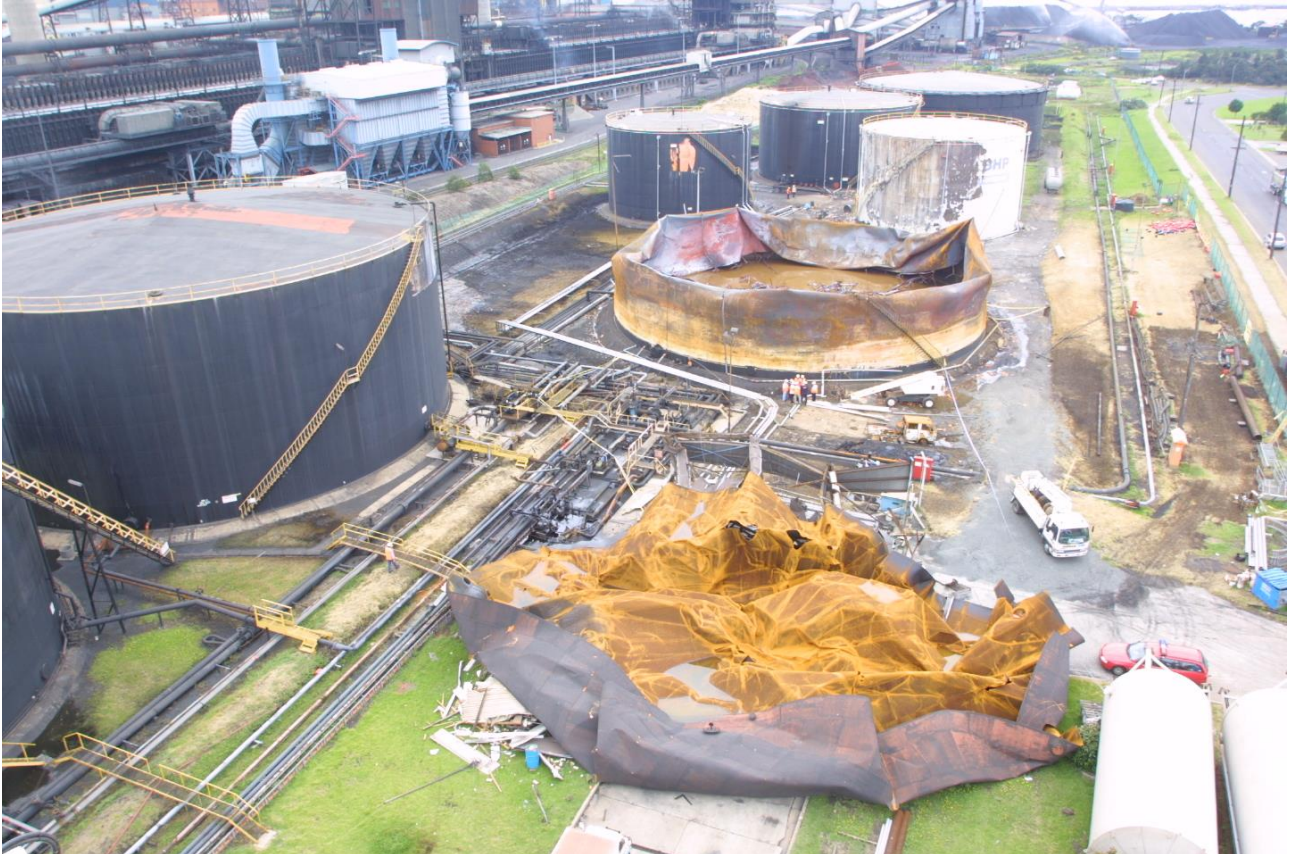
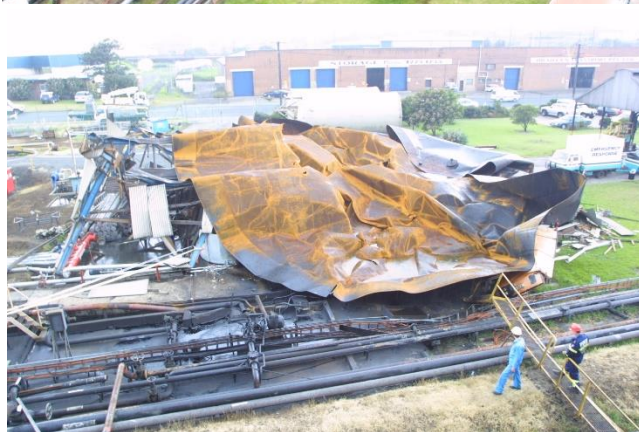
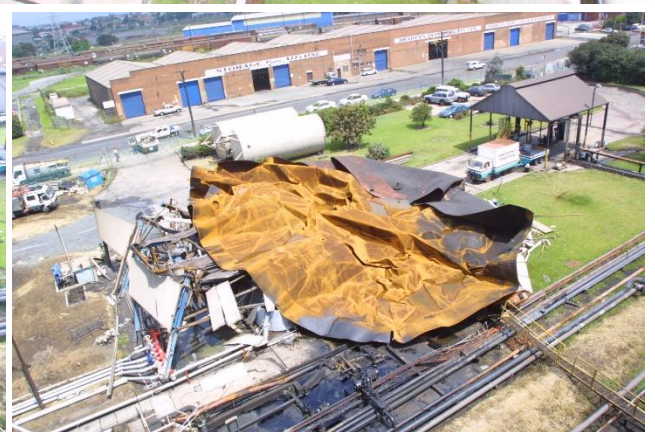
14. When arriving at a bulk flammable liquid storage tank fire, firefighters should be prepared for installed firefighting equipment that has been damaged or destroyed due to the effects of the fire or explosion.

The 120-tonne fixed steel roof was blown off the storage tank by the force of the explosion and landed on the foam fire suppression system, rendering the system inoperable.
