MW1 C STATION TRAINING AND INCIDENT CASE STUDIES

FILE NO. SR/ 06 .

ROCKDALE PETROL TANKER FIRE

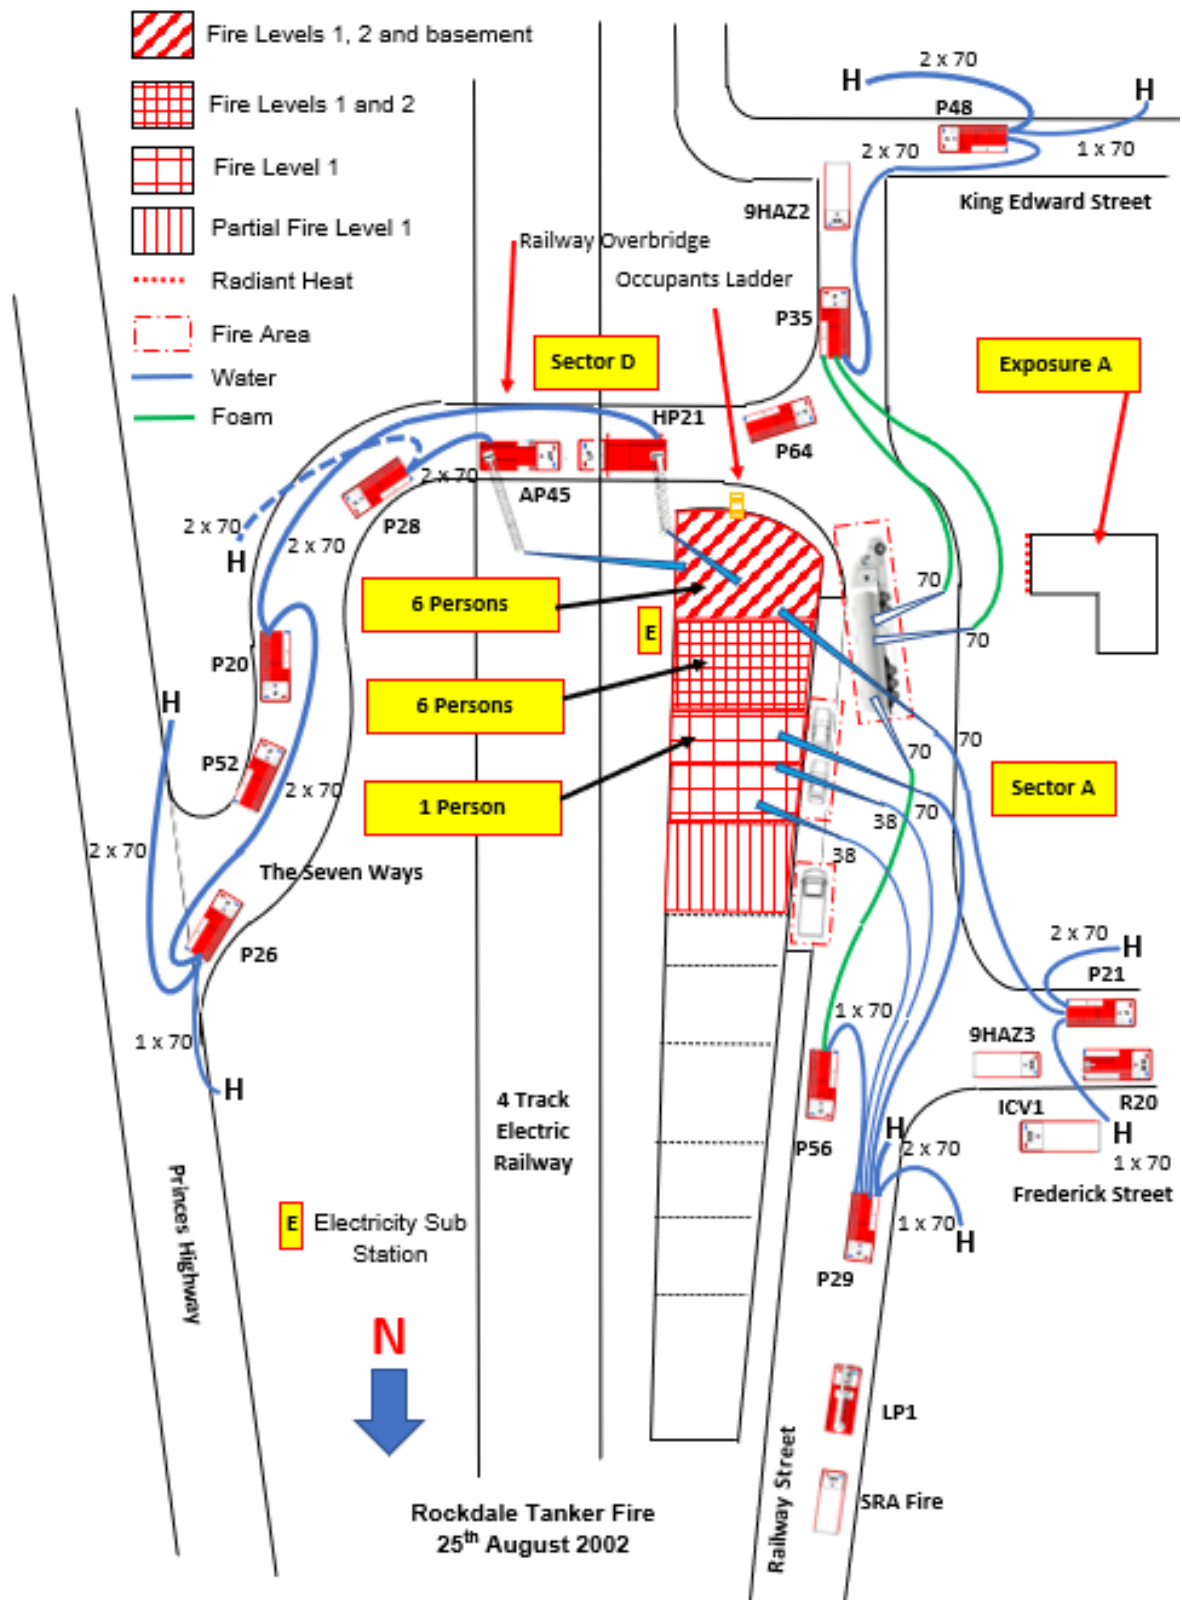
Fireground drawing of Rockdale Tanker Fire – Wide View.

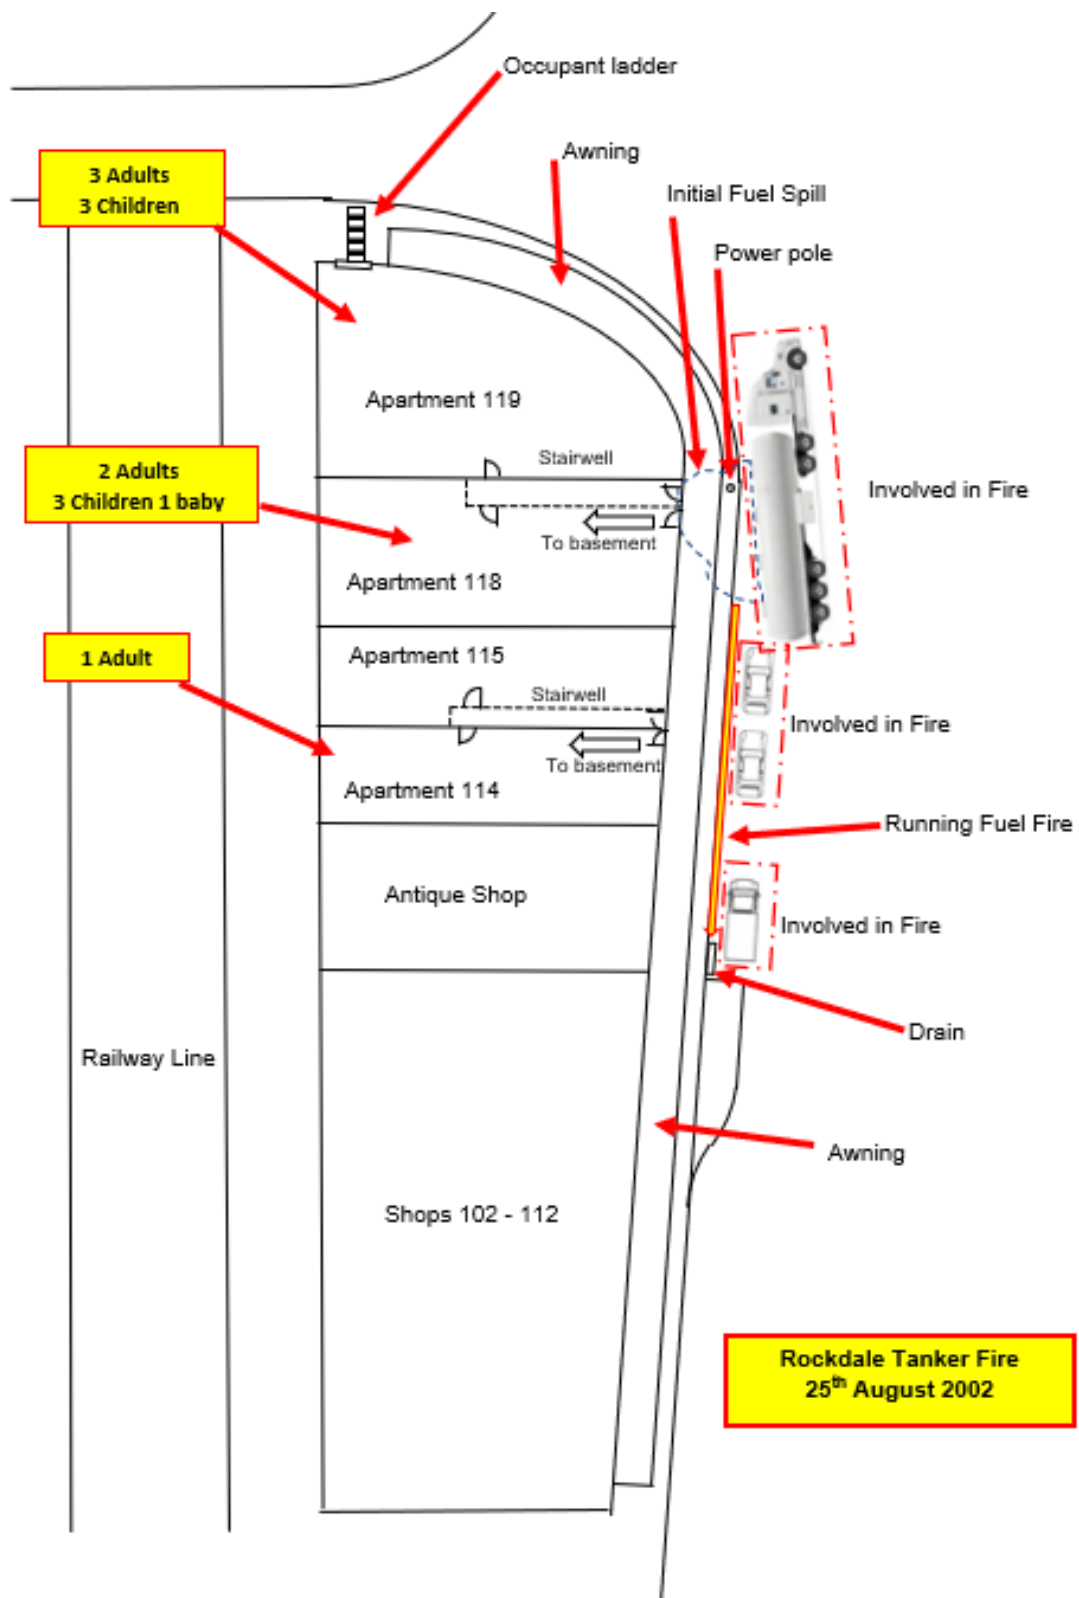
Fireground drawing of Rockdale Tanker Fire – Close View.

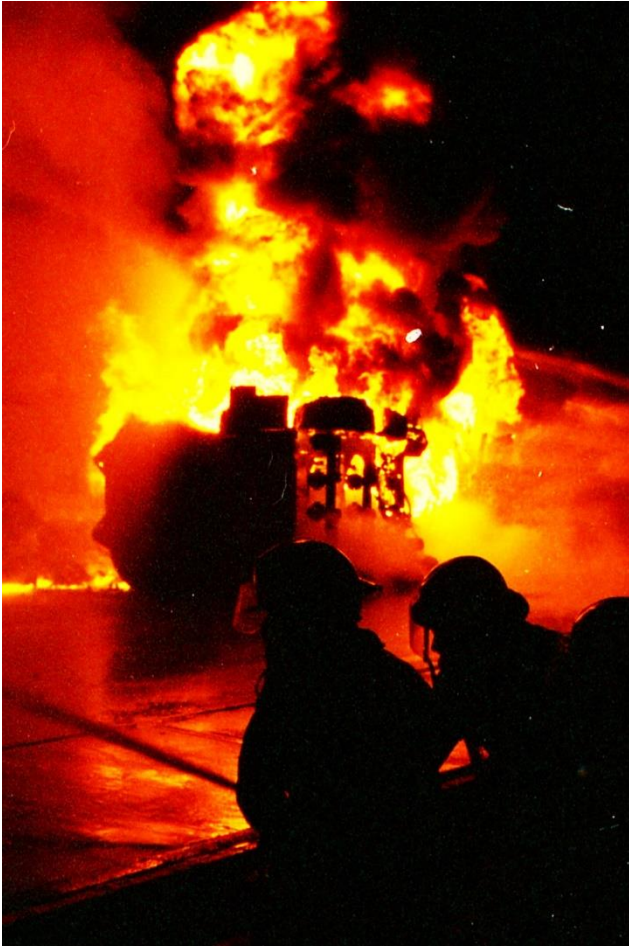
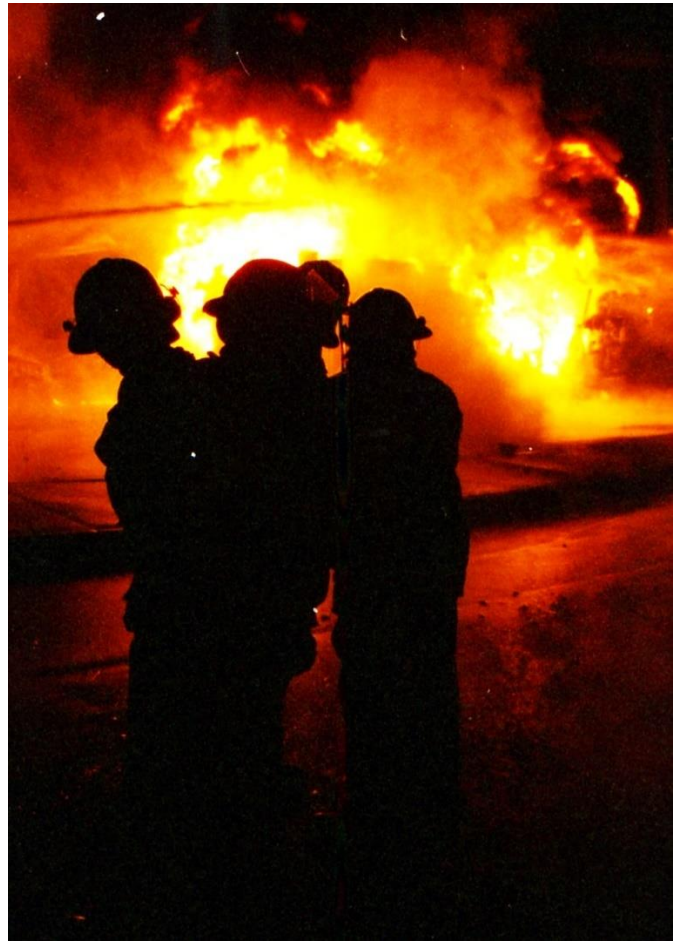
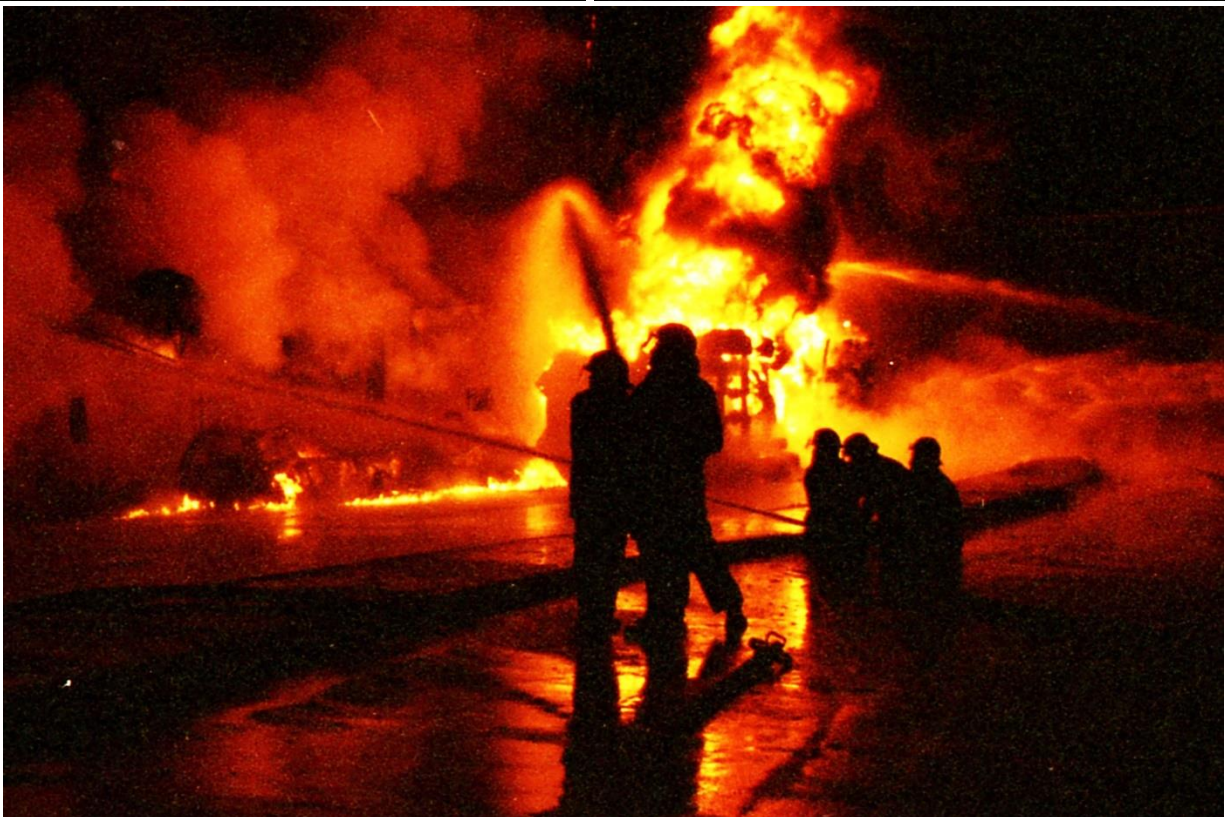
Firefighters battle ferocious and intense fire conditions, directing large 70 mm hose streams into the apartment building where an occupant remains trapped. These operations stopped the fire spreading and saved the building. More importantly, they saved a life.

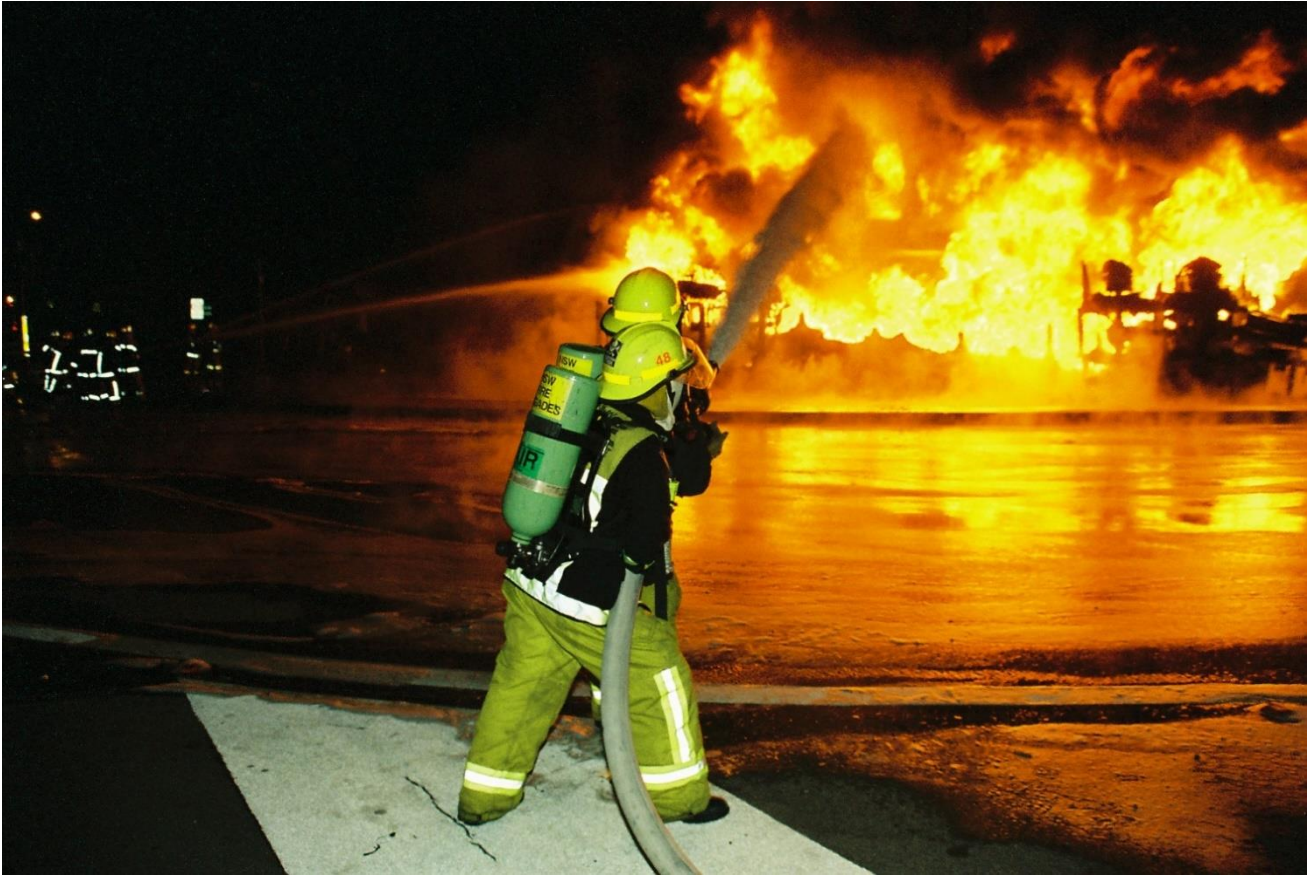
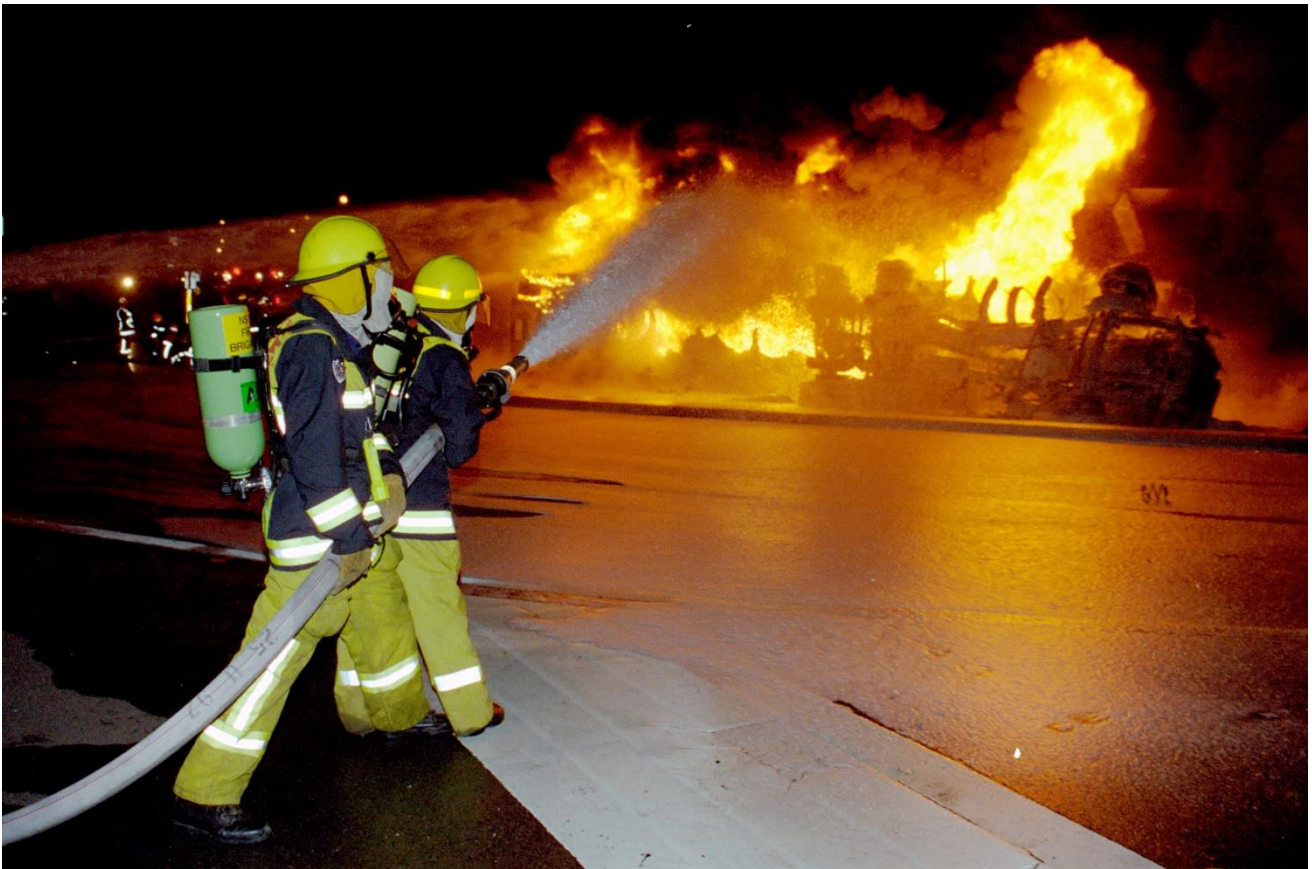
Foam crews attack the fire from 48 (upper) and 35 (lower) stations. The combined “massed” streams of the two foam lines were highly successful, resulting in the fire being extinguished, in conjunction with a third foam line from Pumper 56.

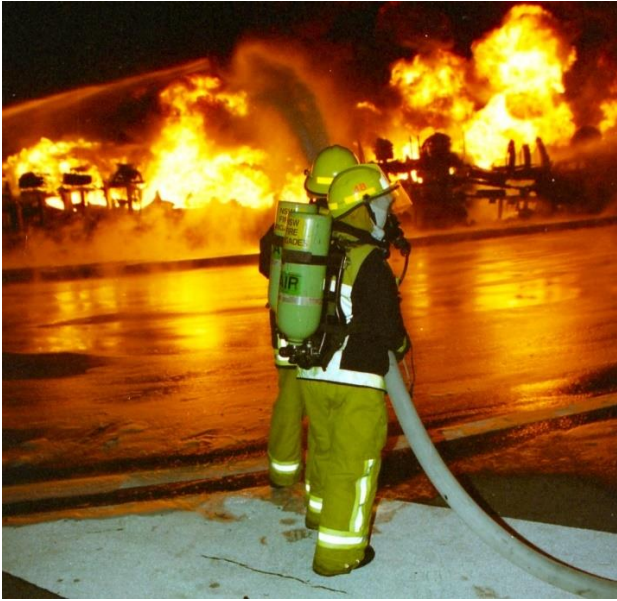
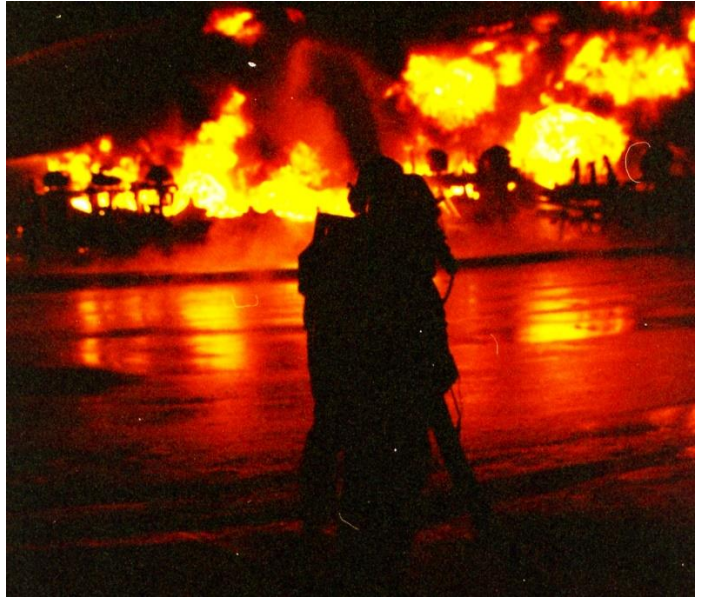
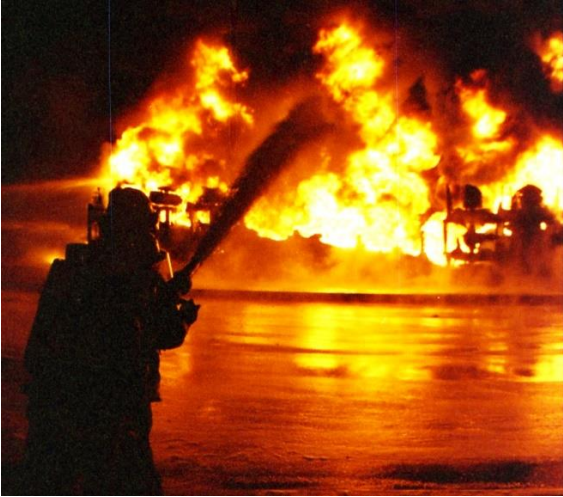
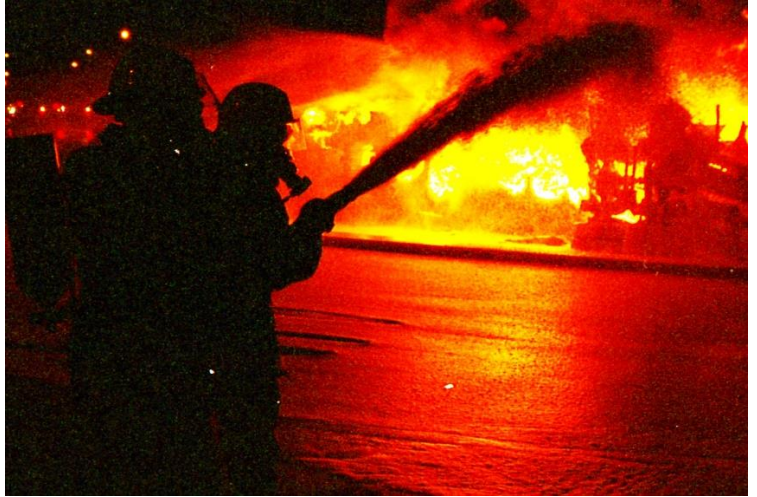
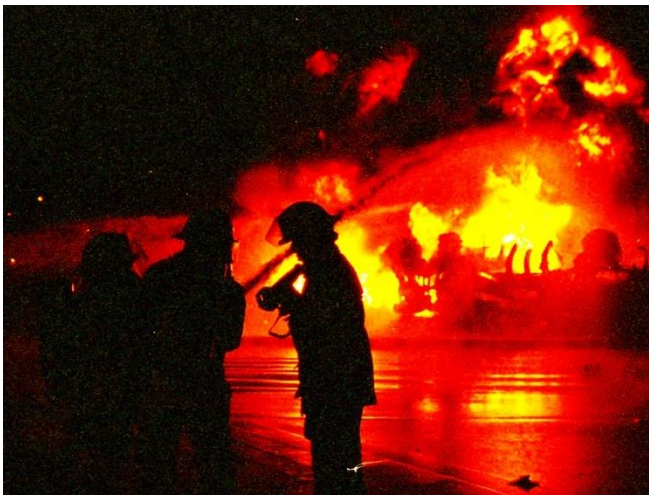
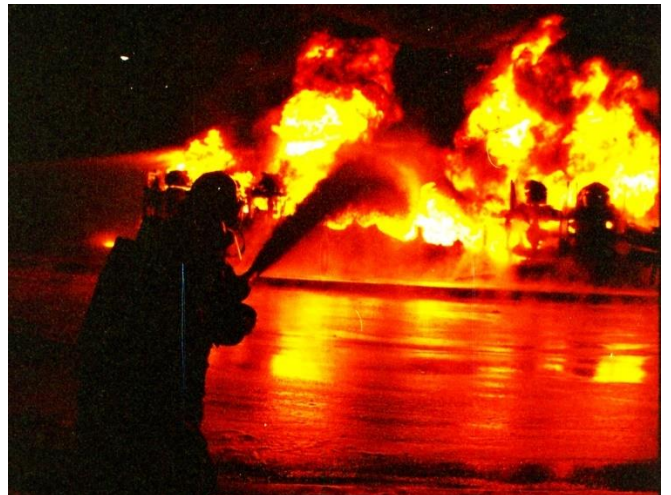
“Massing” of foam streams onto one point on the surface of the burning flammable liquid achieved placement of a foam blanket and extinguishment.

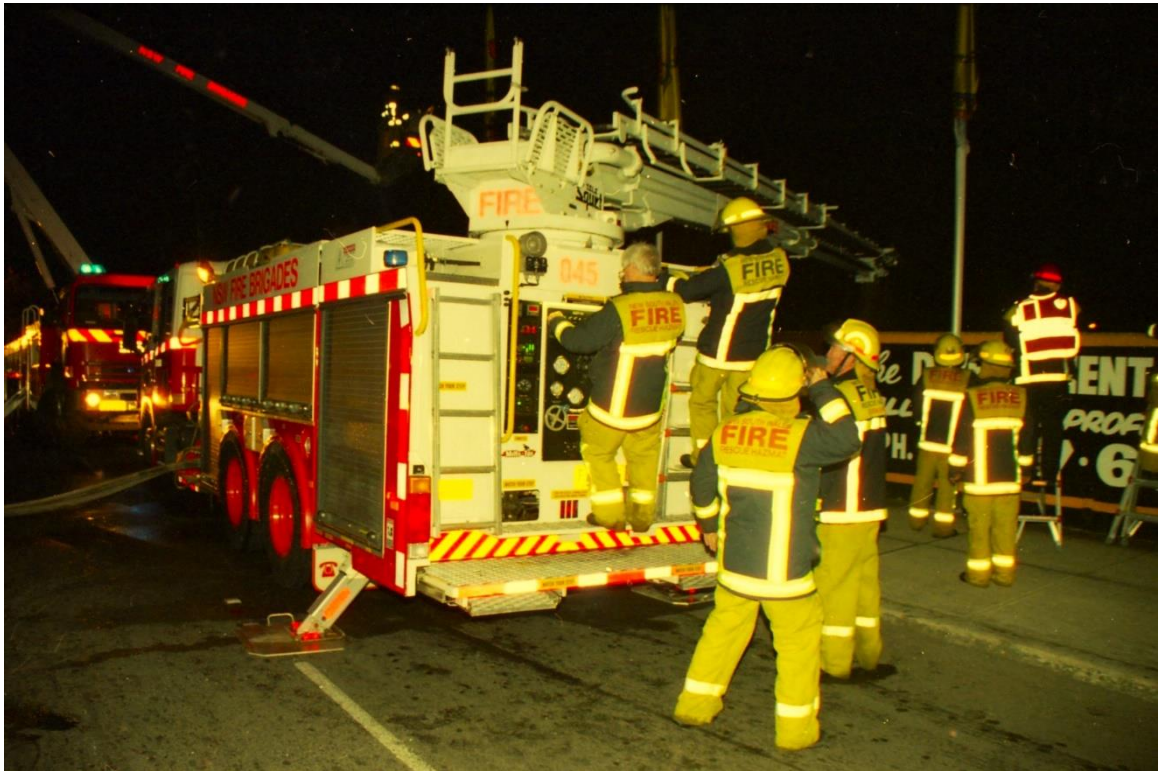
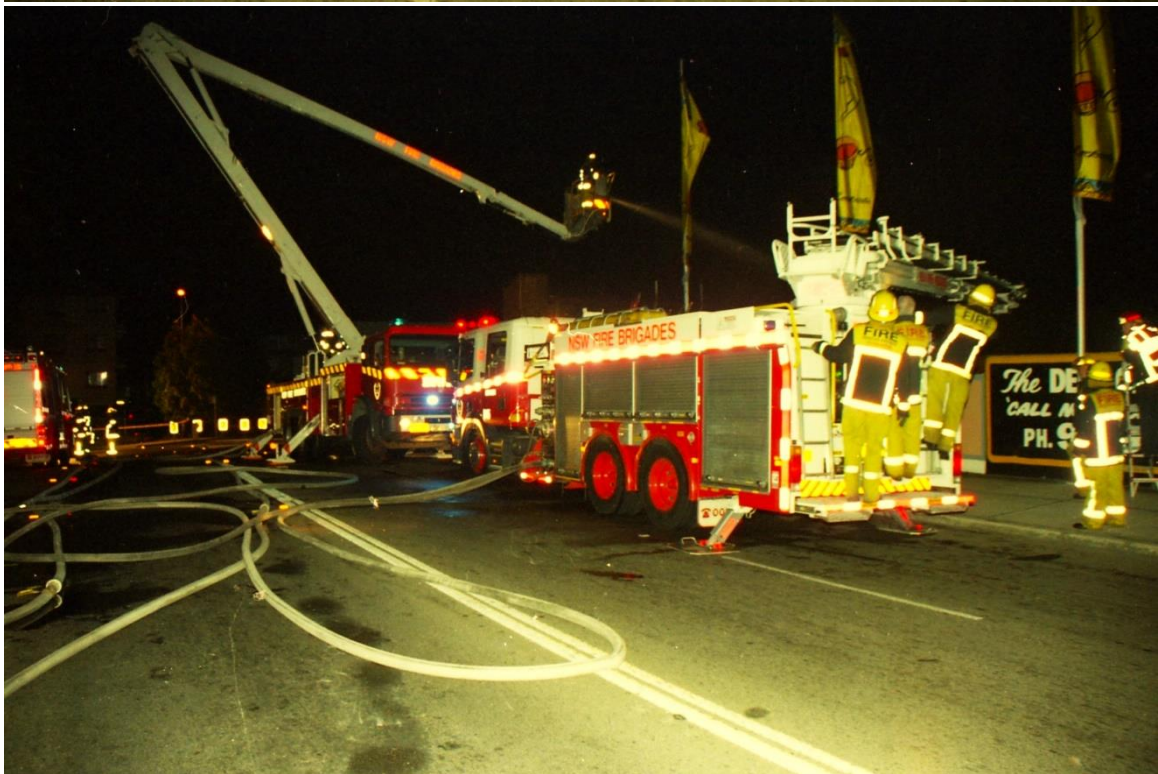
Aerial Pumper 45 attacks the fire from the railway overbridge (upper).
Hydraulic Platform 21 and Aerial Pumper 45 attack the fire (lower).

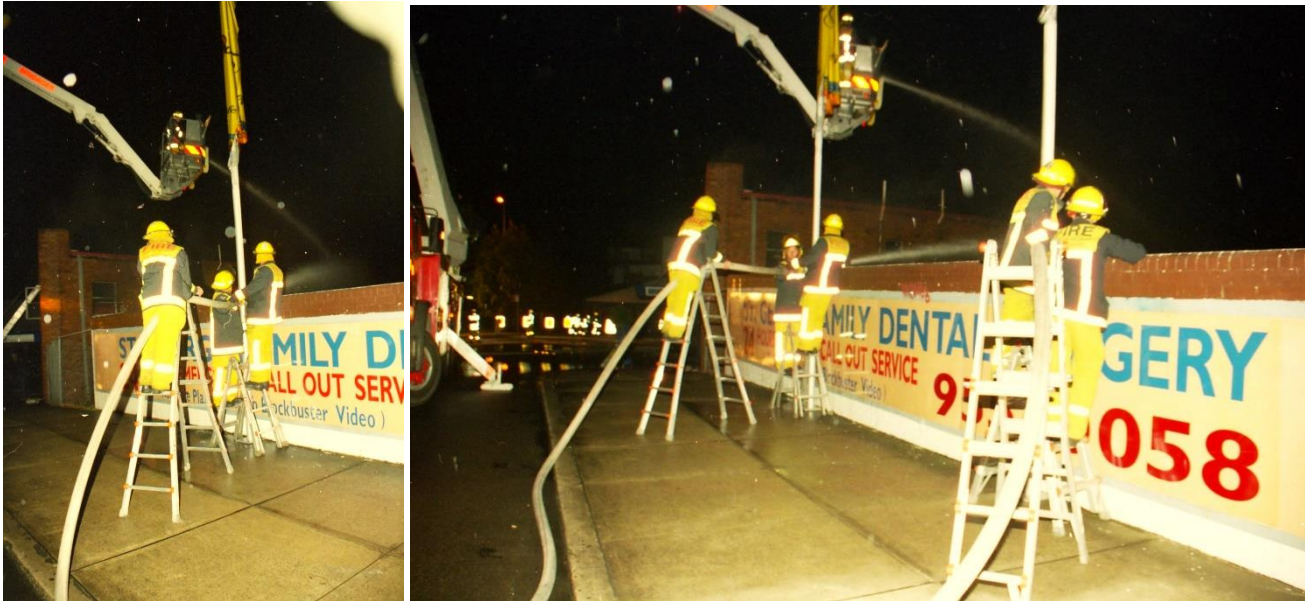
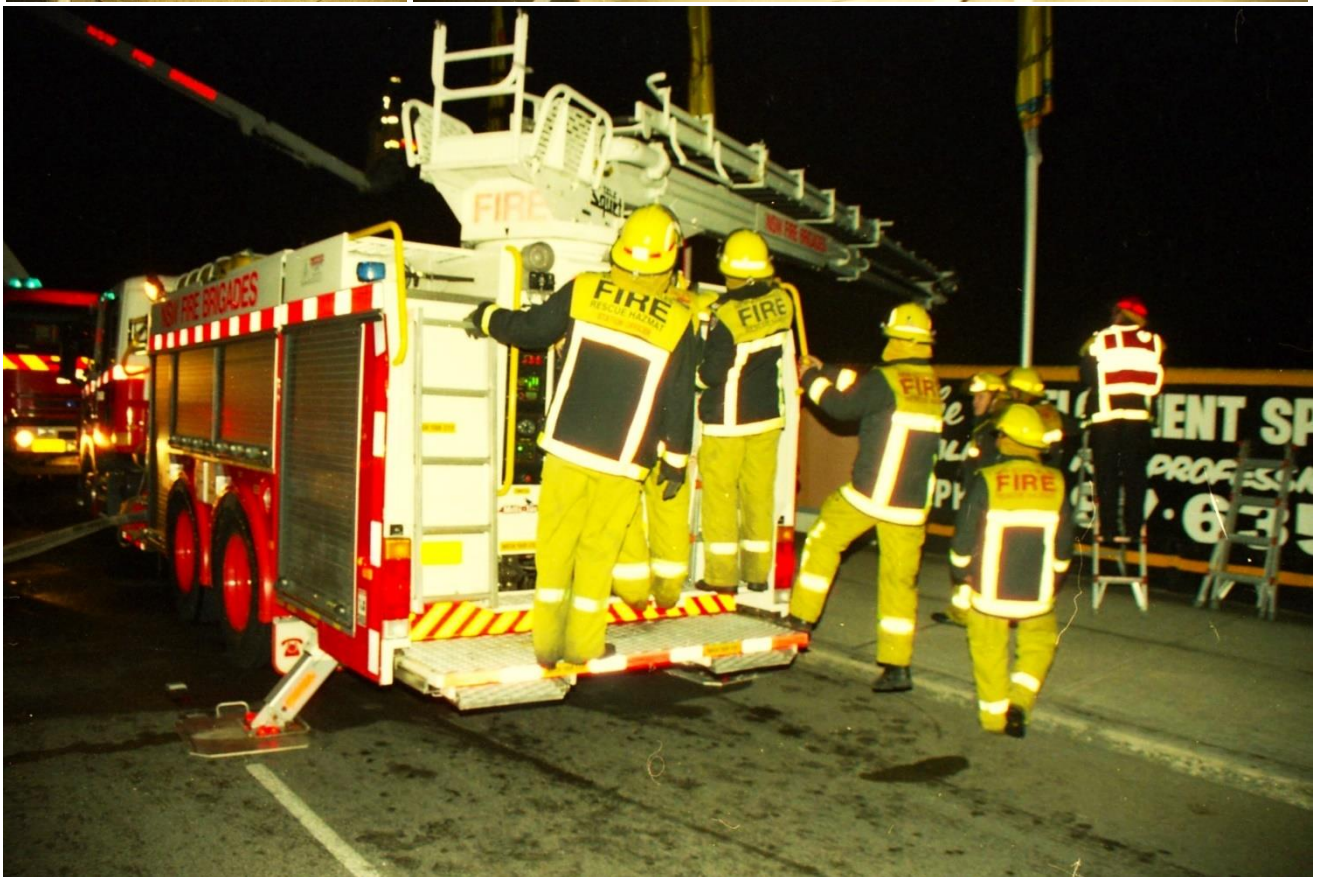
Firefighters use 70 mm handlines to attack the building fire from the railway overbridge (top). These lines were shut down and water supplied to Aerial Pumper 45 (lower).

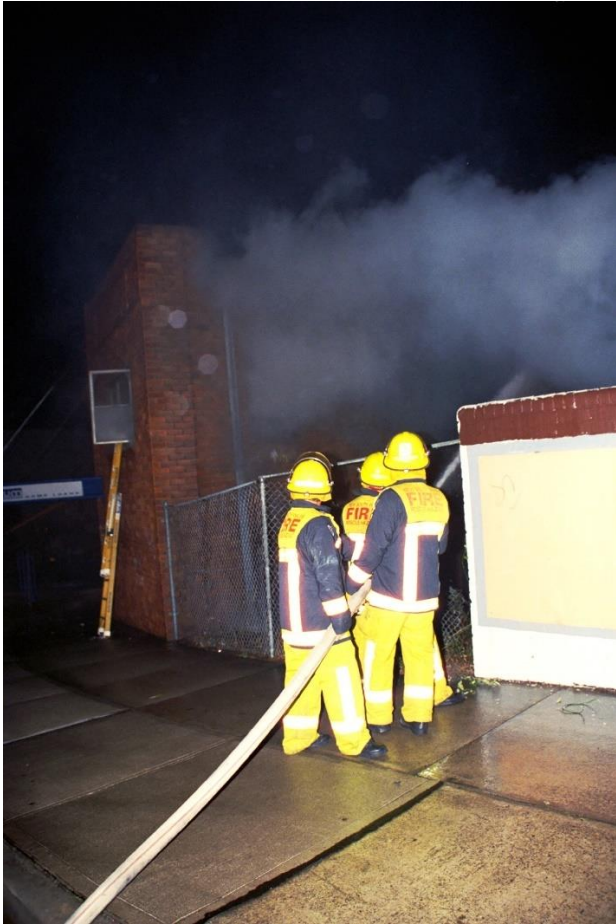
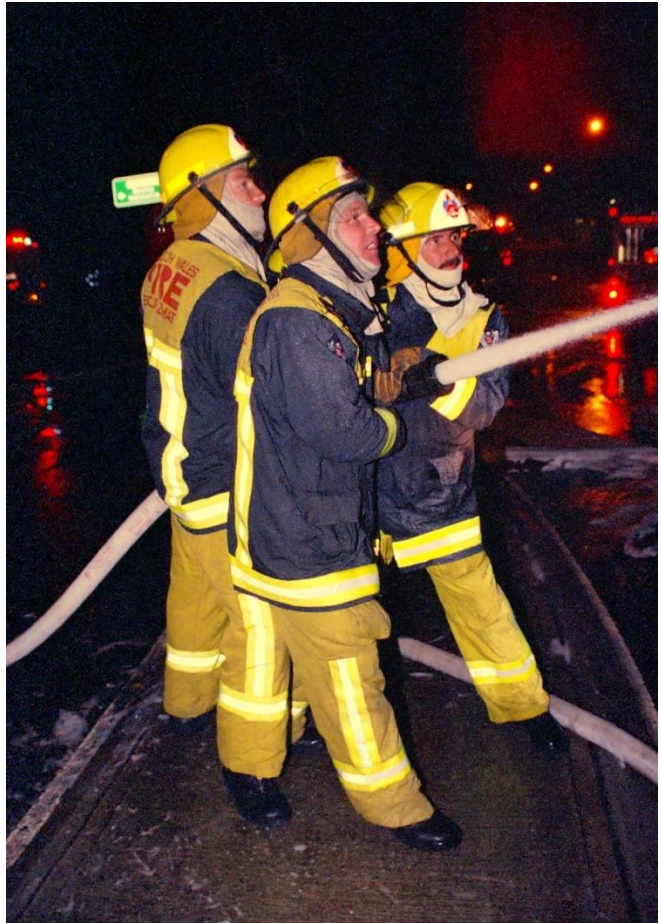
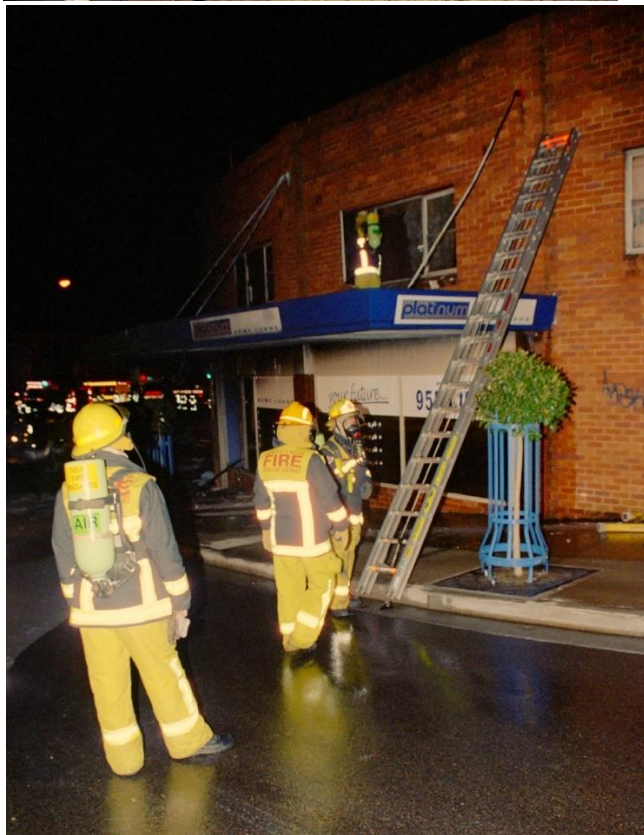
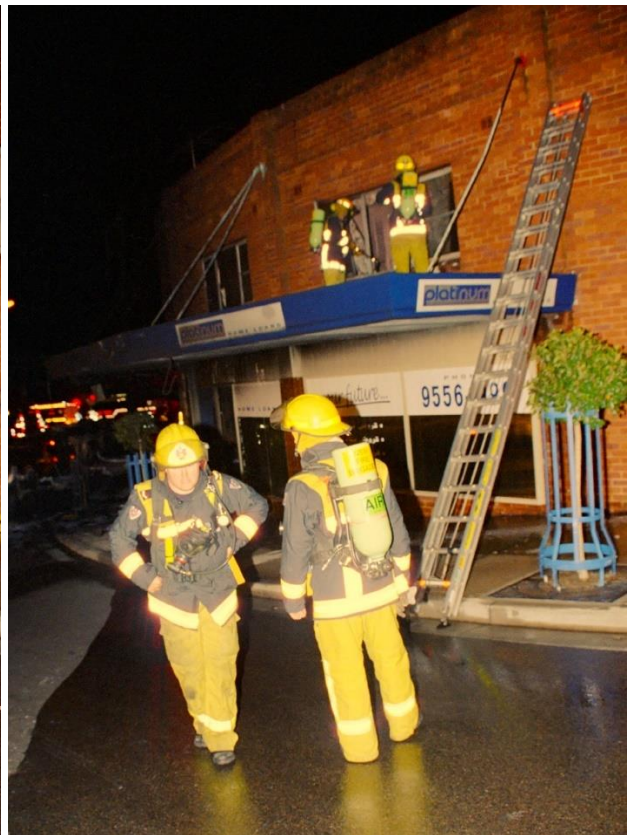
Firefighters attack the building fire from Sector C (top left). Fire attack crews in Sector A operate a 70 mm line (top right). Following extinguishment of the tanker fire a secondary search gets underway from the awning of the units above the involved shops (lower).
